4. Description of Damages				
THE VEHICLE SUSTAINED DAMAGES AT THE REAR PORTION. DAMAGES SEE DETAILS				
5. General Information				
Accident Date	02/03/2020	Inspection Date	13/03/2020	
Survey held at	INDECO ENGINEERS PTE LTD 39 DEFU LANE 12 . SINGAPORE 539139			
5a. Remarks				
A)THE INSPECTION WAS CONDUCTED ON A"WITHOUT PREJUDICE" BASIS. B)IN ACCORDANCE TO YOUR INSTRUCTIONS, WE HAVE NOT AUTHORISED REPAIRS.				
5b. Estimate Days of Repair				
ESTIMATED NORMAL PERIOD FOR REPAIR:		1 Working Days

ADJUSTMENT ON REPAIR COST FOR VEHICLE NO. SLU 5114U

PHOTOGRAPHS FOR VEHICLE NO. SLU 5114U

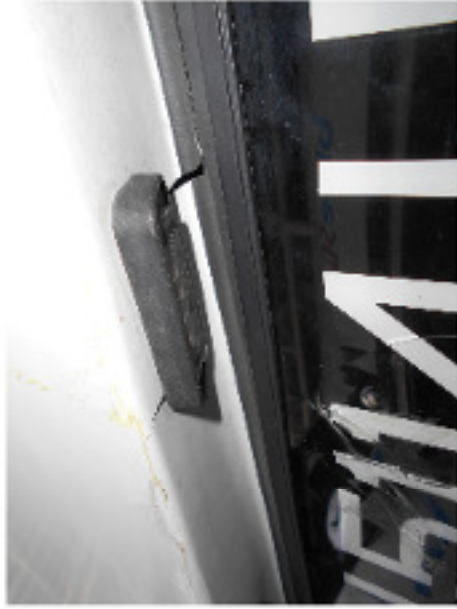
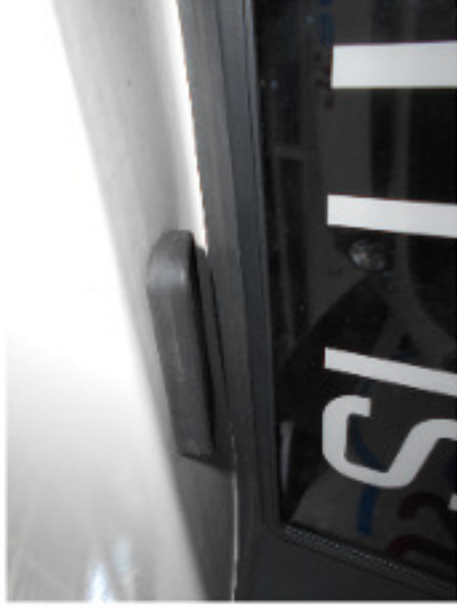
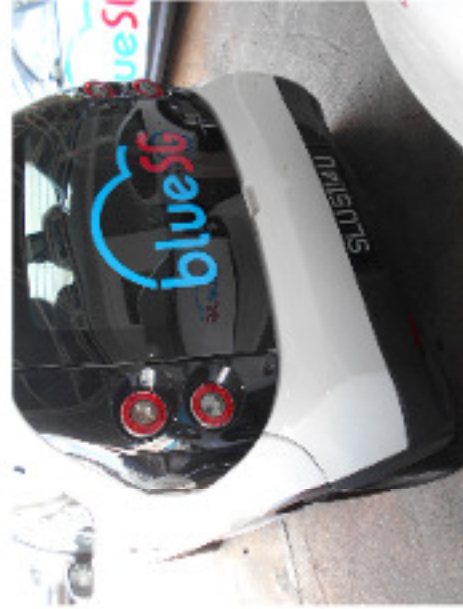
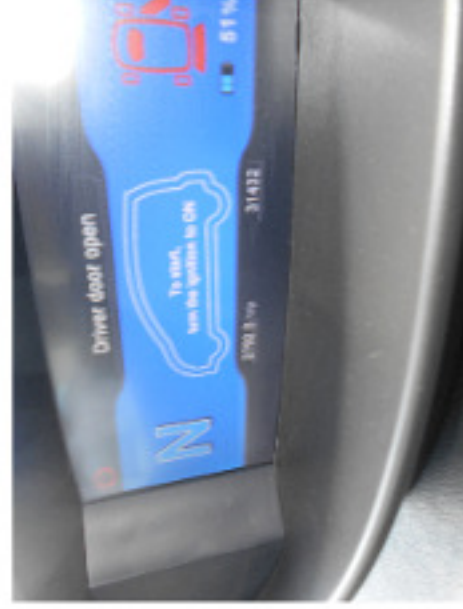
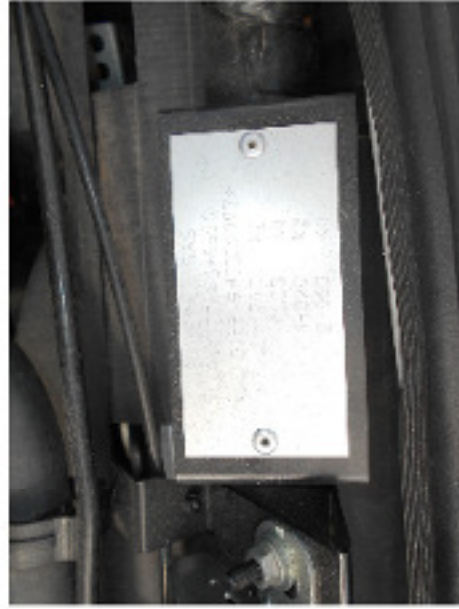
Qty	Description of Parts	Condition	Estimate By Workshop (\$)	Our Adjusted (\$)
<u>REPLACEMENT OF PARTS</u>				
1	REAR BUMPER ASSY (WCP)	DEFORMED	1,364.00	1,364.00
10	REAR BUMPER SCREW @\$2.00 (WCP)	NECESSARY	20.00	20.00
1	REAR BUMPER REFLECTOR RH (WCP)	DISTORTED	122.00	122.00
1	REAR BUMPER REINFORCEMENT (WCP)	NOT NECESSARY	80.00	-
1	REAR BUMPER REINFORCEMENT BRACKET RH (WCP)	NOT NECESSARY	42.00	-
1	NUMBER PLATE LAMP LH (WCP)	BROKEN	38.00	38.00
1	NUMBER PLATE LAMP RH (WCP)	BROKEN	38.00	38.00
	COST PLUS 20%		340.80	-
	COST PLUS 15%		-	237.30
			2,044.80	1,819.30
<u>SPECIAL NETT ITEMS</u>				
1	REAR NUMBER PLATE W CASING (SN)	CRACKED	45.00	45.00

45.00	45.00
<u>LABOUR</u>				
	TO REPAIR ,REPLACE REAR BUMPER ,REFLECTOR ,NUMBER PLATE LAMP AND AFFECTED AREA.		400.00	200.00
	TO APPLY TUFF KOTE.	NOT NECESSARY	150.00	-
	TO CHECK WIRING .		100.00	20.00
