VEHICLE DAMAGE INSPECTION REPORT

Our File No: CS/CTI20004051/UQF3N2
Date: 01/04/2020

Handling Insurer: China Taiping Insurance (Singapore) Pte. Ltd. Policy No: DMPCSNA00000622000
Claimant Vehicle No: SMA8602B Insured Vehicle No: SLV5543J
Date of Loss: 10/03/2020 Nature of Claim: TP Claim No: SNM20D201308

Reg No: SMA8602B
Make & Model: HONDA SHUTTLE, 1.5 G CVT (A) Engine No: L15B5462360
Reg. Date: 21/06/2018 (Man. Year: 2018) Chassis No: GK81202016
Colour: Silver Odometer: 39826 km
Engine Capacity: 1496 cc
Market Value/New Car Price: N/A
Sum Insured (S\$): Market Value/New Car Price

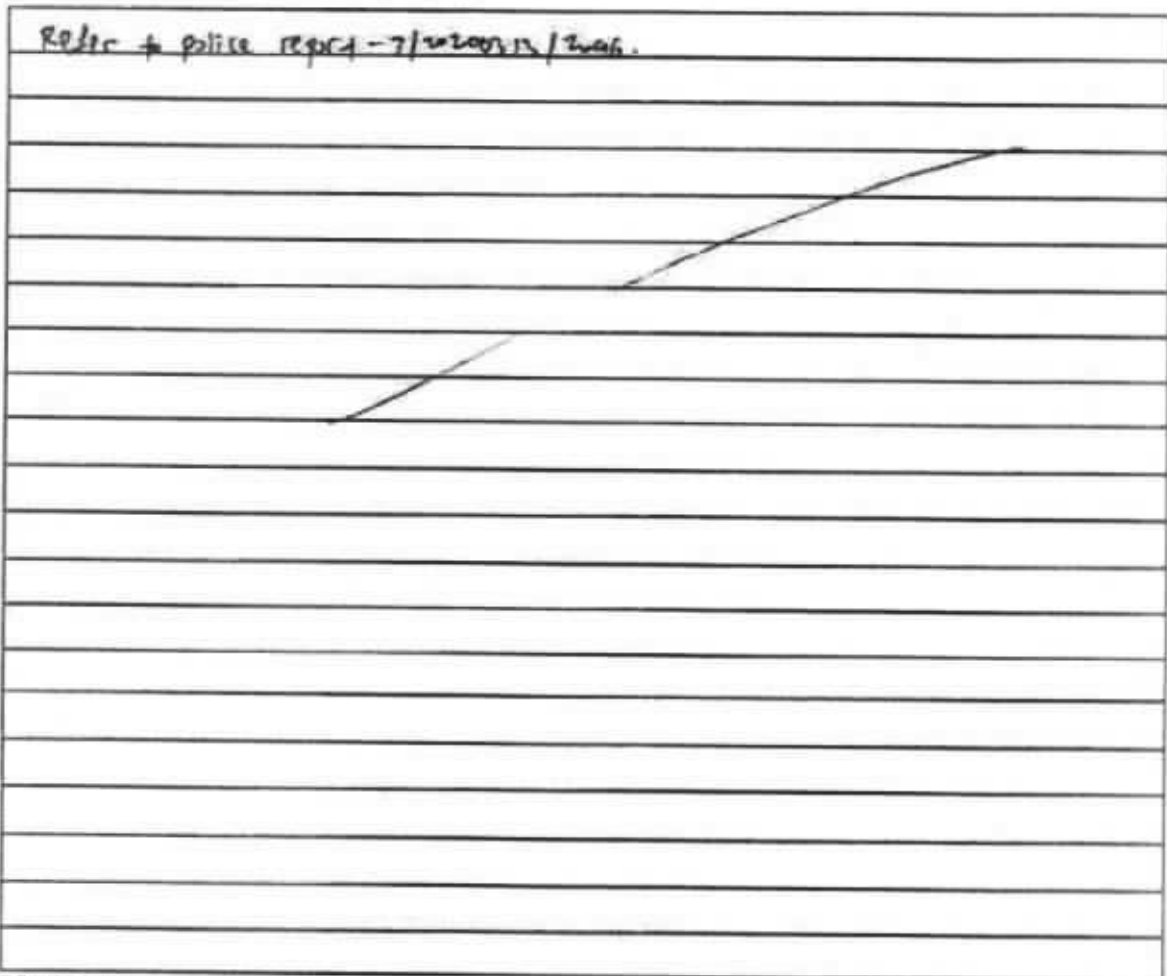
Accident Sketch Plan

Sketch of accident scene on grid paper.

Vehicle A: JMA8602B
Vehicle B: J6V5543

Handwritten notes: Kik Gw Ringe Ronge Rd, uph. space car park

Refer to police report - 7/2003/246.
