4. Description of Damages

THE VEHICLE SUSTAINED DAMAGES AT THE REAR PORTION.

ADJUSTMENT ON REPAIR COST FOR VEHICLE NO. SLU 6579E

PHOTOGRAPHS FOR VEHICLE NO. SLU 6579E

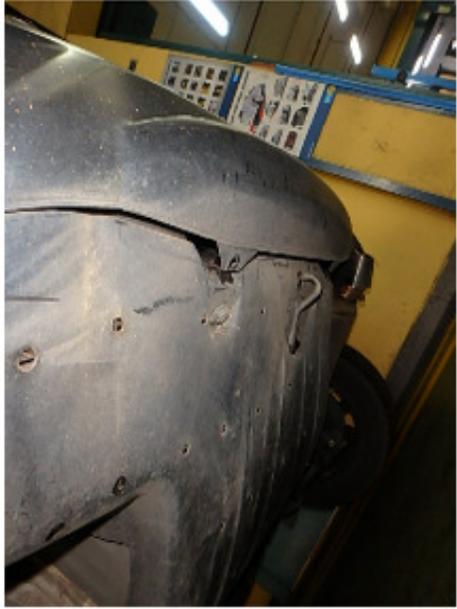
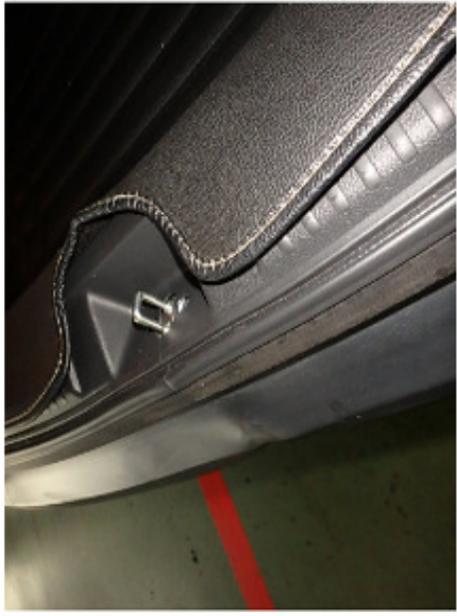
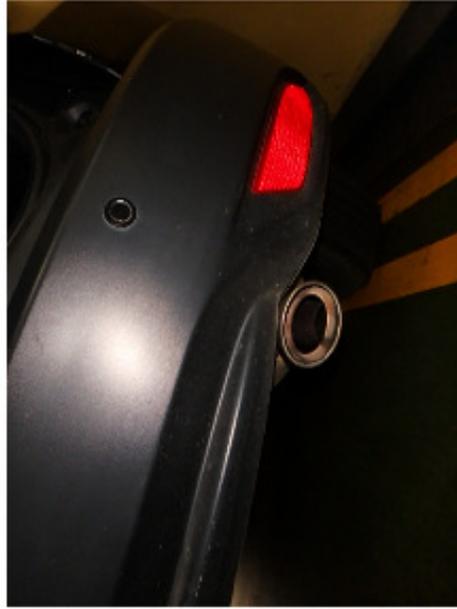
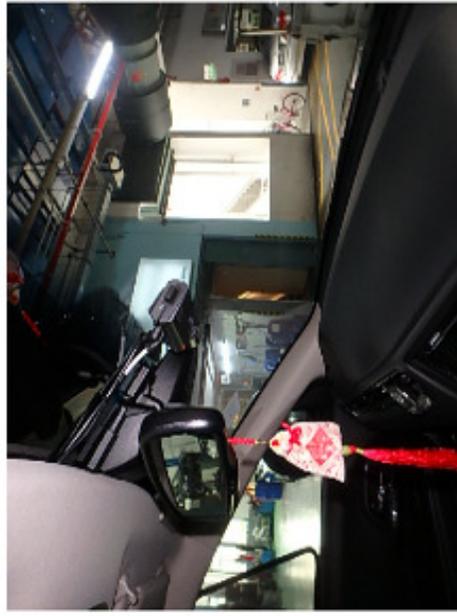
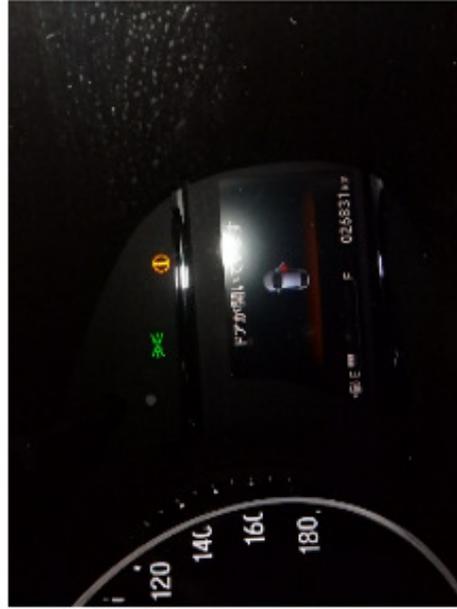
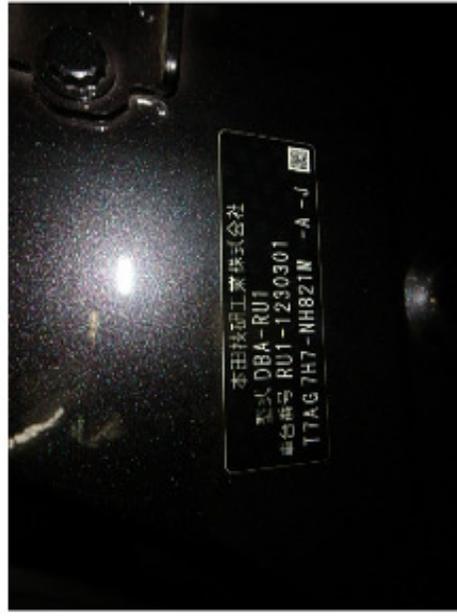
DAMAGES SEE DETAILS.

Qty	Description of Parts	Condition	Estimate By Workshop (\$)	Our Adjusted (\$)
<u>REPLACEMENT OF PARTS</u>				
1	REAR BUMPER	BENT	463.70	463.70
2	REAR BUMPER RETAINER @\$17.50	SERVICEABLE	35.00	-
1	REAR END PANEL	TO REPAIR SEE LABOUR	411.90	-
1	REAR END PANEL GARNISH	SERVICEABLE	92.80	-
1	TAIL GATE	BENT	1,050.00	1,050.00
1	TAIL GATE RUBBER	SERVICEABLE	92.80	-
1	TAIL GATE LOCK	SERVICEABLE	157.00	-
1	TAIL GATE VEZEL EMBLEM	NECESSARY	43.00	43.00
1	REAR WINDSCREEN MOULDING	NECESSARY	120.00	120.00
1	REAR BUZZER ASSY SNERT	CRACKED	75.50	75.50
	LESS 20% DISCOUNT		-508.34	-350.44
			2,033.36	1,401.76
<u>SPECIAL NETT ITEMS</u>				
1	REAR BUMPER SENSOR (SN)	SHORTED	200.00	200.00
1	TUBE REAR WINDSCREEN SEALANT (SN)	NECESSARY	40.00	40.00

240.00	240.00
<u>LABOUR</u>				
	TO PUTTY & SPRAY PAINT.		800.00	400.00
	TO TRANSFER TAIL GATE FITTING.		80.00	60.00
	TO REMOVE & REFIX REAR WINDSCREEN GLASS.		100.00	100.00
	TO ANTI-RUST.		80.00	30.00
	LABOUR CHARGES.INCLUSIVE OF THE REPAIR OF REAR END PANEL.		500.00	400.00
