From: Admin-D (LKKAuto)
Sent: Thursday, 19 March 2020 10:44 AM
To: 'Derrick Tan'; assignments
Cc: 'Sherini Pillai'; SUR
Subject: RE: PAPER SURVEY SLH9713H III REF: MCT20010447

RE: CLAIMANT: KUN SOON JIN ADRIAN
 ACCIDENT INVOLVING VEHICLES NO. SLH9713H & SH9182G ALONG SUMANG
 LINK ON 18.01.2020.

ADJUSTMENT ON REPAIR COST FOR VEHICLE NO. SLH 9713H

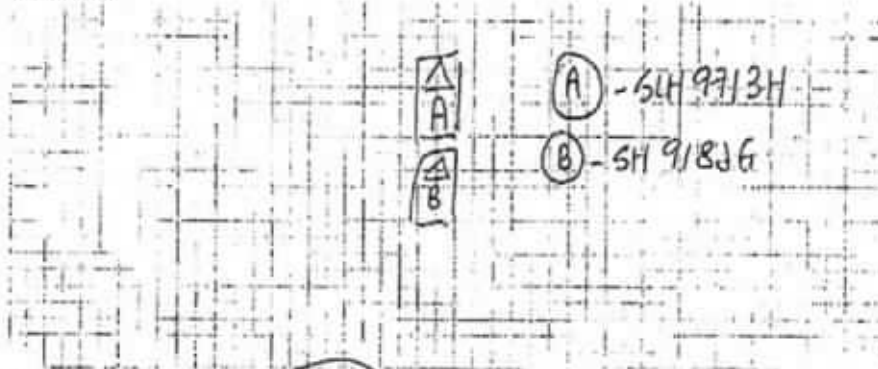
Sketch Plan #2 Pg. 1

my vehicle was stationary / suddenly vehicle B HIT ONTO
my vehicle rear.

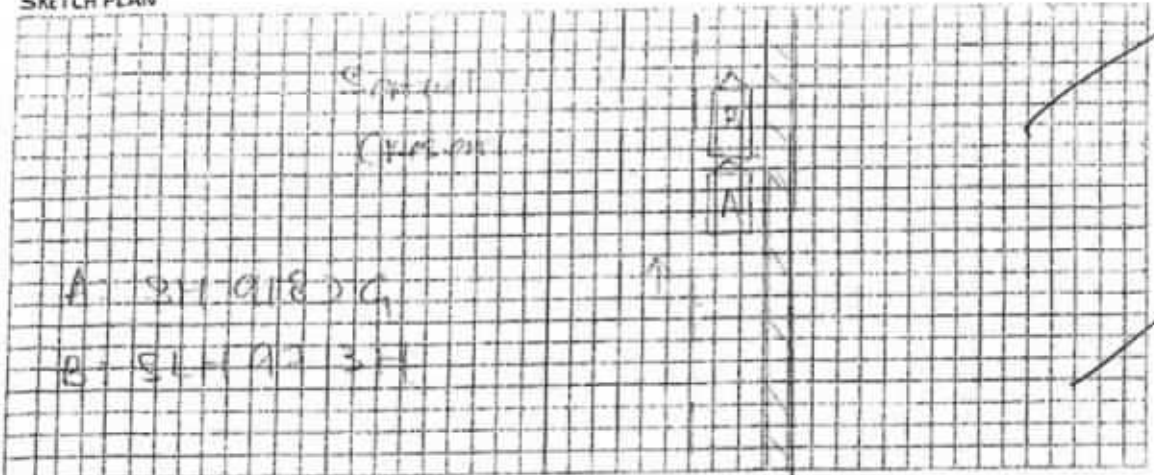
Sketch Plan Pg. 2

On 18/1/2020 at about 11:05 hrs, I Veh A
 roll forward
 have a slight collision with Veh B at above said
 location. No passenger in my taxi No injury
 reported in this accident.

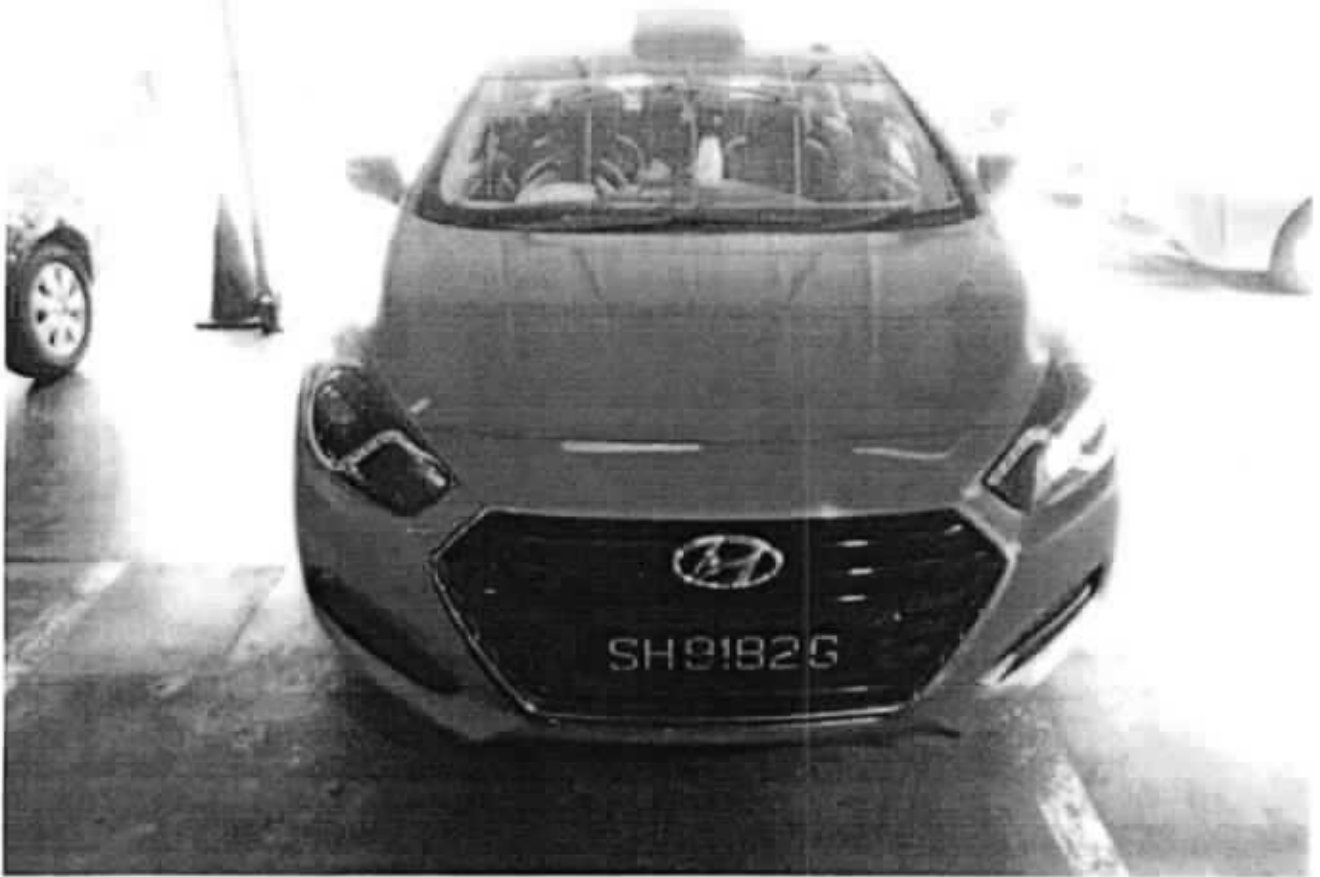
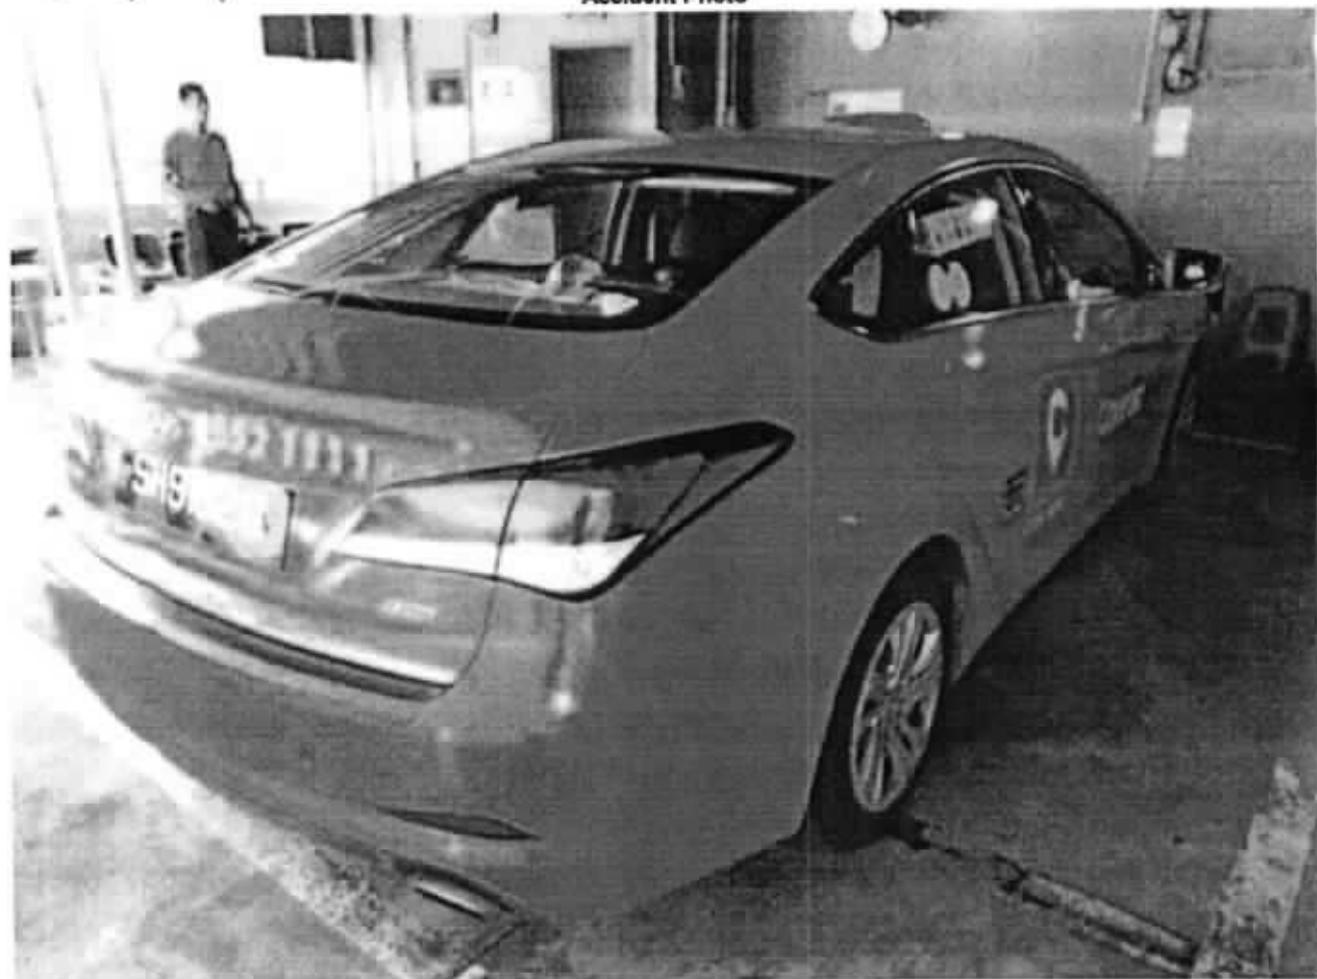
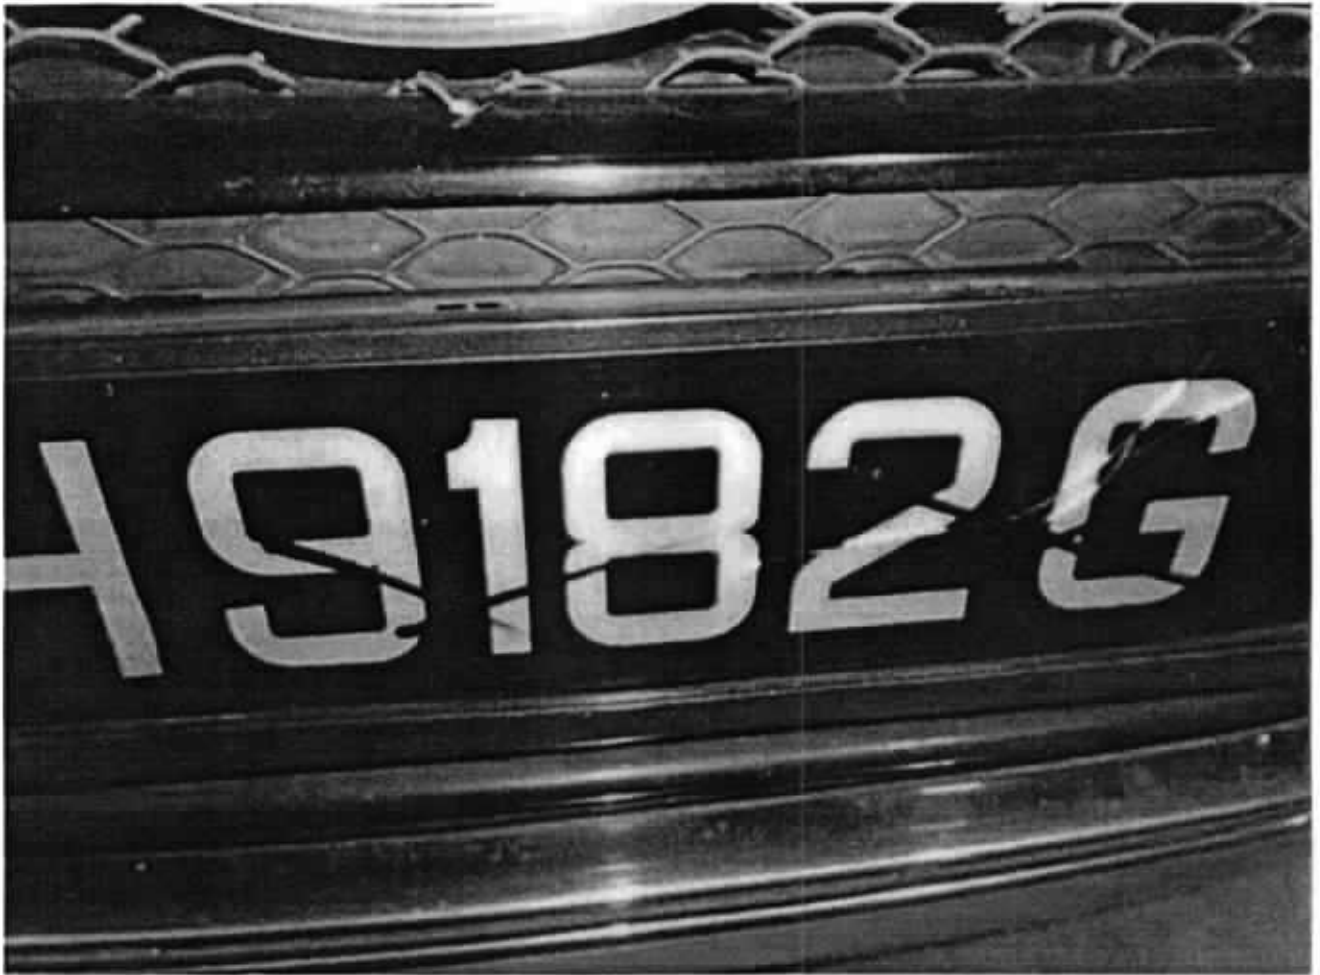
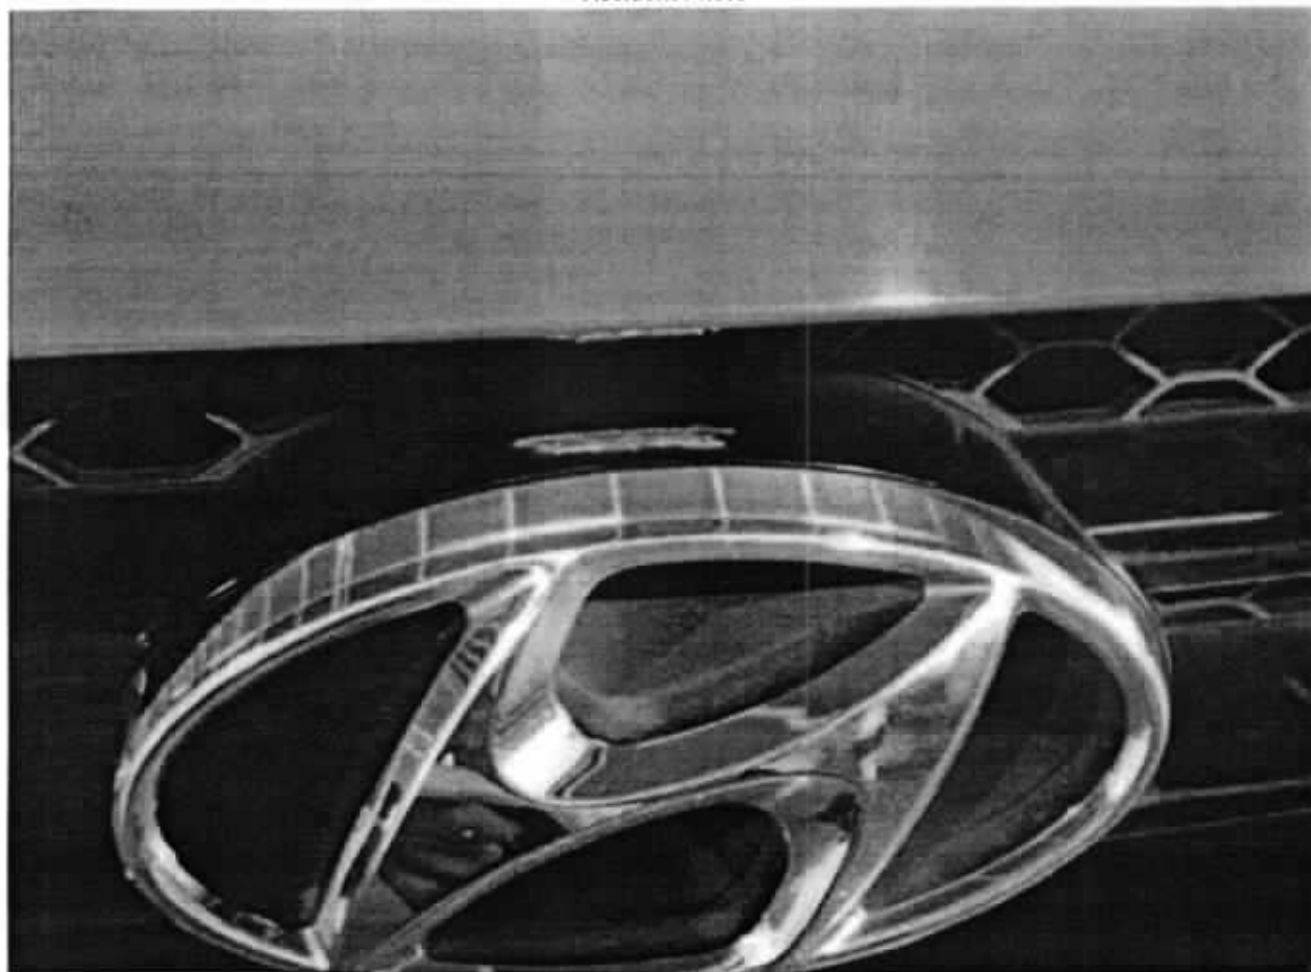
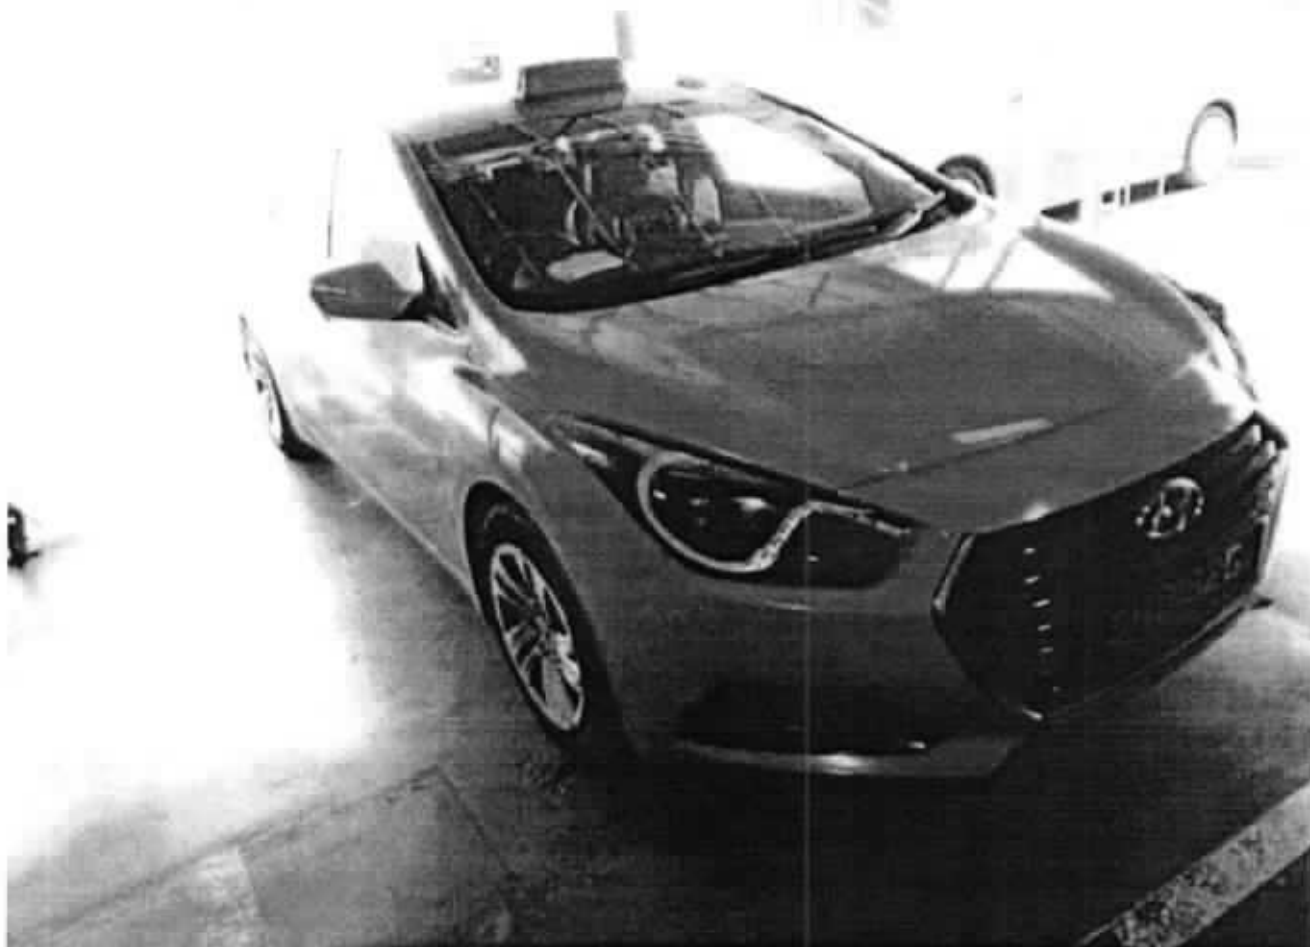
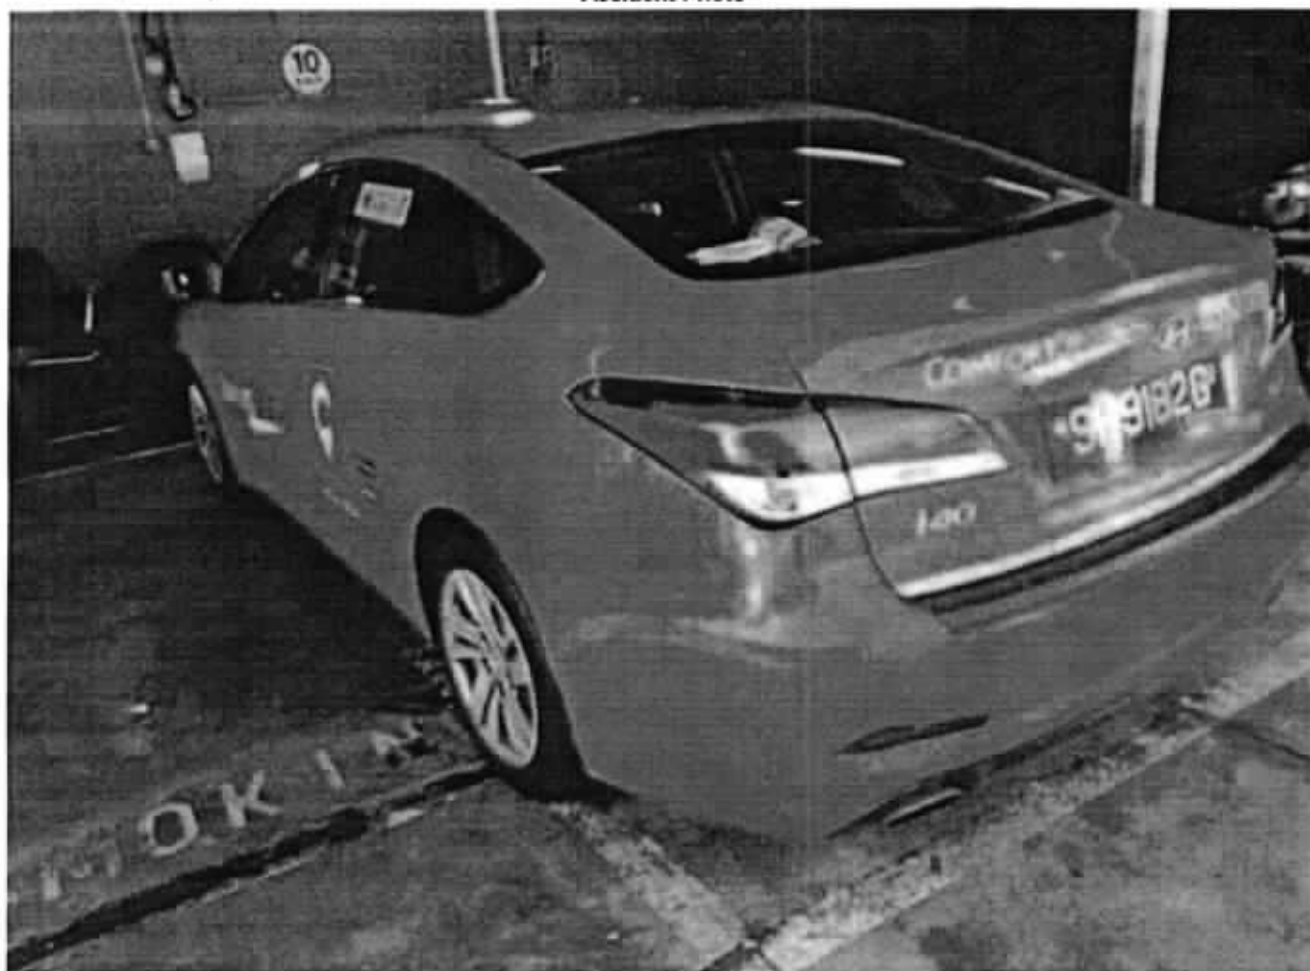
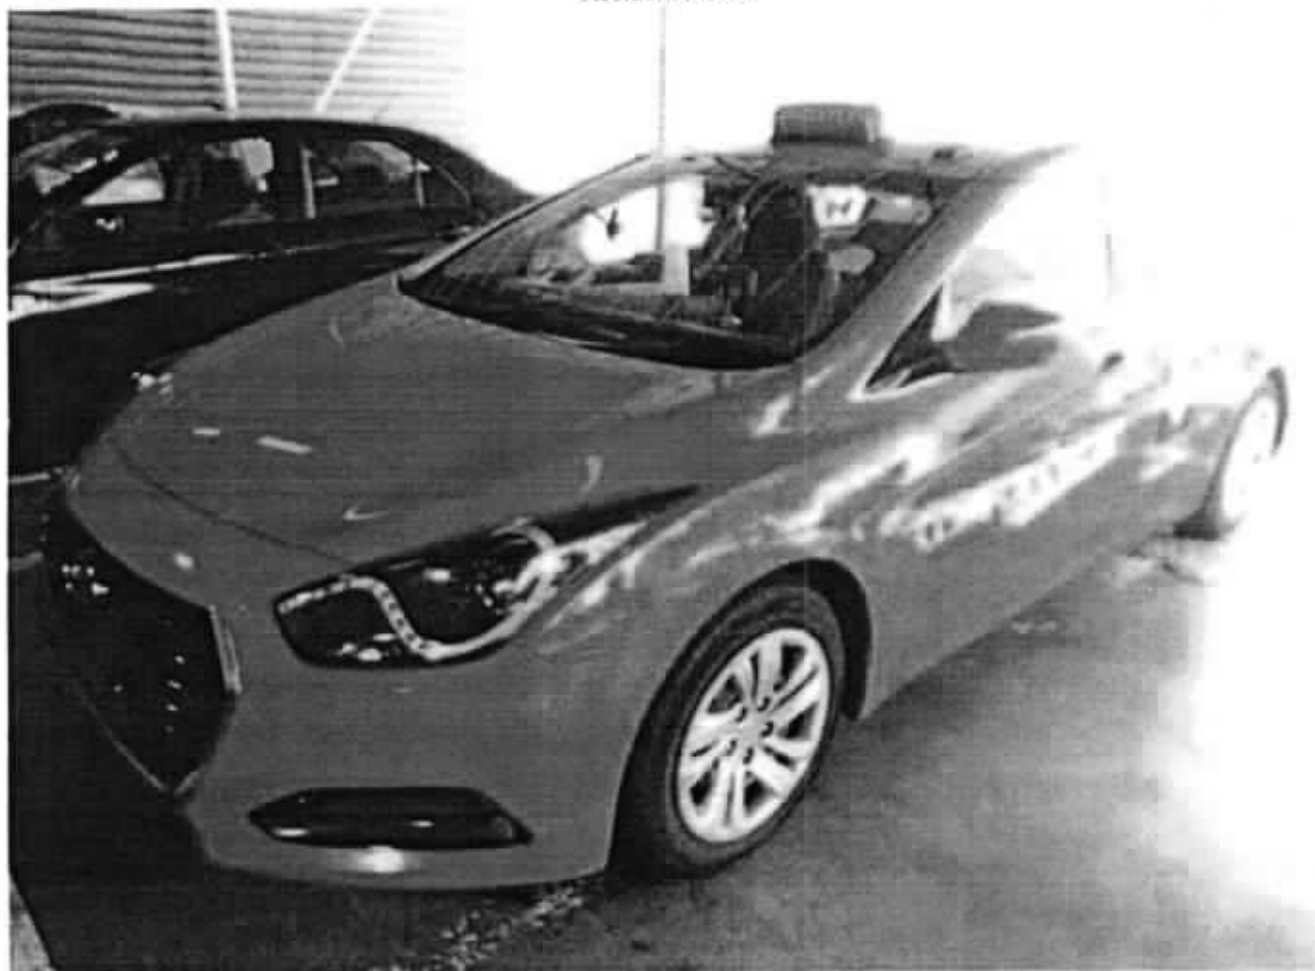
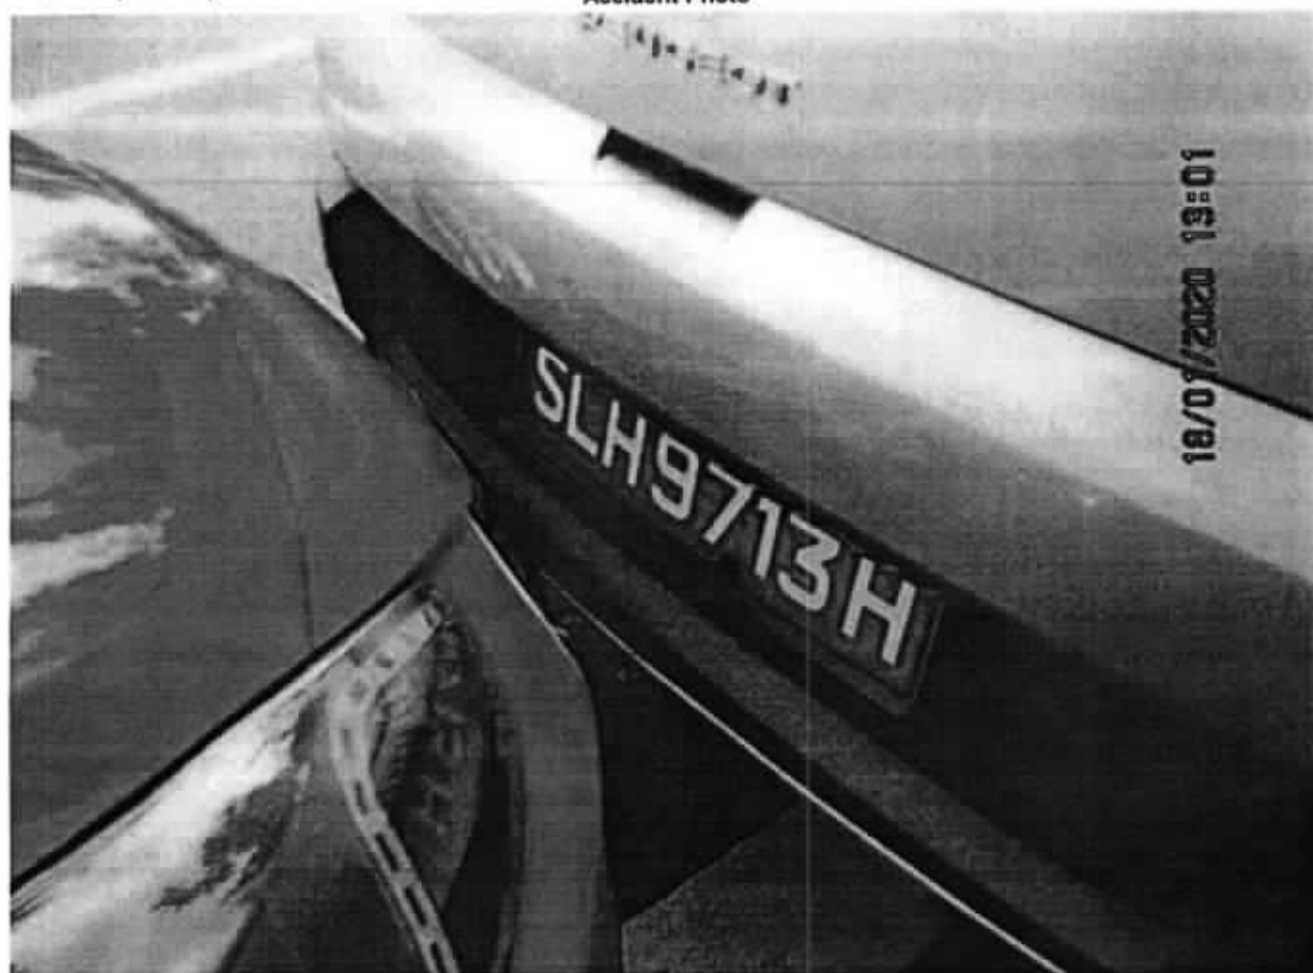
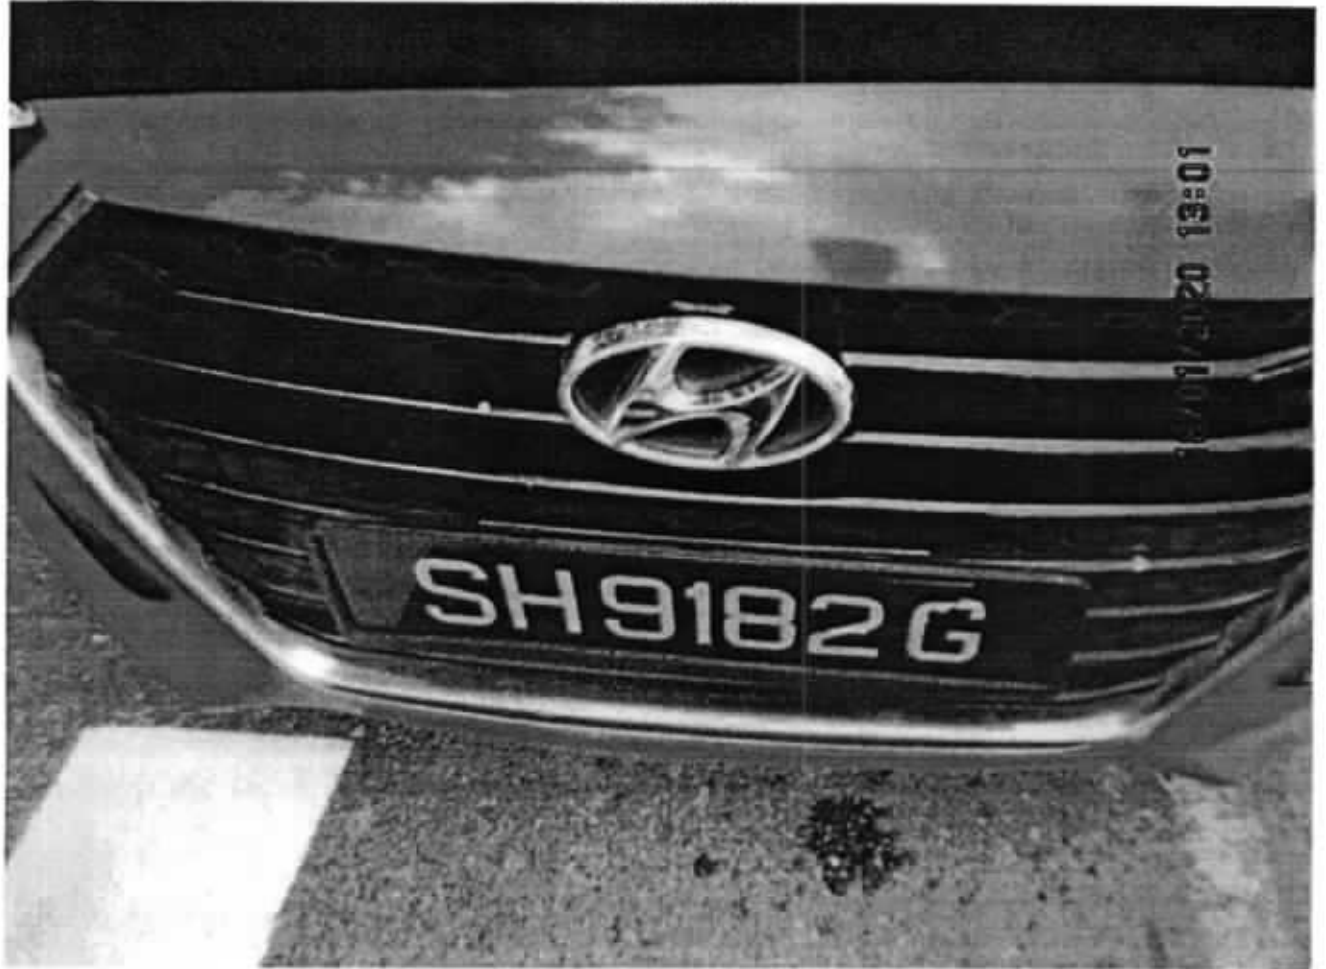
At the time of inspection, we noted that the vehicle has sustained an impact damages on the rear portion(s). For more detail of the damages, please see photograph attached.

4. Description of Damages			
THE VEHICLE SUSTAINED DAMAGES AT THE REAR PORTION. DAMAGES SEE DETAILS.			
5. General Information			
Accident Date	18/01/2020	Inspection Date	30/01/2020
Survey held at	BLUWEL AUTOMOTIVE SERVICE PTE LTD BLK 1 KAKI BUKIT AVE 6 #01-28/51/53/55(MAIN OFFICE) SINGAPORE 417883		
5a. Remarks			
A)THE INSPECTION WAS CONDUCTED ON A"WITHOUT PREJUDICE" BASIS. B)IN ACCORDANCE TO YOUR INSTRUCTIONS, WE HAVE NOT AUTHORISED REPAIRS.			
5b. Estimate Days of Repair			
ESTIMATED NORMAL PERIOD FOR REPAIR:		4 Working Days

Qty	Description of Parts	Condition	Estimate By Workshop (\$)	Our Adjusted (\$)
<u>REPLACEMENT OF PARTS</u>				
1	REAR END PANEL	TO REPAIR SEE LABOUR	1,678.00	-
1	REAR BUMPER	DENTED / DEFORMED	1,150.00	1,150.00
1	REAR BUMPER LOWER CHROME DIFFUSER	CRACKED	367.00	367.00
1	REAR BUMPER REFLECTOR LAMP	CRACKED	158.00	158.00
1	REAR BUMPER INNER CENTRE BRACKET	CRACKED	135.00	135.00
1	SET REAR BUMPER INNER SIDE BRACKET	CRACKED	130.00	130.00
1	REAR BUMPER REINFORCEMENT	DENTED	462.00	462.00
2	REAR BUMPER SENSORS	SERVICEABLE	324.00	-
2	REAR BUMPER SIDE RETAINERS	NOT NECESSARY	72.00	-
	LESS 10% DISCOUNT		-447.60	-240.20
			4,028.40	2,161.80
<u>SPECIAL NETT ITEMS</u>				
1	REAR NUMBER PLATE WITH SEAL (SN)	NECESSARY	80.00	60.00

80.00	60.00
<u>LABOUR</u>				
	TO DISCONNECT AND RECONNECT, CHECK ELECTRICAL WIRING, HARNESS WIRES, SOCKETS, REPLACE DAMAGED PARTS.		60.00	30.00
	TO REMOVE AND REFIT REAR BUMPER SENSOR.		150.00	50.00
	TO REMOVE AND REPLACE THE ABOVE DAMAGED PARTS, STRAIGHTEN, KNOCK OUT, REALIGN AND REPAIR INCLUDING CUT AND WELD BODY PANELS. TO RE-ADJUST TO THE ORIGINAL POSITION USING POWER TOOLS. INCLUSIVE OF THE REPAIR OF REAR END PANEL.		900.00	300.00
	TO SPRAY PAINT ON THE REPLACED AND REPAIRED PARTS, PREPARE SPRAY SUCH AS MASKING TAPE THE UNAFFECTED AREAS WITH PAPER, CLEANING AND SANDING OF SURFACES, FINAL POLISHING AND WAXING ARE ALSO AVAILABLE.		800.00	400.00

Qty	Description of Parts	Condition	Estimate By Workshop (\$)	Our Adjusted (\$)
	TO APPLY UNDERCOATING ON THE REPAIRED AND REPLACED PANELS FOR RUST PROTECTION.	NOT NECESSARY	100.00	-
			2,010.00	780.00
GRAND TOTAL			6,118.40	3,001.80
RECOMMENDED COST OF LUMP SUM REPAIRS (TO ITS PRE-ACCIDENT CONDITION)				2,400.00
