Vehicle No. SMK 573B

2.	•	Vehicle Partic	culars & Condition					
	Make & Model	B.M.W. 216I GRAN TOURER	c.c	1499				
	Engine No.	HIDDEN	Year of Reg.	2019				
	Chassis No.	WBA6V12020ED05730	Colour	BLACK				
	Odometer	26975	Steering	IN ORDER				
	Brakes	IN ORDER	Modification	SPORTS RIM				
	General	FAIR

ADJUSTMENT ON REPAIR COST FOR VEHICLE NO. SMK 573B

PHOTOGRAPHS FOR VEHICLE NO. SMK 573B

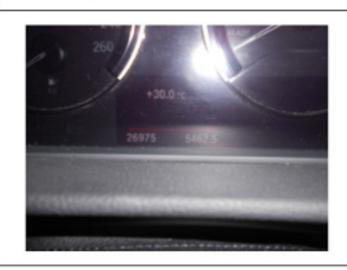
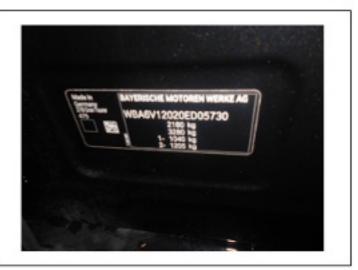
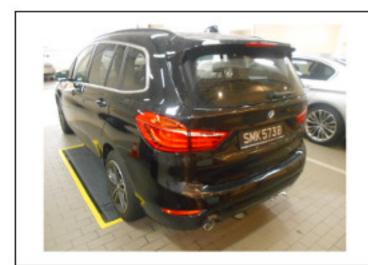
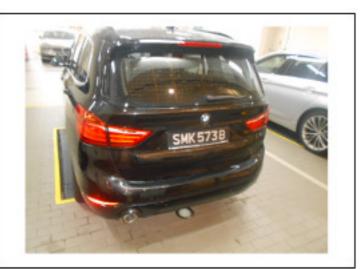
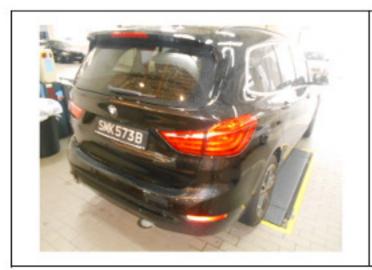
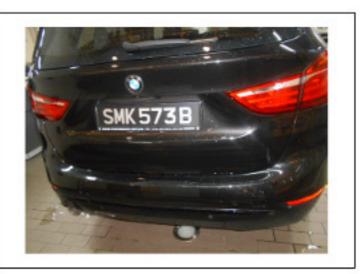
4.	I	•	on of Damages					
	THE VEHICLE SU	STAINED DAMAGES AT THE FRO	ONT AND REAR PORTION.					
	DAMAGES SEE D							
5.			Information					
	Accident Date	12/03/2020	Inspection Date	22/06/2020				
	Survey held at	PERFORMANCE MOTORS LTD						
		303 ALEXANDRA ROAD SINGAPORE 159941						
5a.			emarks					
	A)THE INSPECTION WAS CONDUCTED ON A"WITHOUT PREJUDICE" BASIS. B)IN ACCORDANCE TO YOUR INSTRUCTIONS, WE HAVE NOT AUTHORISED REPAIRS.							
5b.	Estimate Days of Repair							
	ESTIMATED NOR	MAL PERIOD FOR REPAIR:	5 Working Days

Qty	Description of Parts	Condition	Estimate By Workshop (\$))	Our Adjusted (\$)
	REPLACEMENT OF PARTS			
1	SUNDRIES (SN)	NECESSARY	80.00	80.00
1	IMPACT ABSORBER TOP(SN)	SERVICEABLE	49.30	-
1	FRT BUMPER PRIMED PANEL (PMA) (SN)	DEFORMED	897.25	897.25
1	REAR BUMPER CARRIER (SN)	BENT	460.40	460.40
1	SUPPORT (SN)	CRACKED	45.55	45.55
1	REAR BUMPER TOWING FLAP EYE PRIMED (SN)	NOT NECESSARY	43.05	-
1	REAR BUMPER TRIM STRIP (BLACK) (SN)	SCRATCHED	72.20	72.20
1	REAR BUMPER PANEL PRIMED (LINES PDC)	DEFORMED	1,045.45	1,045.45
1	FRT LH GRILLE (SPORT) (SN)	CRACKED	112.65	112.65
1	FRT RH GRILLE (SPORT) (SN)	CRACKED	112.65	112.65
1	PLAQUE 82MM (SN)	NECESSARY	71.60	71.60
			2,990.10	2,897.75
	LABOUR			
	TO REPLACE FRONT BUMPER ,REAR BUMPER AND ATTACHMENTS.		2,550.00	1,700.00
	PAINTING FRONT BUMPER AND REAR BUMPER .		2,076.00	1,868.00
	TO CHECK ELECTRICAL WIRING SYSTEM AT THE FRONT AND REAR SECTIONS FOR PROPER FUNCTION INCLUDING ADJUSTMENT OF HEADLIGHTS.		295.00	250.00

TO REMOVE OLD PDC ASSEMBLY ,REPLACE DAMAGED PARTS AND RECONNECT TO NEW BUMPER INCLUDING CONDUCT CHECKS FOR PROPER FUNCTION.		177.00	150.00
			5,098.00	3,968.00
	GRAND TOTAL		8,088.10	6,865.75
