VEHICLE APPRAISAL REPORT

Our Ref : PA/FBN6926/1119/tpw
Date : 31 January 2020

Reg. No : FBN 6926 S
Make : Piaggio
Model : Vespa GTS 150 ABS
Year : 23 November 2018

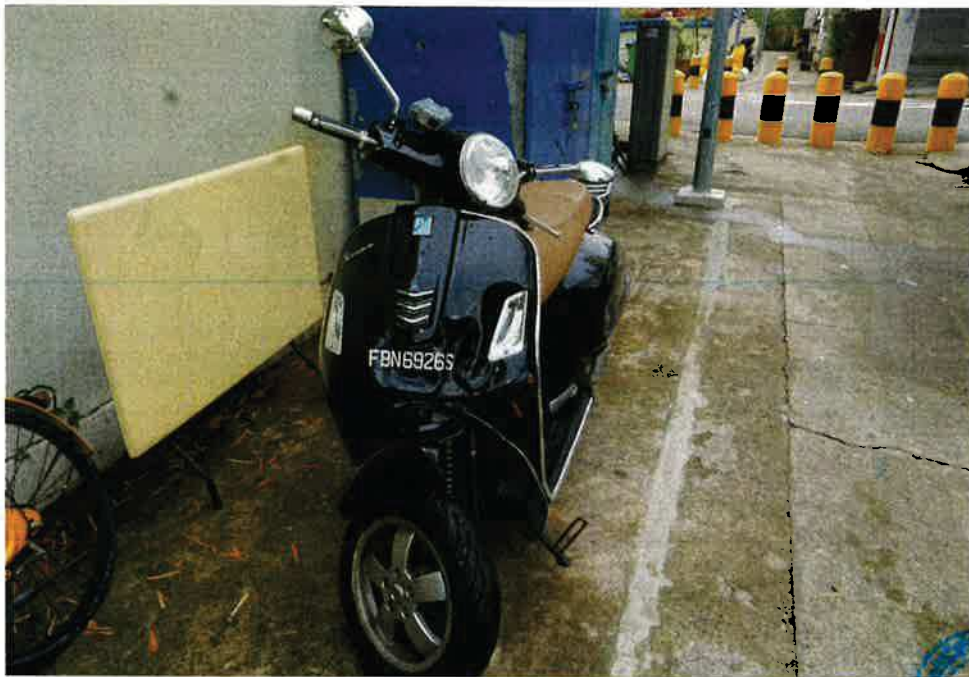
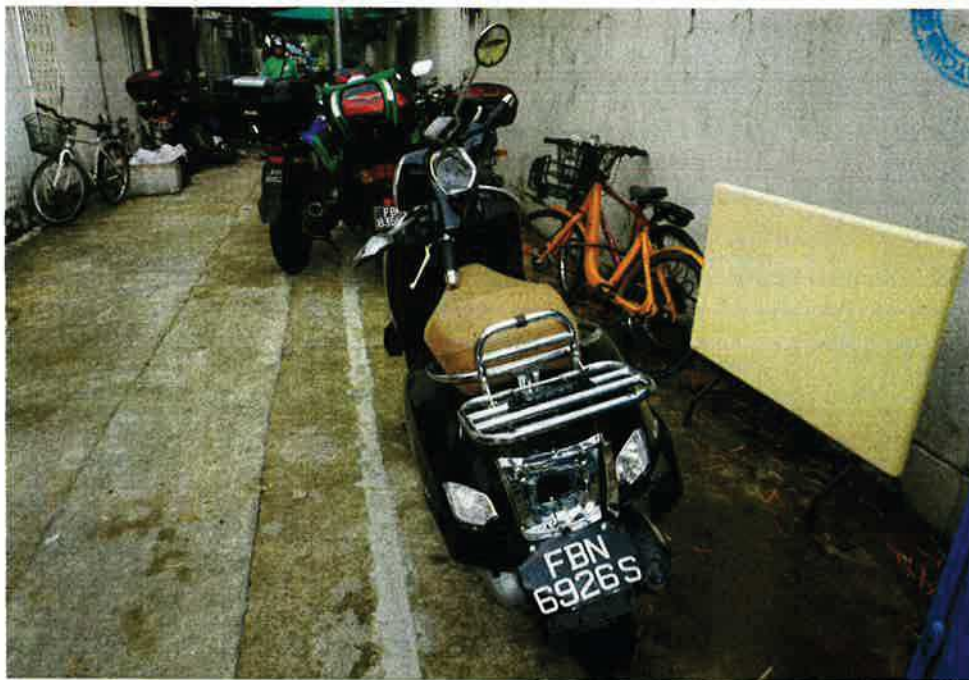
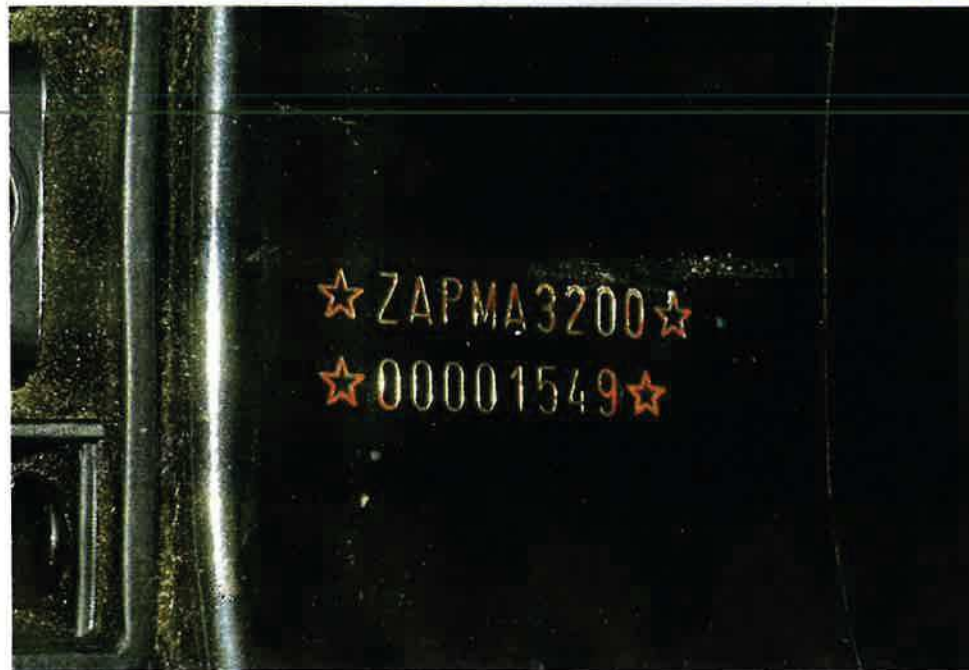
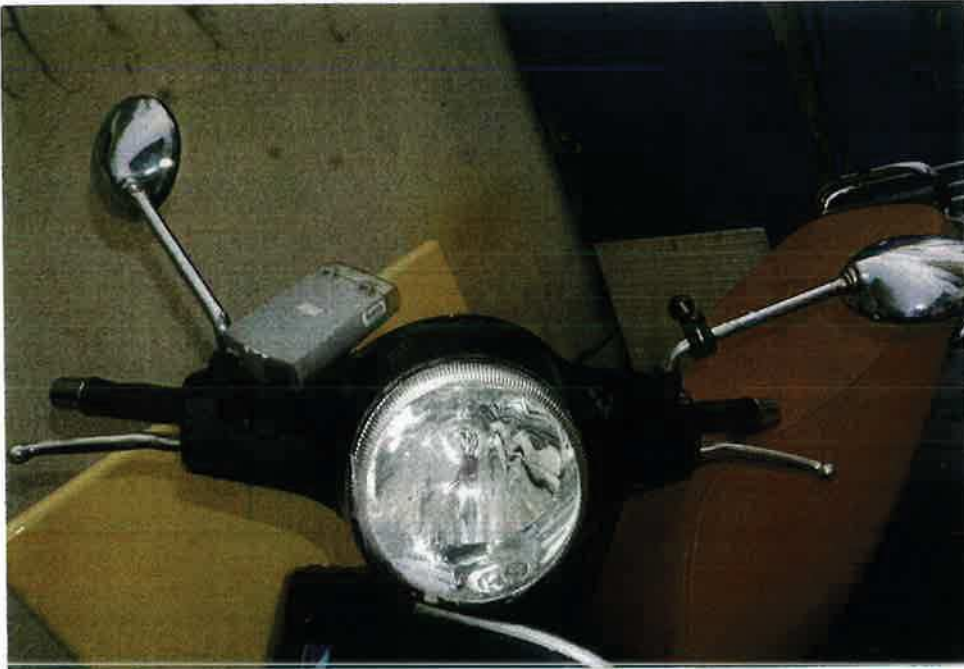
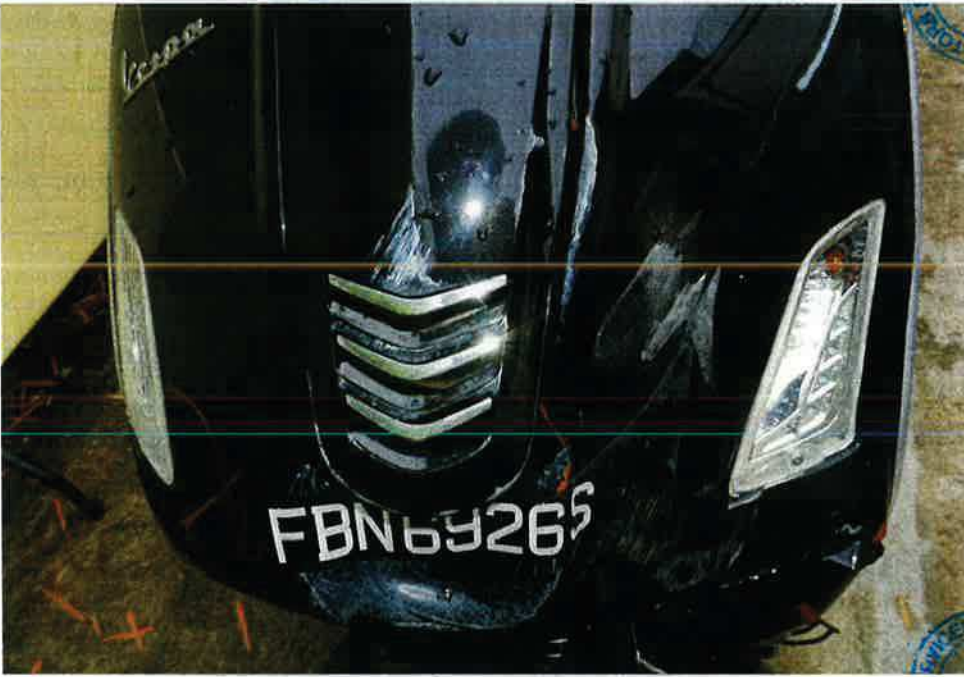
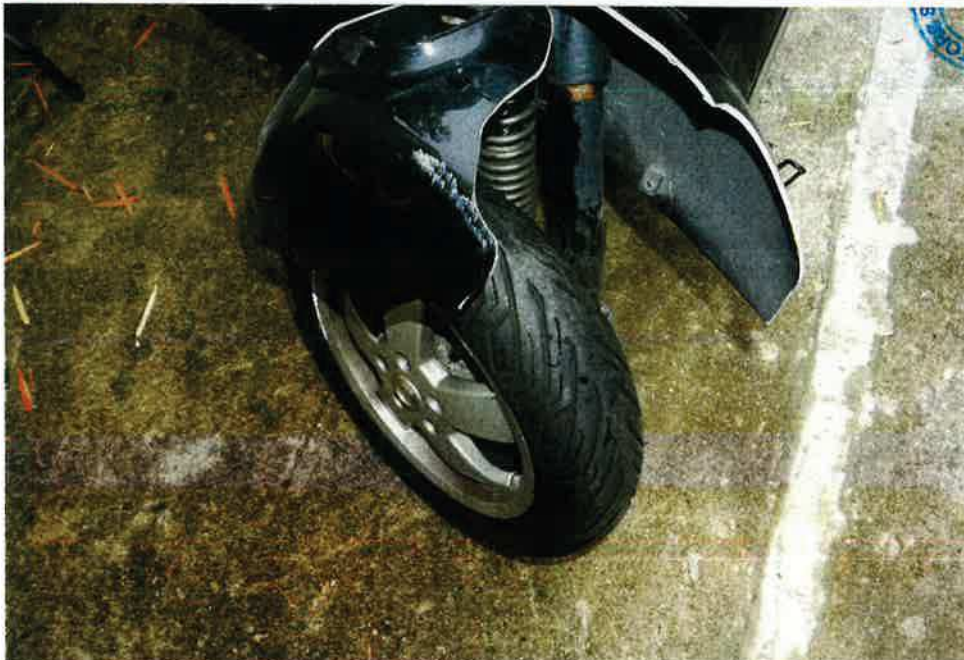
The Scooters sustained severe damage at all sides. Chassis frame badly distorted and damaged beyond repair. The Scooters was not able to restore to road worthy condition.

Enclosed (65) photographs depicting damage to the scooters.

The Scooters was rendered not safe to repair. **Hence recommended as Total Loss.**
