Vehicle No. SMJ 3766Y

Accident Date 17/03/2020

ADJUSTMENT ON REPAIR COST FOR VEHICLE NO. SMJ 3766Y

PHOTOGRAPHS FOR VEHICLE NO. SMJ 3766Y

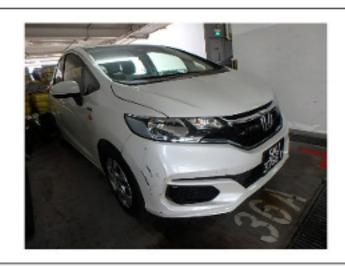
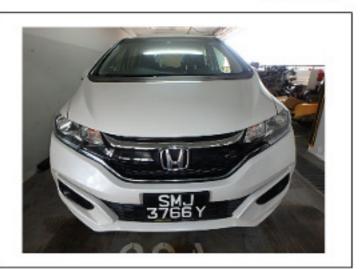
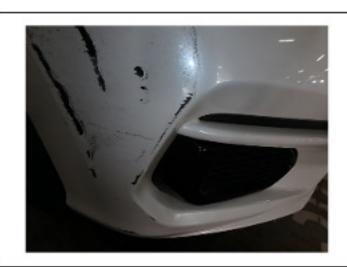
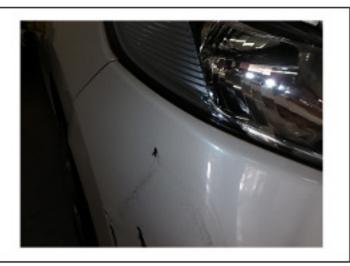
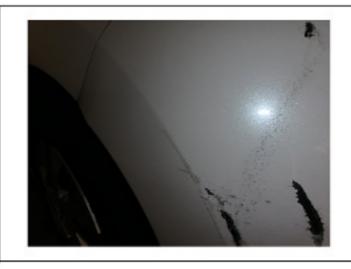
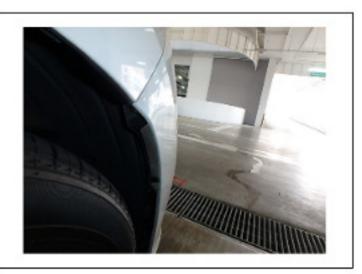
4.	4. Description of Damages											
	THE VEHICLE SUS	STAINED DAMAGES AT THE O/S	FRONT PORTION.									
	DAMAGES SEE DETAILS.											
5.		General	Information									
	Accident Date	17/03/2020	Inspection Date	20/03/2020								
	Survey held at	160 SIN MING IND #05-01										
	Repairer	CITY AUTO PTE LTD										
5a.		Re	emarks									
	A)THE INSPECTION WAS CONDUCTED ON A"WITHOUT PREJUDICE" BASIS. B)IN ACCORDANCE TO YOUR INSTRUCTIONS, WE HAVE NOT AUTHORISED REPAIRS.											
5b.	Estimate Days of Repair											
	ESTIMATED NORMAL PERIOD FOR REPAIR: 2 Working Days

Qty	Description of Parts	Condition	Estimate By Workshop (\$))	Our Adjusted (\$)
	REPLACEMENT OF PARTS			
1	FRONT BUMPER	BUCKLED	517.70	517.70
1	FRONT BUMPER RETAINER -RH	SERVICEABLE	10.40	-
1	RH HEADLAMP	SERVICEABLE	850.10	-
1	RH FOGLAMP COVER	SERVICEABLE	29.00	-
	LESS 20% DISCOUNT		-281.44	-103.54
			1,125.76	414.16
	<u>LABOUR</u>			
	TO CHECK WIRING AND LIGHTING .		60.00	10.00
	TO KNOCK JACKOUT DAMAGED PARTS ,PANEL BEATING ,WELDING ,ALIGN,REFIX AND TO RENEW ACCIDENT PARTS.		300.00	200.00
	SPRAY PAINTING ON AFFECTED & REPLACE PARTS.		250.00	220.00
			610.00	430.00
	GRAND TOTAL		1,735.76	844.16
