REF: CS/AGI 2006 4450 /A/F3

To Inspect Vehicle No: SJG 1110D

Claim No: C10006022

From: Ivy Ratilla <ivy.r@budgetdirect.com.sg>
Sent: Tuesday, 24 March, 2020 3:09 PM
To: Admin-D (LKKAuto)
Cc: SUR; Julie Mangubat
Subject: FW: PRI - ACCIDENT INVOLVING SJG 1110D AND SFJ 3456A ALONG BLK 459 TAMPINES ST 42 ON 22.03.2020 || C10006022
Attachments: SJG1110D.pdf; SFJ3456A.pdf

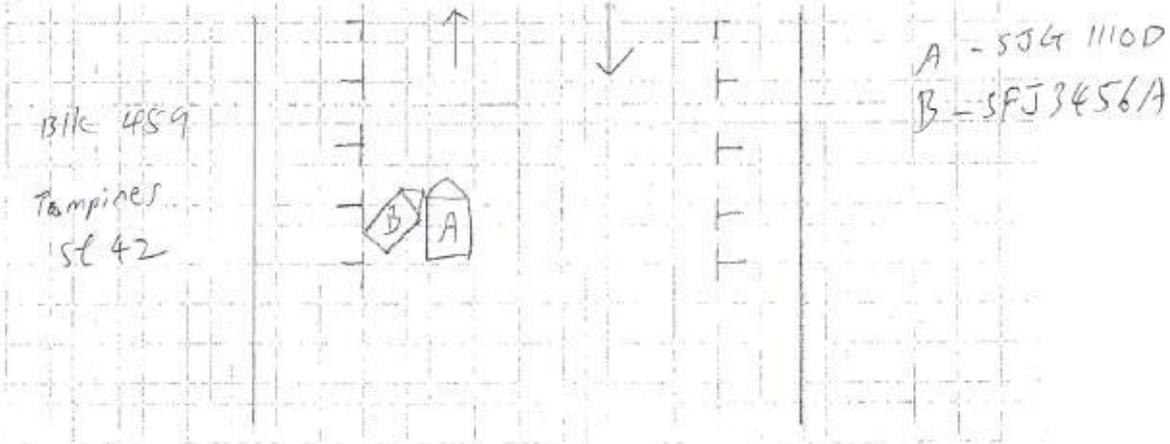
Sketch Plan #2 Pg. 1

On 22-07-2020, at about 1848, I was travelling straight along tampines st 42, blk 459, suddenly, vehicle B came out of carpark without checking the traffic, causing the damages to the left hand portion of my vehicle A and my front rim of the left hand side.
