REFCS/ICS20004596/Ktd3

To Inspect Vehicle No:

SLR 2000 A

ESTIMATE COSTS OF REPAIR

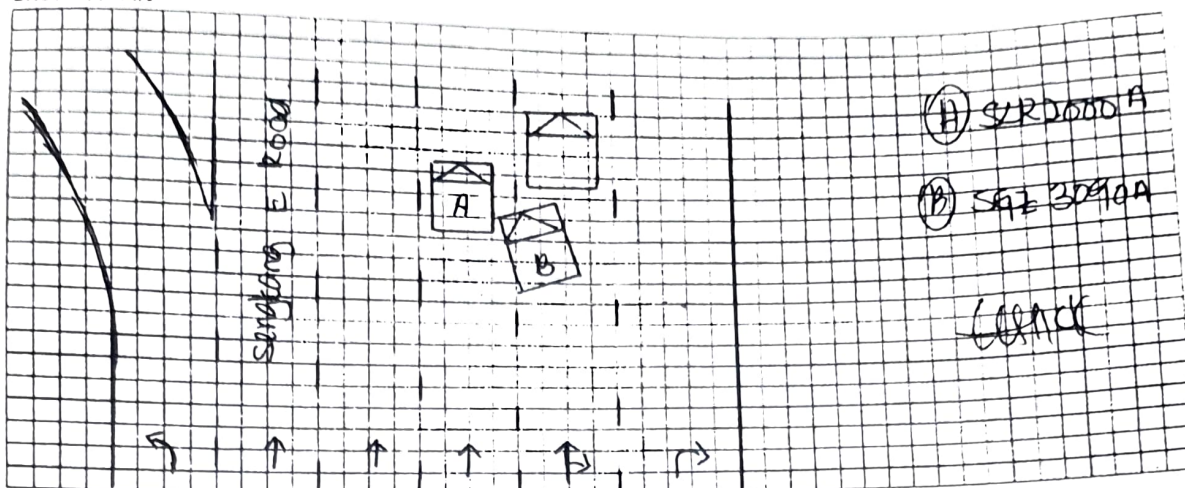
SKETCH PLAN

On 25/03/2020 at about 1145 hours, while I was driving my motor vehicle A SRJ000A along Sengkang E Road at the third lane from my right, keeping within my lane. Green light on my favour. Suddenly I felt an impact from my right. I realised that was motor vehicle B SGE 3090A which was driving on my right cut into my lane and his front, left portion hit onto the rear right portion of my motor vehicle A SRJ000A. NO one was injured. I'm lodging this report to claim against the insurer of SGE 3090A.
