LKK Auto Consultants Pte Ltd

Vehicle No. SLQ 9078K
Insured Veh. SHC 7082G
Claim No. D20001695MFSH
Policy No. D-18088937MFSH
Accident Date 25/03/2020
Inspection Date 27/03/2020

ADJUSTMENT ON REPAIR COST FOR VEHICLE NO. SLQ 9078K

PHOTOGRAPHS FOR VEHICLE NO. SLQ 9078K

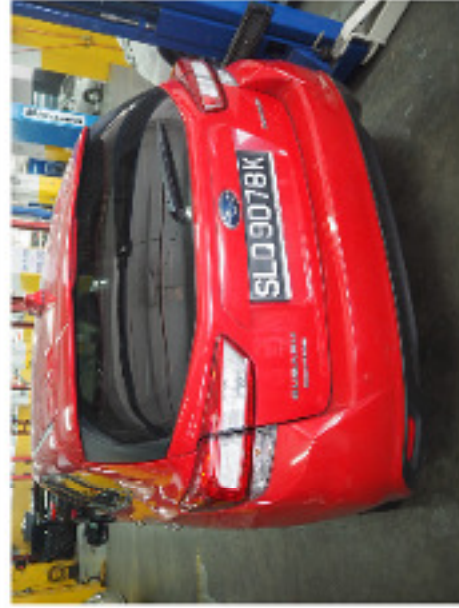
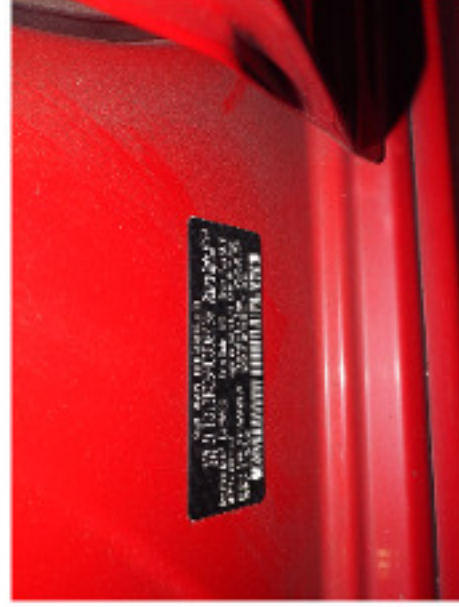
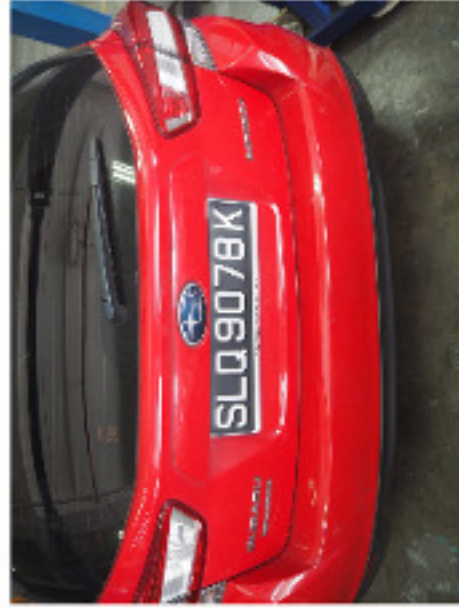
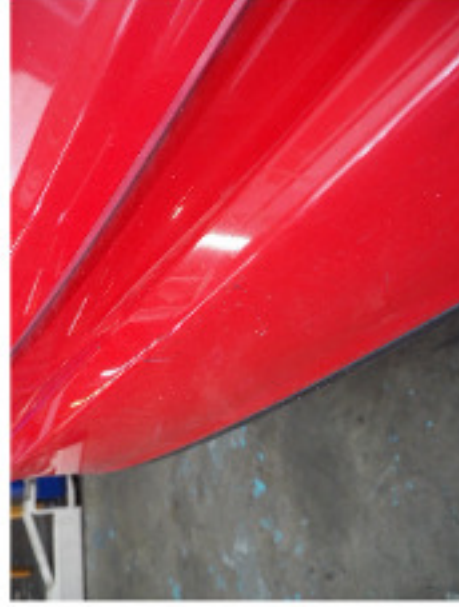
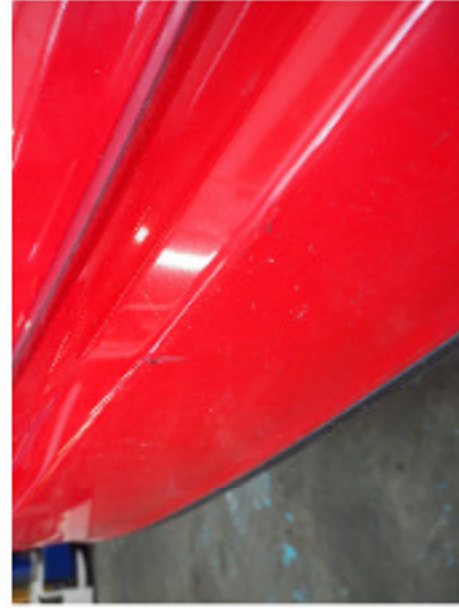
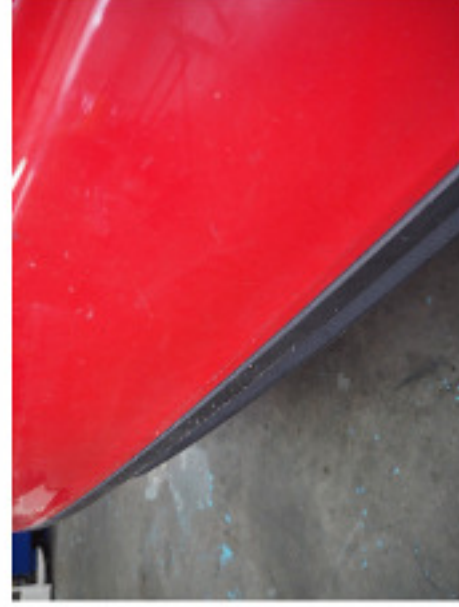
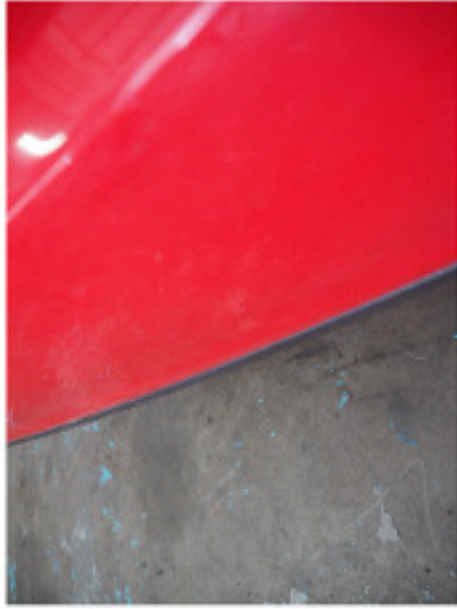
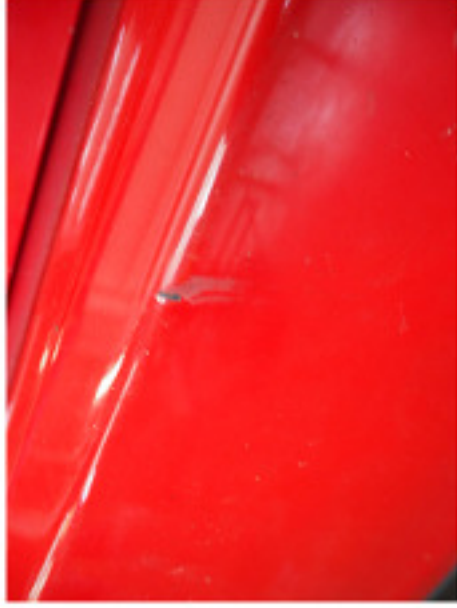
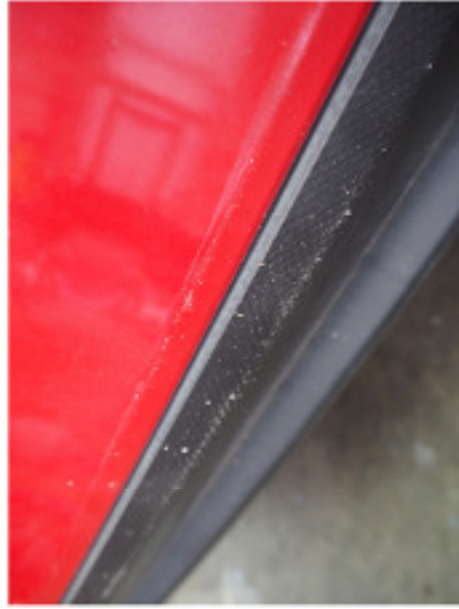
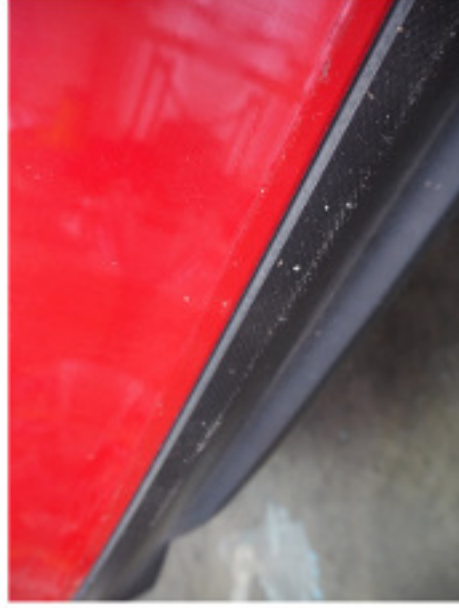
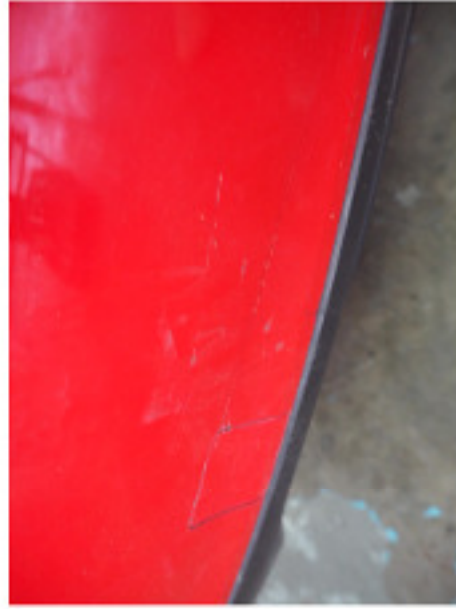
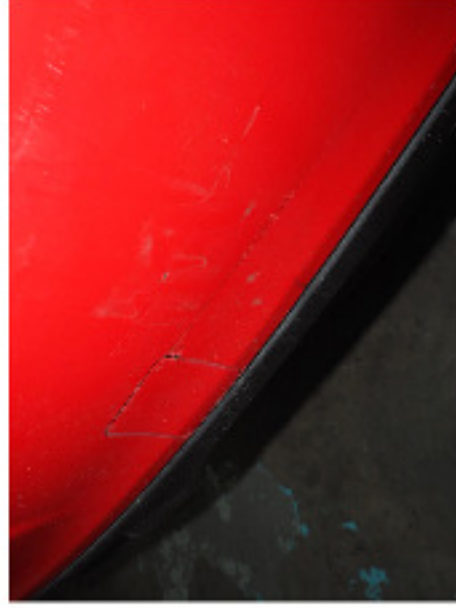
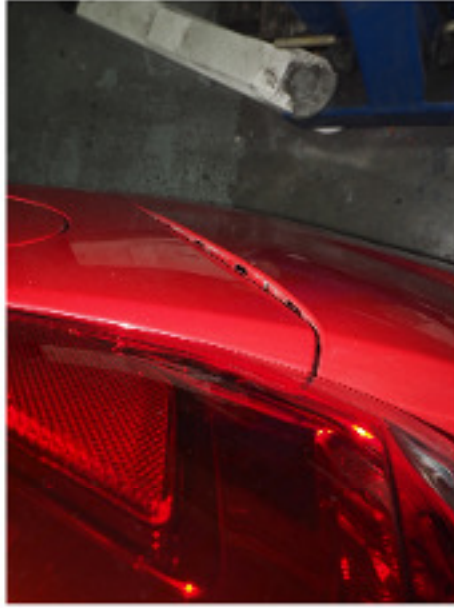
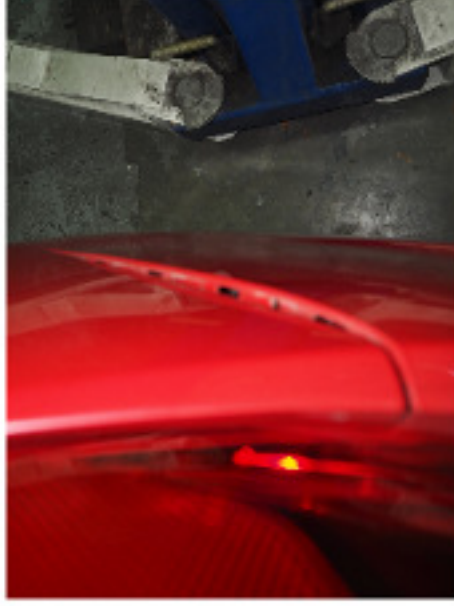
4. Description of Damages				
THE VEHICLE SUSTAINED DAMAGES AT THE REAR PORTION. DAMAGES SEE DETAILS.				
5. General Information				
Accident Date	25/03/2020	Inspection Date	27/03/2020	
Survey held at	MG SOLUTION PTE LTD 23 KAKI BUKIT AVE 4 (SOUTH WING) #02-03B VICOM INSPECTION CENTRE, SINGAPORE 415933			
5a. Remarks				
A)THE INSPECTION WAS CONDUCTED ON A"WITHOUT PREJUDICE" BASIS. B)IN ACCORDANCE TO YOUR INSTRUCTIONS, WE HAVE NOT AUTHORISED REPAIRS.				
5b. Estimate Days of Repair				
ESTIMATED NORMAL PERIOD FOR REPAIR:		3 Working Days
