4.			on of Damages				
	THE VEHICLE SU	STAINED DAMAGES AT THE REA	AR PORTION.				
	DAMAGES SEE D	ETAILS.					
5.		General	Information				
	Accident Date	25/03/2020	Inspection Date	30/03/2020			
	Survey held at	RALLY PITSTOP					
		176 SIN MING DRIVE #04-17 SIN MING AUTO CARE SINGAPORE 575721					
5a.		Re	emarks				
	A)THE INSPECTION WAS CONDUCTED ON A"WITHOUT PREJUDICE" BASIS. B)IN ACCORDANCE TO YOUR INSTRUCTIONS, WE HAVE NOT AUTHORISED REPAIRS.						
5b.	b. Estimate Days of Repair						
	ESTIMATED NORMAL PERIOD FOR REPAIR: 2 Working Days

ADJUSTMENT ON REPAIR COST FOR VEHICLE NO. SMQ 7439D

PHOTOGRAPHS FOR VEHICLE NO. SMQ 7439D

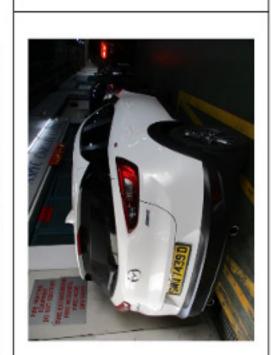
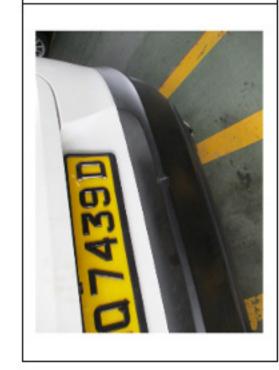
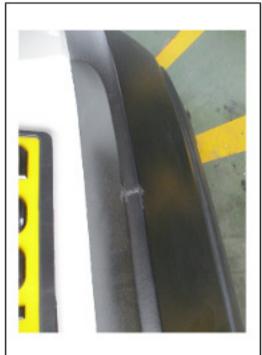
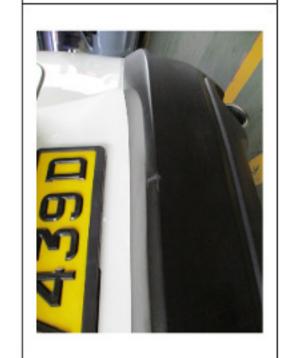
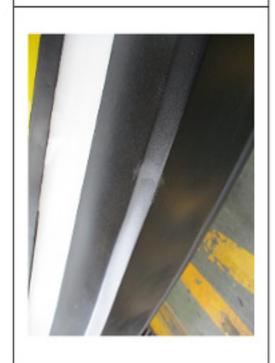
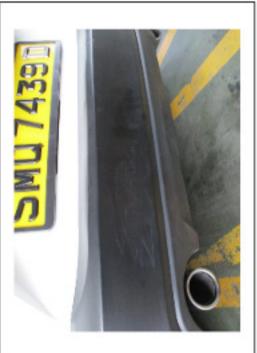
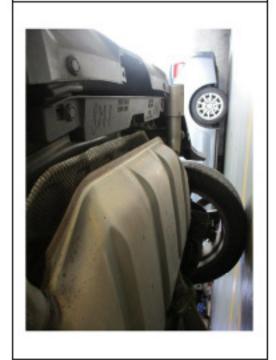
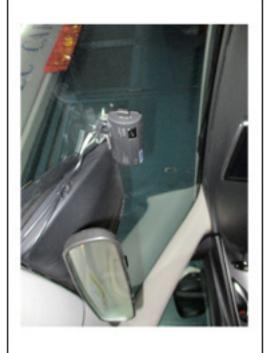
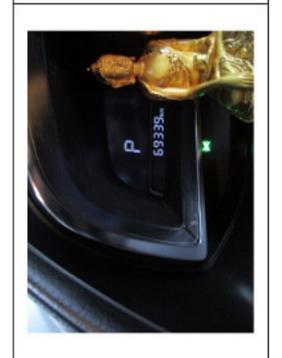
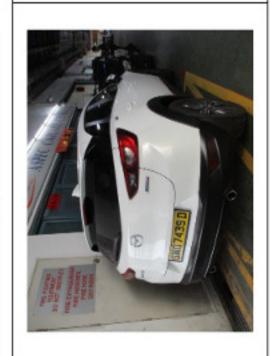
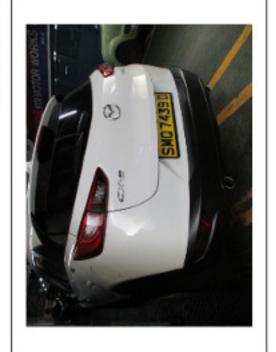
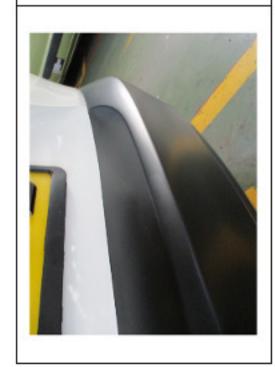
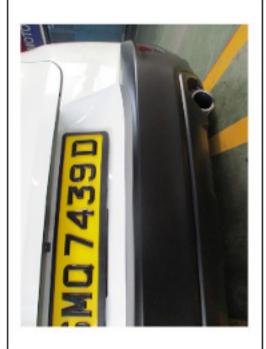
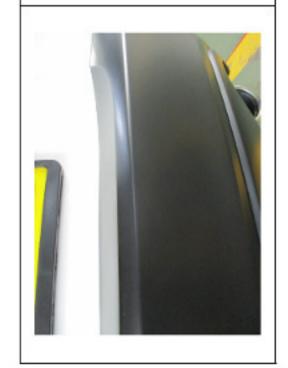
Qty	Description of Parts	Condition	Estimate By Workshop (\$))	Our Adjusted (\$)
	REPLACEMENT OF PARTS			
1	REAR BUMPER	DISTORTED / DENTED	640.90	640.90
5	REAR BUMPER CLIPS @\$3.00	NECESSARY	15.00	15.00
1	REAR END PANEL	NOT NECESSARY	456.90	-
1	REAR REINFORCEMENT	BENT	479.60	479.60
	LESS 10% DISCOUNT		-159.24	-
	LESS 20% DISCOUNT		-	-227.10
			1,433.16	908.40
	<u>LABOUR</u>			
	LABOUR TO DISMANTLE AND CHARGE ALL DAMAGED PARTS.		800.00	400.00
	TO PUTTY AND SPRAY PAINT.		500.00	300.00
	TO DO UNDERCOATING.	NOT NECESSARY	30.00	-
			1,330.00	700.00
	GRAND TOTAL		2,763.16	1,608.40

RECOMMENDED COST OF LUMP SUM REPAIRS	1,250.00
(TO ITS PRE-ACCIDENT CONDITION)
