Reference NS/INC20004869/Ftf3n2

Vehicle No. SHC 1879P

## ADJUSTMENT ON REPAIR COST FOR VEHICLE NO. SHC 1879P

PHOTOGRAPHS FOR VEHICLE NO. SHC 1879P

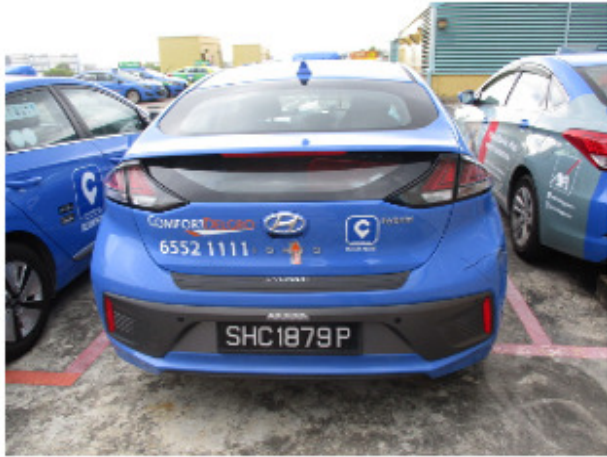
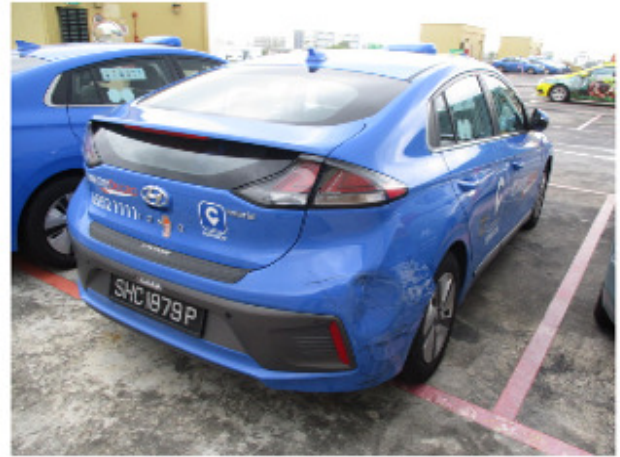
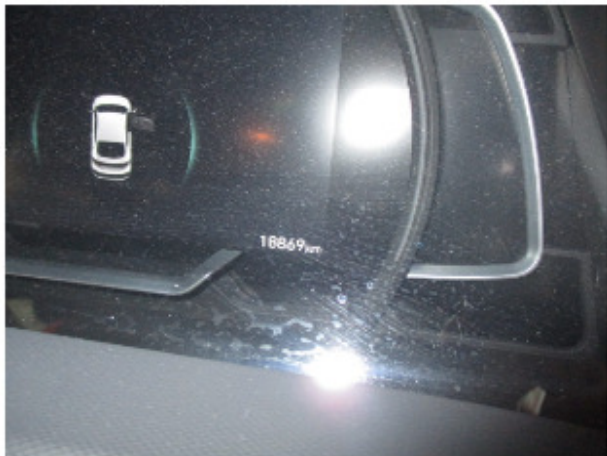
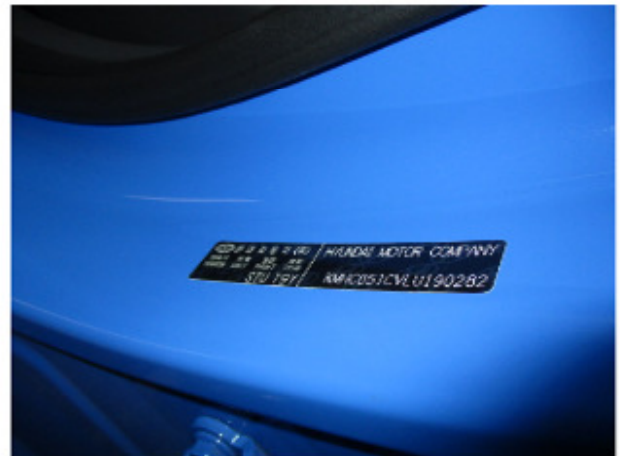
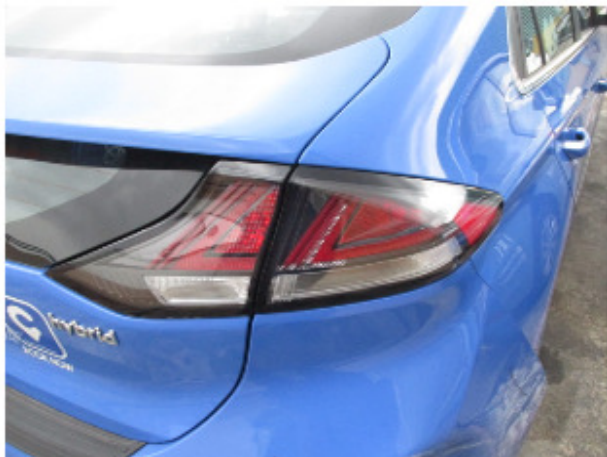
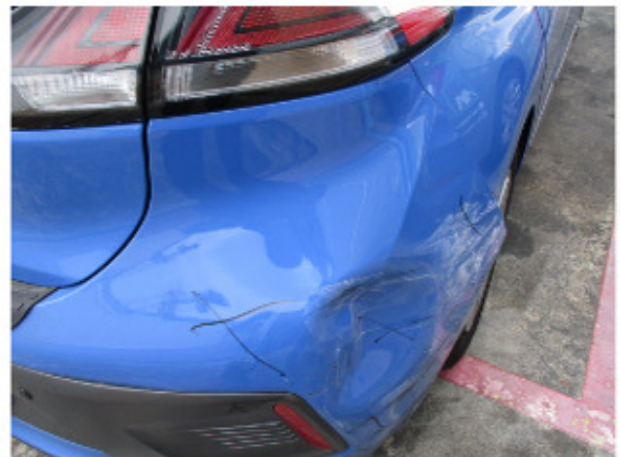
INSPECTION

Code: INC4				
<b>1. Policy Particulars :- THIRD PARTY CLAIM</b>				
Insured Veh.	SLU 5358H	Veh. Inspected	SHC 1879P	
Policy No.	5106049188-01	Coverage (\$)	0.00	
Claim No.	MT/1090468-002	Excess (\$)	0.00	
Assign From		Assign Date	02/04/2020	
<b>2. Vehicle Particulars &amp; Condition</b>				
Make & Model	HYUNDAI IONIQ	c.c	1580	
Engine No.	HIDDEN	Year of Reg.	2019	
Chassis No.	KMHC851CVLU190282	Colour	BLUE	
Odometer	18869	Steering	IN ORDER	
Brakes	IN ORDER	Modification	SPORTS RIM	
General	GOOD			
<b>3. Conditions of Tyres</b>				
	Size	Make	Balance	
R/H Front Tyre	195/65 R15	DAVANTI	8 mm	
L/H Front Tyre	195/65 R15	DAVANTI	8 mm	
R/H Rear Tyre	195/65 R15	DAVANTI	8 mm	
L/H Rear Tyre	195/65 R15	DAVANTI	8 mm	
<b>4. Description of Damages</b>				
	THE VEHICLE SUSTAINED DAMAGES AT THE O/S REAR AND REAR PORTION. DAMAGES SEE DETAILS.

Qty	Description of Parts	Condition	Estimate By Workshop (\$)	Our Adjusted (\$)
	<b><u>REPLACEMENT OF PARTS</u></b>			
1	IONIQVC COVER-RR BUMPER	DEFORMED	459.40	459.40
1	IONIQVC BRACKET ASSY-RR B	NOT NECESSARY	55.80	-
10	HYUNDAI BUMPER COVER CLIP	NECESSARY	22.00	22.00
1	IONIQV2 MOULDING ASSY-RR	SCRATCHED	451.25	451.25
1	IONIQVC GUARD-REAR WHEEL	NOT NECESSARY	73.60	-
	LESS 20% DISCOUNT		-212.41	-186.53
			849.64	746.12
	<b><u>SPECIAL NETT ITEMS</u></b>			
1	IONIQVC PROTECTOR MAT (SN)	NECESSARY	50.00	50.00
			50.00	50.00
	<b><u>LABOUR</u></b>			
	PANEL BEATING.(REPAIR RR FENDER RH).		500.00	480.00
	SPRAYPAINT ON AFFECTED AREA.		450.00	400.00
	TUFF COAT ON AFFECTED PARTS.		50.00	30.00
	REMOVE/REFIX REVERSE SENSOR.		80.00	60.00
			1,080.00	970.00
	<b>GRAND TOTAL</b>		<b>1,979.64</b>	<b>1,766.12</b>
	<b>RECOMMENDED COST OF REPAIRS (CONFIRMED)</b>			<b>1,766.12</b>
