## LKK Auto Consultants Pte Ltd

### ADJUSTMENT ON REPAIR COST FOR VEHICLE NO. GBH 4972C

PHOTOGRAPHS FOR VEHICLE NO. GBH 4972C

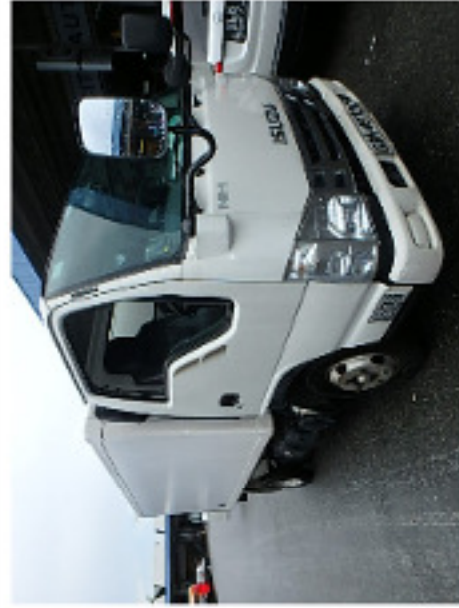
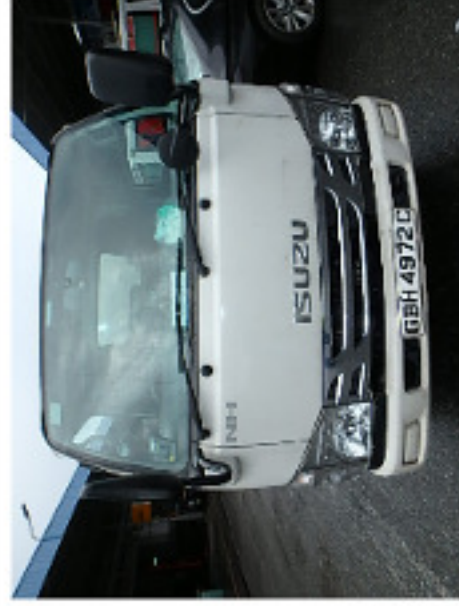
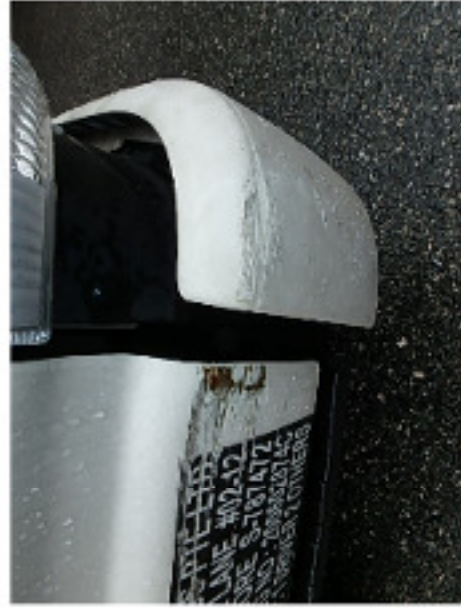
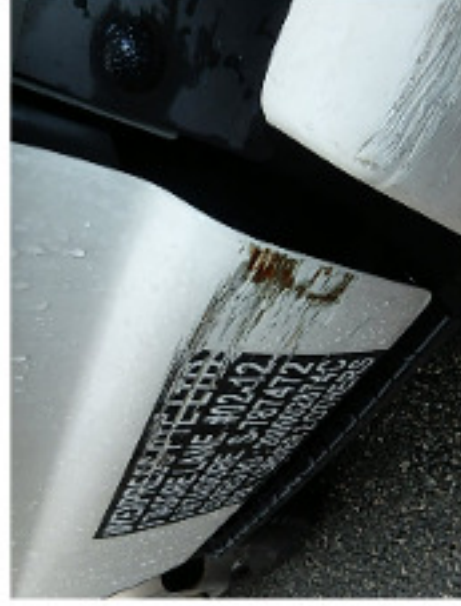
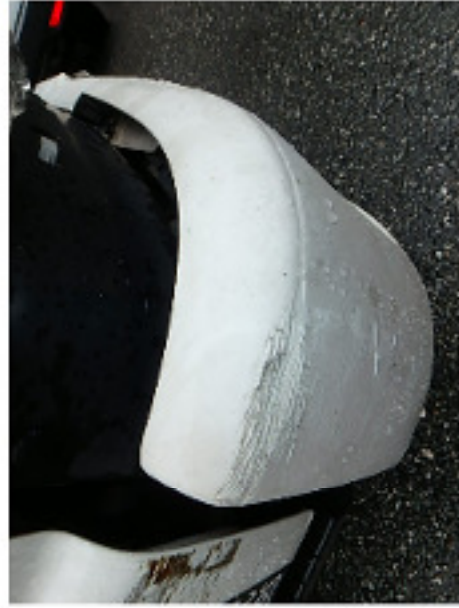
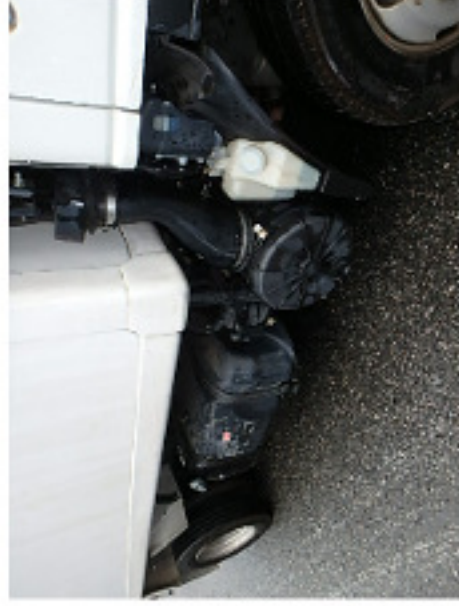
<b>4. Description of Damages</b>				
THE VEHICLE SUSTAINED DAMAGES AT THE O/S BODY. DAMAGES SEE DETAILS.				
<b>5. General Information</b>				
Accident Date	01/04/2020	Inspection Date	03/04/2020	
Survey held at	CITY AUTO PTE LTD BLK 8, SIN MING IND. ESTATE #01-60/62 Sector C SINGAPORE 575643.			
<b>5a. Remarks</b>				
A)THE INSPECTION WAS CONDUCTED ON A"WITHOUT PREJUDICE" BASIS. B)IN ACCORDANCE TO YOUR INSTRUCTIONS, WE HAVE NOT AUTHORISED REPAIRS.				
<b>5b. Estimate Days of Repair</b>				
ESTIMATED NORMAL PERIOD FOR REPAIR:		<b>2 Working Days</b>

Qty	Description of Parts	Condition	Estimate By Workshop (\$))	Our Adjusted (\$)
	<b><u>REPLACEMENT OF PARTS</u></b>			
1	FRONT BUMPER (DENTED)	NOT CONSISTENT WITH THE IMPACT	377.00	-
1	FRONT BUMPER BRACKET RH	TO REPAIR SEE LABOUR	92.00	-
1	CORNER LAMP RH	SERVICEABLE	84.00	-
1	STEP BOARD RH	SERVICEABLE	128.00	-
1	DIESEL TANK	DENTED	651.10	651.10
1	DIESEL TANK BRACKET	TO REPAIR SEE LABOUR	63.00	-
1	REAR RH MUDGUARD	BENT	185.00	185.00
	LESS 15% DISCOUNT		-237.02	-125.41
			1,343.08	710.69
	<b><u>SPECIAL NETT ITEMS</u></b>			
1	FRONT DOOR BODY LETTERING (SN)	NOT NECESSARY	35.00	-
1	FRONT DOOR STICKER (SN)	NOT NECESSARY	38.00	-

73.00	-
	<b><u>LABOUR</u></b>			
	TO REMOVE AND INSTALL OF PETROL TANK .		150.00	60.00
	TO KNOCK JACKOUT DAMAGED PARTS ,PANEL BEATING ,WELDING ,ALIGN ,REFIX AND TO RENEW ACCIDENT PARTS.INCLUSIVE OF THE FRONT BUMPER BRACKET RH AND DIESEL TANK BRACKET .		400.00	100.00
	SPRAY PAINTING ON AFFECTED & REPLACE PARTS.		600.00	120.00
	TOWING CHARGE.	NOT NECESSARY	120.00	-
			1,270.00	280.00
	<b>GRAND TOTAL</b>		<b>2,686.08</b>	<b>990.69</b>
	<b>RECOMMENDED COST OF REPAIRS</b>			<b>990.69</b>
