Affiliated to Federation Internationale Des Experts En Automobile			
LONF	PAC INSURANCE BHD Ref: CC4/LPC20005091/Uka3q2			1/Uka3q2
	BEACH ROAD 04/07 THE CONC	OURSESINGAPORE 199555	Date: 10-12-2020 Code: LPC2

1.		Policy Particulars	:- THIRD PARTY CLAIM	
	Insured Veh.	GW 8893H	Veh. Inspected	FBP 4375J
	Policy No.	Z19VC05004062	Coverage (\$)	0.00
	Claim No.	19/20/20/VC05/023276	Excess (\$)	0.00
	Assign From	KENNY LIM	Assign Date	08/04/2020

ADJUSTMENT ON REPAIR COST FOR VEHICLE NO. FBP 4375J

PHOTOGRAPHS FOR VEHICLE NO. FBP 4375J

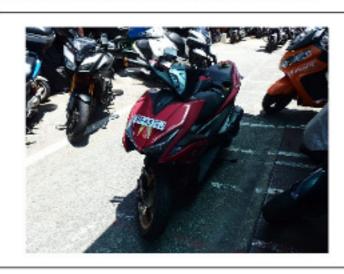
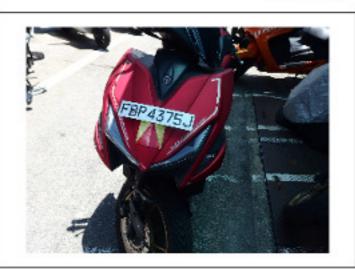
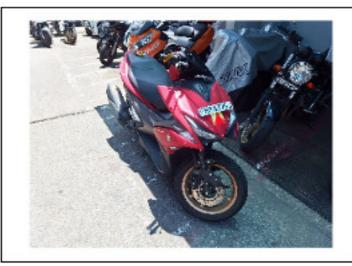
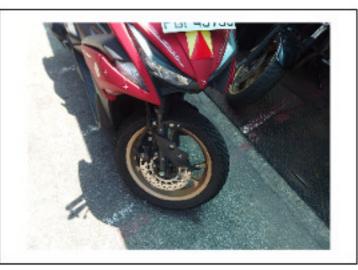
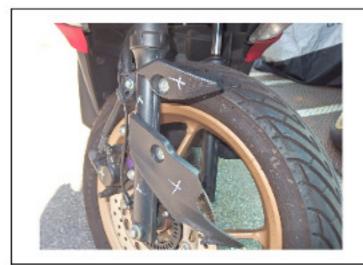
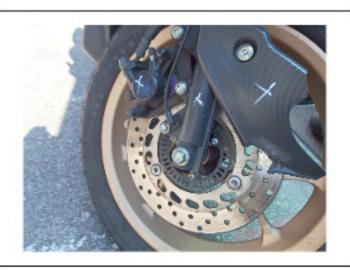
4.		Description	on of Damages	
	THE VEHICLE SU	STAINED DAMAGES AT THE FRO	ONT PORTION AND O/S FR	ONT PORTION.
	DAMAGES SEE D	ETAILS.		
5.		Genera	Information	
	Accident Date	31/03/2020	Inspection Date	08/04/2020
	Survey held at	BAN HOCK HIN CO.PTE LTD		
		NO 6 DEFU LANE 4 SINGAPORE 539410		
5a.			emarks	
	A)THE INSPECTION WAS CONDUCTED ON A"WITHOUT PREJUDICE" BASIS. B)IN ACCORDANCE TO YOUR INSTRUCTIONS, WE HAVE NOT AUTHORISED REPAIRS.			
5b.	b. Estimate Days of Repair			
	ESTIMATED NORMAL PERIOD FOR REPAIR: 3 Working Days
