1.	1. Policy Particulars :- THIRD PARTY CLAIM							
	Insured Veh.	SFT 2320L	Veh. Inspected	SHC 8616K				
	Policy No.	DMPCSN30217719000	Coverage (\$)	0.00				
	Claim No.	SNM20D201728/C02	Excess (\$)	0.00				
	Assign From		Assign Date	08/04/2020

ADJUSTMENT ON REPAIR COST FOR VEHICLE NO. SHC 8616K

PHOTOGRAPHS FOR VEHICLE NO. SHC 8616K

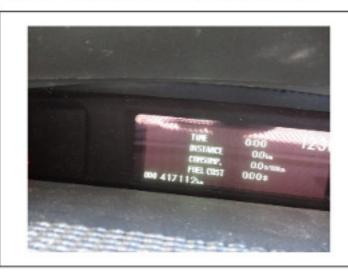
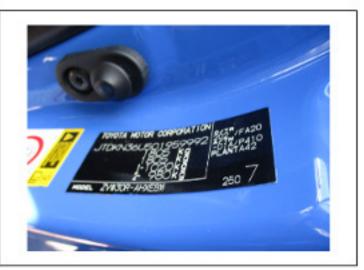
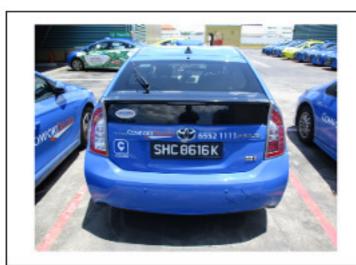
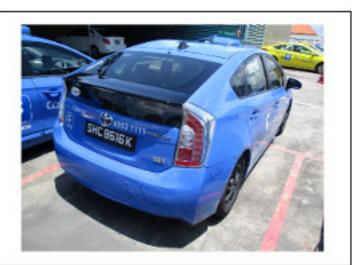
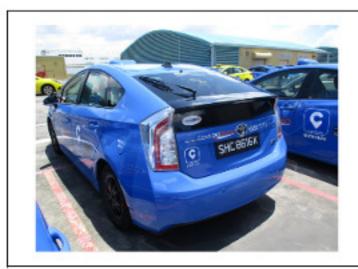
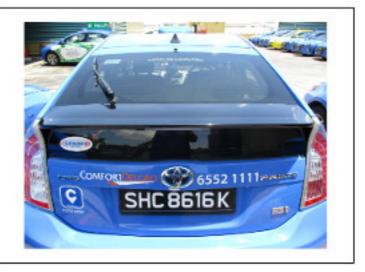
4.		Description	on of Damages					
	THE VEHICLE SUS	STAINED DAMAGES AT THE REA	AR PORTION.					
	DAMAGES SEE DI	ETAILS.						
5.		General	Information					
	Accident Date	06/04/2020	Inspection Date	08/04/2020				
	Survey held at	COMFORTDELGRO ENGINEER	RING PTE LTD					
		59 LOYANG DRIVE SINGAPORE 508969						
5a.		Re	emarks					
	A)THE INSPECTION WAS CONDUCTED ON A"WITHOUT PREJUDICE" BASIS. B)IN ACCORDANCE TO YOUR INSTRUCTIONS, WE HAVE NOT AUTHORISED REPAIRS.							
5b.	<u> </u>							
	ESTIMATED NORMAL PERIOD FOR REPAIR: 2 Working Days

Qty	Description of Parts	Condition	Estimate By Workshop (\$))	Our Adjusted (\$)
	REPLACEMENT OF PARTS			
1	REAR BUMPER	DEFORMED / CRACKED	458.60	458.60
1	REAR BUMPER SIDE RETAINER RH	NOT NECESSARY	112.70	-
1	TOWING COVER	NOT NECESSARY	82.70	-
	LESS 25% DISCOUNT		-163.50	-114.65
			490.50	343.95
	SPECIAL NETT ITEMS			
1	REVERSE SENSOR (SN)	NOT NECESSARY	135.70	-
			135.70	-
	<u>LABOUR</u>			
	PANEL BEATING.		380.00	320.00
	SPRAY PAINTING .		400.00	200.00
	WIRING .	NOT NECESSARY	60.00	-
	TUFF KOTE.		60.00	30.00
	REMOVE/REFIX REVERSE SENSOR .		60.00	60.00
			960.00	610.00
	GRAND TOTAL		1,586.20	953.95

RECOMMENDED COST OF LUMP SUM REPAIRS		750.00
(TO ITS PRE-ACCIDENT CONDITION)
