Vehicle No. SH 7007T
Insured Veh. FBN 1670L
Claim No. MT/1091205-002
Policy No. 5102815542-01
Accident Date 09/04/2020
Inspection Date 09/04/2020

ADJUSTMENT ON REPAIR COST FOR VEHICLE NO. SH 7007T

PHOTOGRAPHS FOR VEHICLE NO. SH 7007T

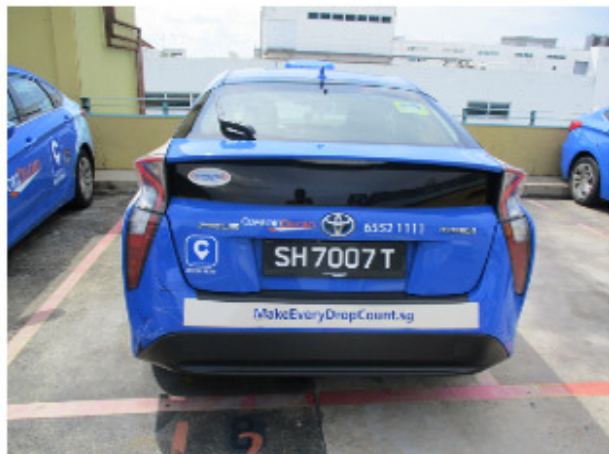
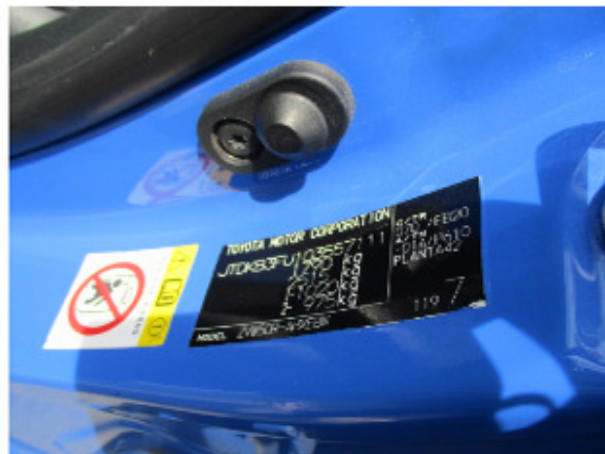
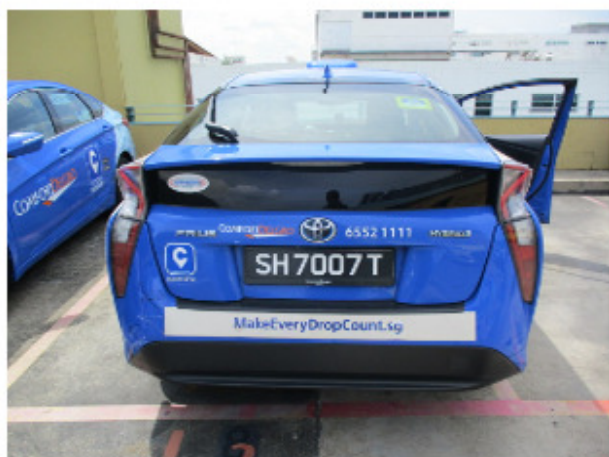
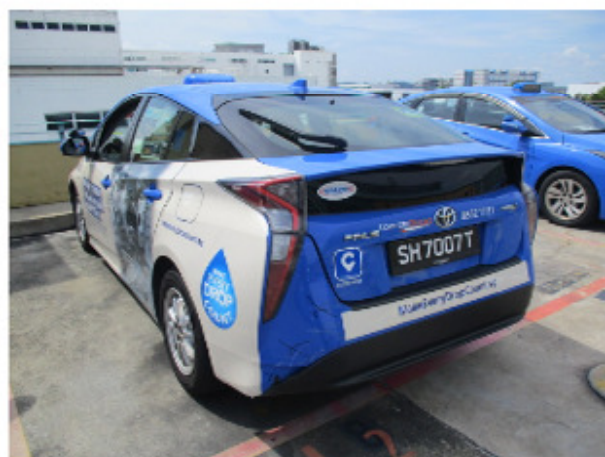
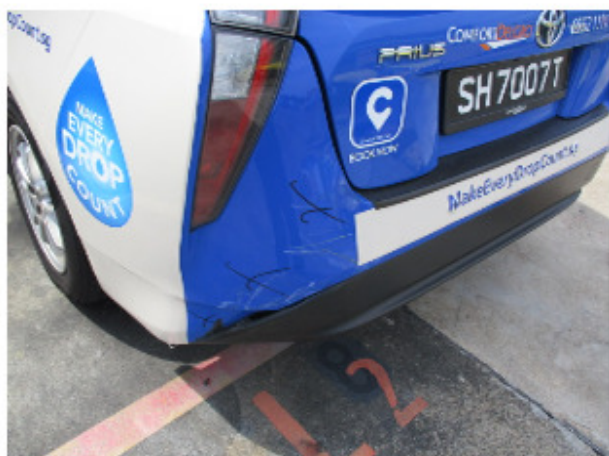
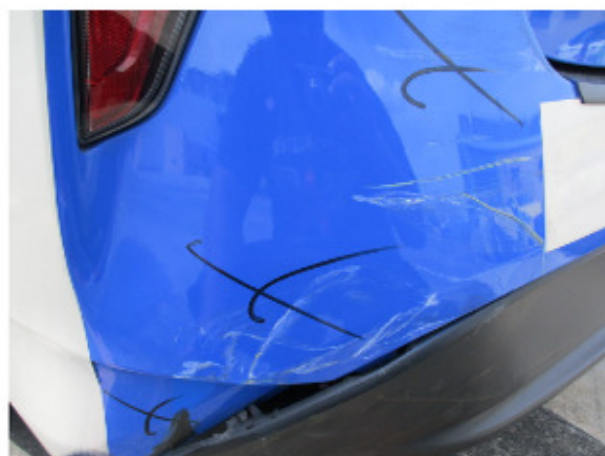
4. Description of Damages				
	THE VEHICLE SUSTAINED DAMAGES AT THE REAR PORTION. DAMAGES SEE DETAILS.			
5. General Information				
Accident Date	09/04/2020	Inspection Date	09/04/2020	
Survey held at	COMFORTDELGRO ENGINEERING PTE LTD 59 LOYANG DRIVE SINGAPORE 508969			
5a. Remarks				
	A)THE INSPECTION WAS CONDUCTED ON A"WITHOUT PREJUDICE" BASIS. B)IN ACCORDANCE TO YOUR INSTRUCTIONS, WE HAVE NOT AUTHORISED REPAIRS.			
5b. Estimate Days of Repair				
	ESTIMATED NORMAL PERIOD FOR REPAIR: 2 Working Days

Qty	Description of Parts	Condition	Estimate By Workshop (\$)	Our Adjusted (\$)
	<u>REPLACEMENT OF PARTS</u>			
1	PRIG4 COVER REAR BUMPER	DEFORMED / SCRATCHED	458.60	458.60
10	PRIVC BUMPER PIECE	NECESSARY	22.00	22.00
1	PRIG4 GUARD-REAR BUMPER C	SCRATCHED	552.60	552.60
1	PRIG4 FILLER-REAR BUMPER	DEFORMED	148.40	148.40
	LESS 25% DISCOUNT		-295.40	-295.40

300.00	300.00
	<u>LABOUR</u>			
	PANEL BEATING.		350.00	320.00
	SPRAYPAINT ON AFFECTED AREA.		300.00	200.00
	REMOVE/REFIX REVERSE SENSOR.		80.00	60.00
			730.00	580.00
	GRAND TOTAL		1,916.20	1,766.20
	RECOMMENDED COST OF LUMP SUM REPAIRS (TO ITS PRE-ACCIDENT CONDITION) (CONFIRMED)			1,400.00
