Vehicle No. SLK 2460S  
Insured Veh. SHA 7908K  
Claim No. D20001931MFSH  
Policy No. D-18088936MFSH  
Accident Date 03/04/2020  
Inspection Date 16/04/2020

### 4. Description of Damages

## ADJUSTMENT ON REPAIR COST FOR VEHICLE NO. SLK 2460S

PHOTOGRAPHS FOR VEHICLE NO. SLK 2460S

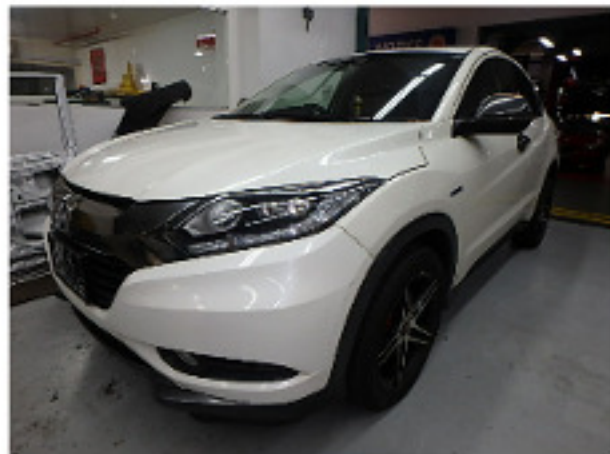
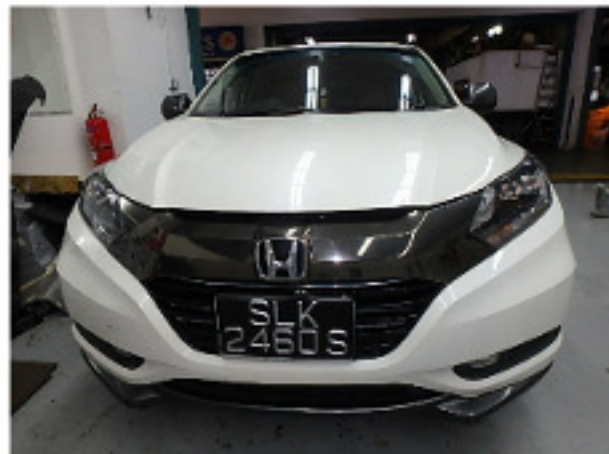
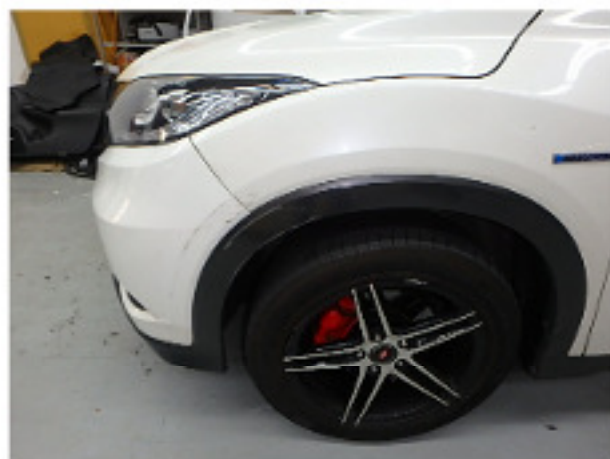
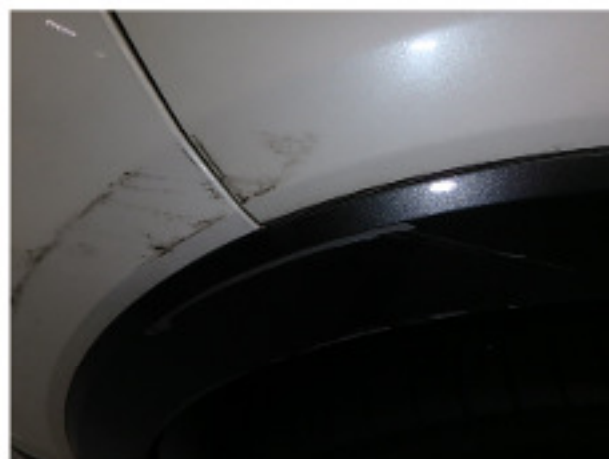
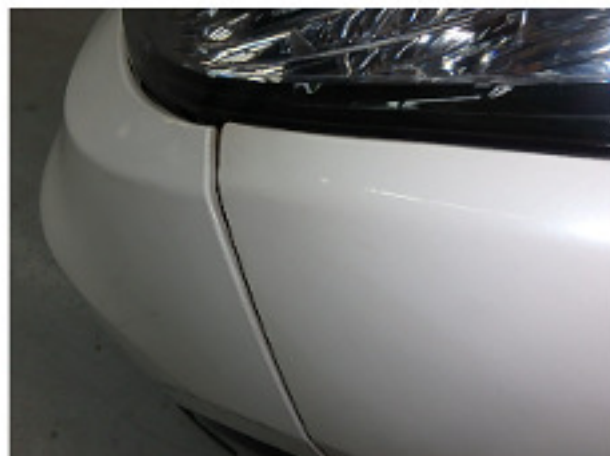
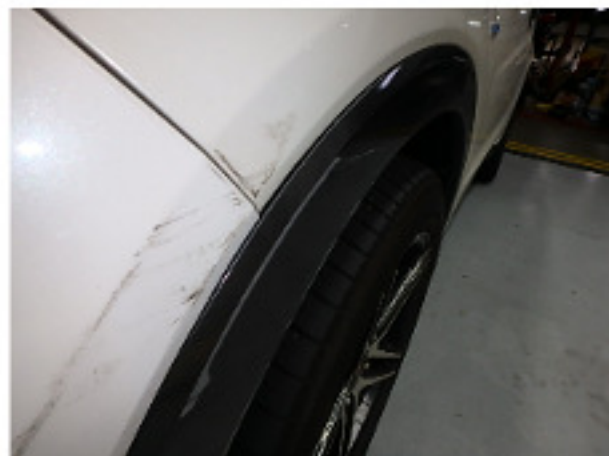
INSPECTION

THE VEHICLE SUSTAINED DAMAGES AT THE N/S FRONT PORTION. DAMAGES SEE DETAILS.
---

Qty	Description of Parts	Condition	Estimate By Workshop (\$))	Our Adjusted (\$)
	<b><u>REPLACEMENT OF PARTS</u></b>			
1	FRONT LH HEADLAMP	MTG CRACKED	1,559.40	1,559.40
1	FRONT LH HEADLAMP LOWER BRACKET	SERVICEABLE	35.00	-
1	FRONT BUMPER	MTG CRACKED	927.50	801.70
1	FRONT BUMPER LH SIDE RETAINER	DISTORTED	31.70	31.70
1	FRONT BUMPER LOWER SPOILER	SERVICEABLE	351.00	-
20	FRONT BUMPER CLIP @\$5.00	NECESSARY	100.00	100.00
1	FRONT BUMPER REINFORCEMENT	TO REPAIR SEE LABOUR	321.50	-
1	FRONT BUMPER LH FOG LAMP GARNISH	SERVICEABLE	185.85	-
1	FRONT LH FENDER	TO REPAIR SEE LABOUR	580.00	-
1	FRONT LH FENDER PROTECTOR	DENTED	195.00	195.00
1	FRONT LH FENDER 'HYBIRD' EMBLEM	NECESSARY	65.50	65.50
	LESS 20% DISCOUNT		-870.49	-550.66
			3,481.96	2,202.64
	<b><u>SPECIAL NETT ITEMS</u></b>			
1	FRONT LH SPORT RIM (SN)	SERVICEABLE	680.00	-

680.00	-
	<b><u>LABOUR</u></b>			
	ALIGNMENT.		80.00	60.00
	WIRING .		60.00	20.00
	TUFFKOTE.	NOT NECESSARY	80.00	-
	SPRAY PAINTING .		800.00	550.00
	LABOUR CHARGES.INCLUSIVE OF THE REPAIR OF FRONT BUMPER REINFORCEMENT AND FRONT LH FENDER .		800.00	360.00
			1,820.00	990.00
	<b>GRAND TOTAL</b>		<b>5,981.96</b>	<b>3,192.64</b>
	<b>RECOMMENDED COST OF LUMP SUM REPAIRS (TO ITS PRE-ACCIDENT CONDITION)</b>			<b>2,550.00</b>
