## LKK Auto Consultants Pte Ltd

## ADJUSTMENT ON REPAIR COST FOR VEHICLE NO. SKZ 9393P

### PHOTOGRAPHS FOR VEHICLE NO. SKZ 9393P

PHOTOGRAPHS FOR VEHICLE NO. SKZ 9393P

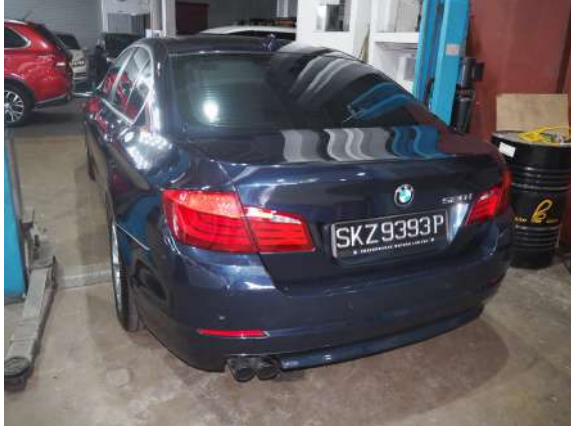
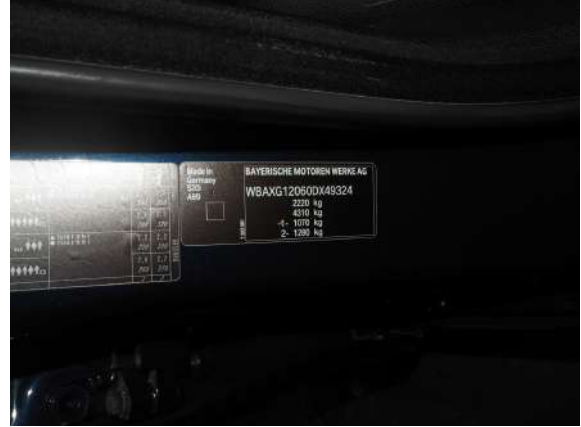
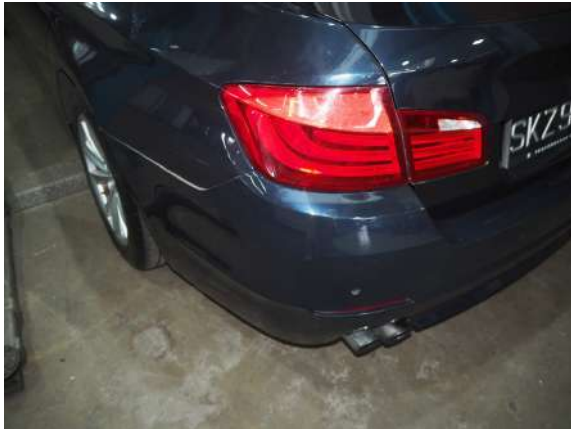
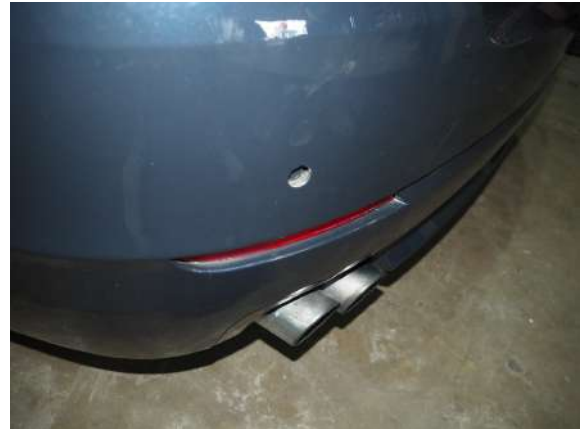
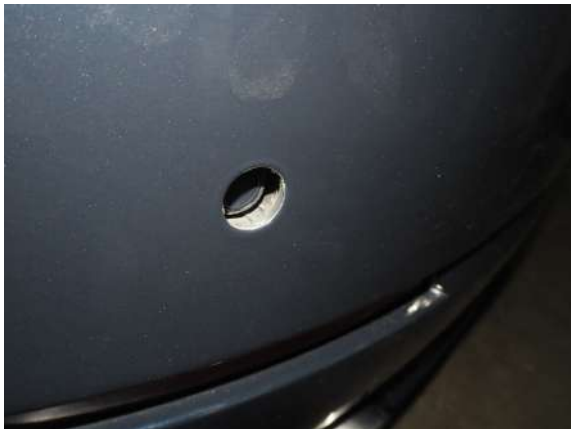
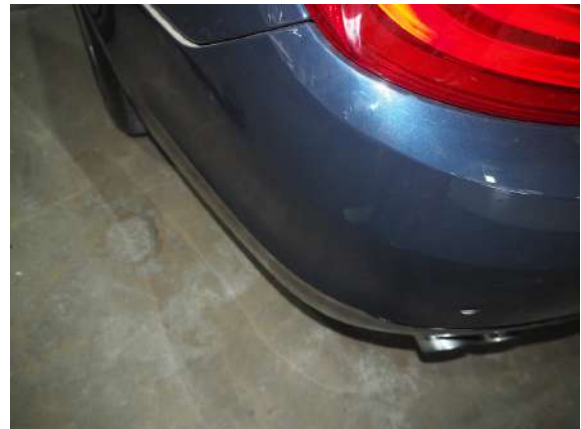
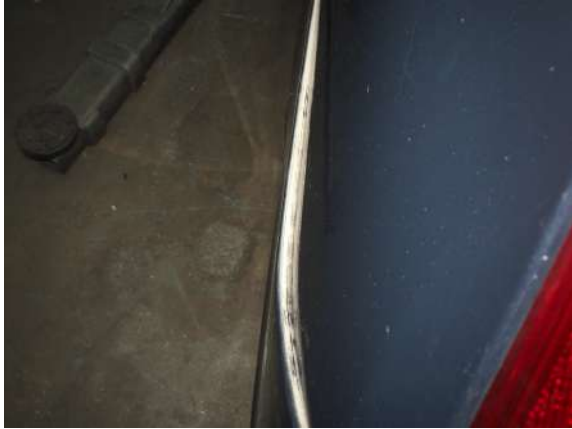
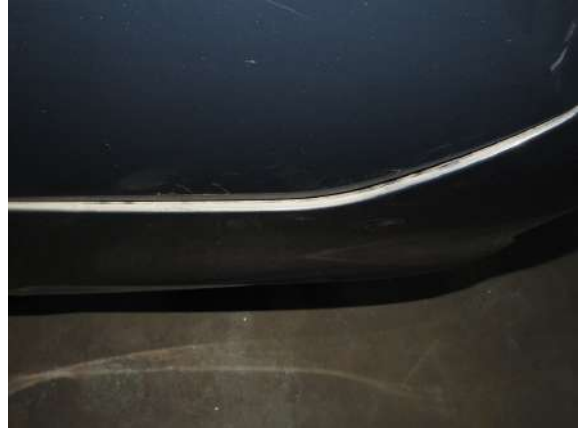
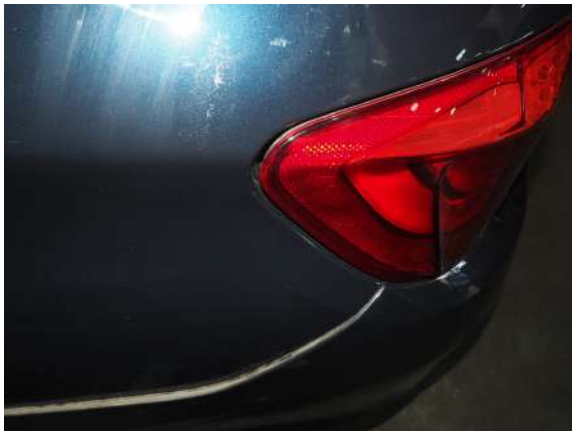
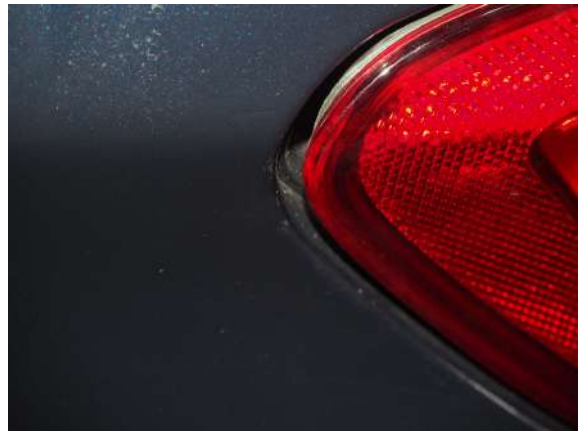
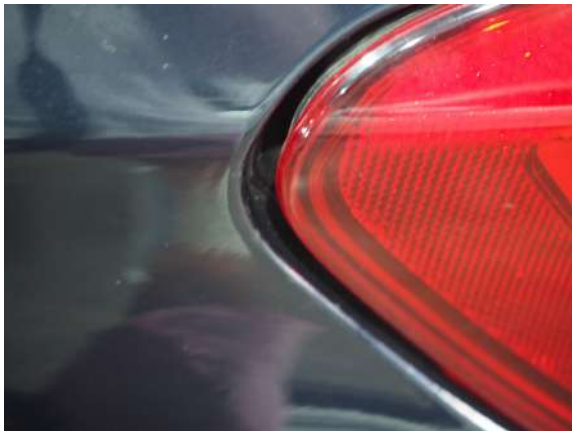
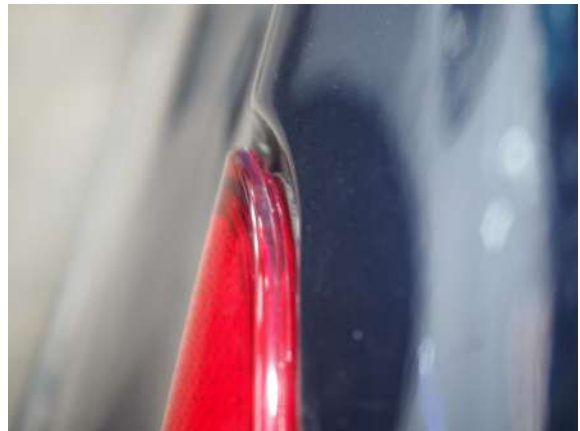
### INSPECTION

| Affiliated to Federation Internationale Des Experts En Automobile | | | | |
|---|---|---|---|--|
| THE VEHICLE SUSTAINED DAMAGES AT THE REAR N/S PORTION.<br>DAMAGES SEE DETAILS. | | | | |
