National Assessment Centre Services

Vehicle No. SH 9384R
Insured Veh. GBJ 5915B
Claim No. MT/1091947-002
Policy No. 5110409450
Accident Date 27/04/2020
Inspection Date 29/04/2020

ADJUSTMENT ON REPAIR COST FOR VEHICLE NO. SH 9384R

PHOTOGRAPHS FOR VEHICLE NO. SH 9384R

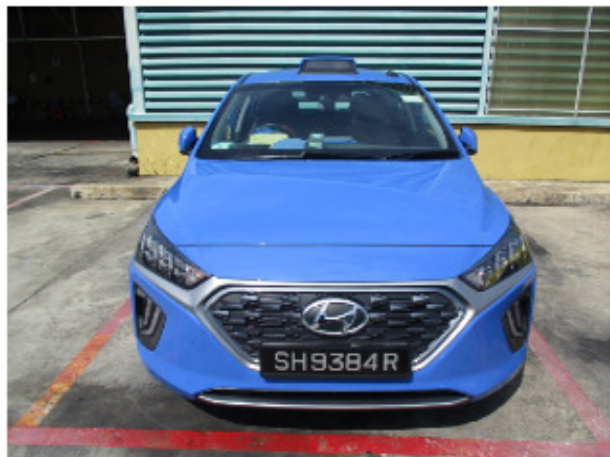
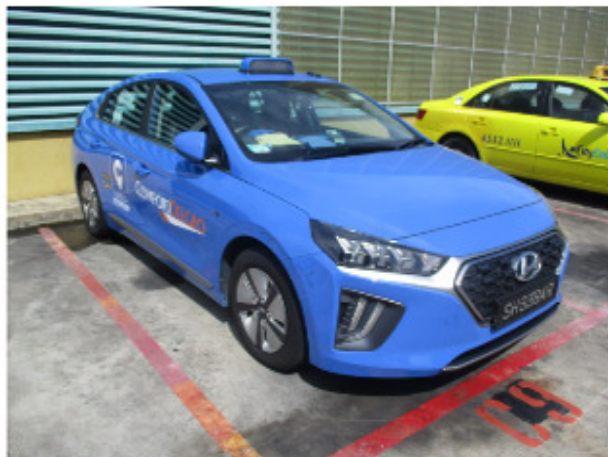
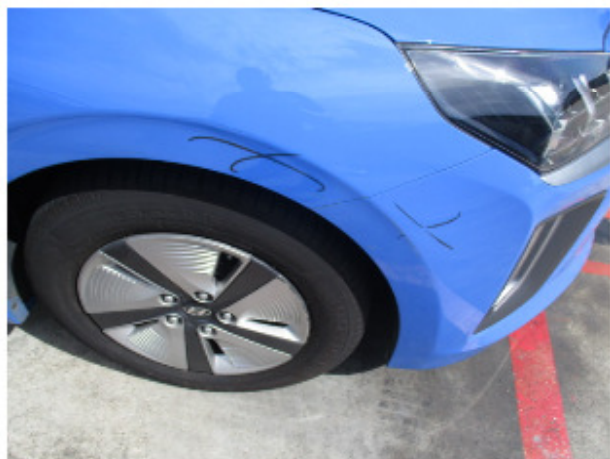
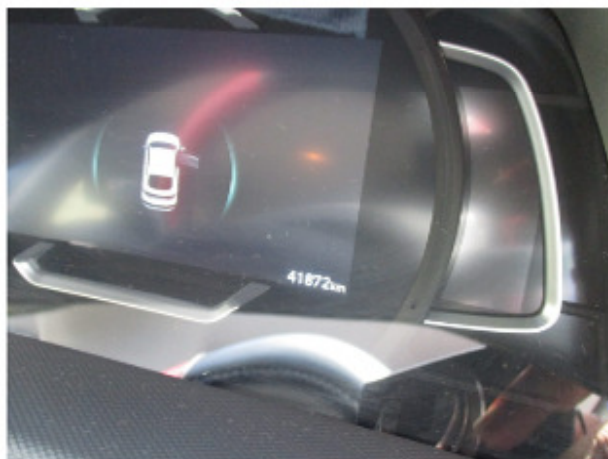
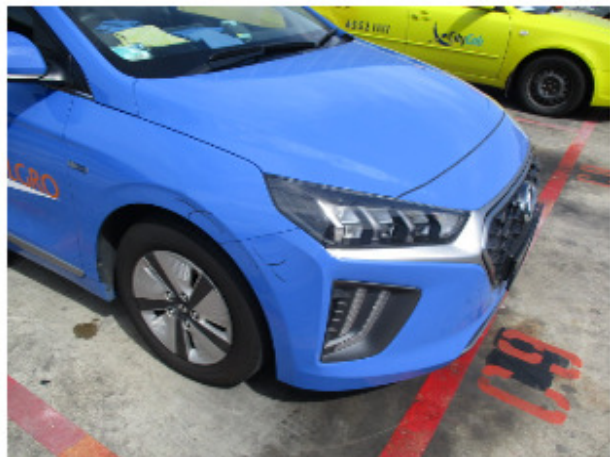
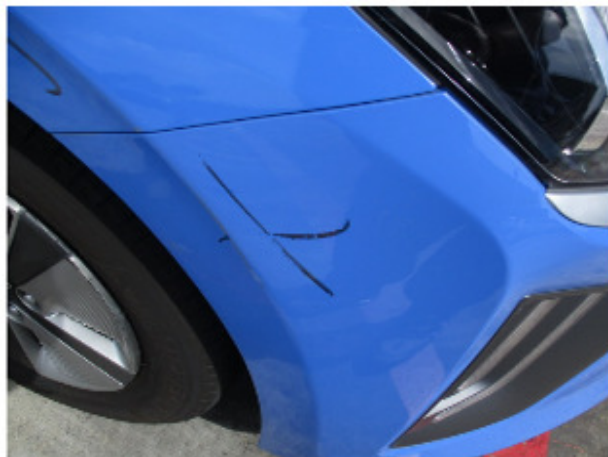
4. Description of Damages				
	THE VEHICLE SUSTAINED DAMAGES AT THE O/S FRONT AND FRONT PORTION. DAMAGES SEE DETAILS.			
5. General Information				
Accident Date	27/04/2020	Inspection Date	29/04/2020	
Survey held at	COMFORTDELGRO ENGINEERING PTE LTD 59 LOYANG DRIVE SINGAPORE 508969			
5a. Remarks				
	A)THE INSPECTION WAS CONDUCTED ON A"WITHOUT PREJUDICE" BASIS. B)IN ACCORDANCE TO YOUR INSTRUCTIONS, WE HAVE NOT AUTHORISED REPAIRS.			
5b. Estimate Days of Repair				
	ESTIMATED NORMAL PERIOD FOR REPAIR: 2 Working Days

Qty	Description of Parts	Condition	Estimate By Workshop (\$)	Our Adjusted (\$)
	<u>REPLACEMENT OF PARTS</u>			
1	FRONT BUMPER COVER	TO REPAIR SEE LABOUR	418.30	-
1	FRONT BUMPER BRACKET-RH	NOT NECESSARY	28.00	-
1	FRONT BUMPER TOP BRACKET-RH	NOT NECESSARY	12.00	-
10	FRONT BUMPER CLIPS @\$2.20	NOT NECESSARY	22.00	-
1	FRONT FENDER-RH	TO REPAIR SEE LABOUR	490.70	-
1	FRONT FENDER EMBLEM-BLUEDRIVE	NECESSARY	26.60	26.60
	LESS 20% DISCOUNT		-199.52	-5.32
			798.08	21.28
	<u>LABOUR</u>			
	PANEL BEATING.INCLUSIVE OF THE REPAIR OF FRONT BUMPER COVER AND FRONT FENDER-RH.		700.00	640.00
	SPRAY PAINTING CHARGE.		500.00	400.00
	WIRING CHARGE.	NOT NECESSARY	80.00	-
	TUFF KOTE.		80.00	30.00
			1,360.00	1,070.00
	GRAND TOTAL		2,158.08	1,091.28
	RECOMMENDED COST OF REPAIRS (CONFIRMED)			1,091.28
