4.		Description	on of Damages		
	THE VEHICLE SU	STAINED DAMAGES AT THE REA	AR PORTION.		
	DAMAGES SEE D	ETAILS.			
5.		General	Information		
	Accident Date	02/05/2020	Inspection Date	11/05/2020	
	Survey held at	TENG MENG MOTOR SERVICE			
		176 SIN MING DRIVE SIN MING AUTOCARE #04-01 & #04-10 SINGAPORE 575721			
5a.		Re	emarks		
	A)THE INSPECTION WAS CONDUCTED ON A"WITHOUT PREJUDICE" BASIS. B)IN ACCORDANCE TO YOUR INSTRUCTIONS, WE HAVE NOT AUTHORISED REPAIRS.				
5b.	Estimate Days of Repair

ADJUSTMENT ON REPAIR COST FOR VEHICLE NO. SKB 7516S

PHOTOGRAPHS FOR VEHICLE NO. SKB 7516S

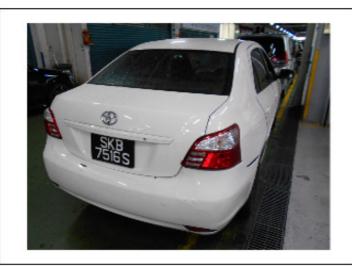
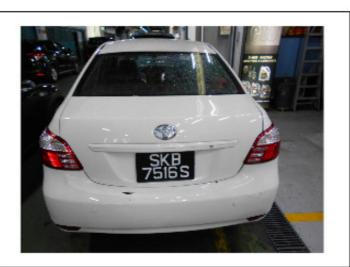
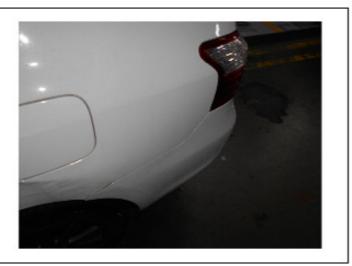
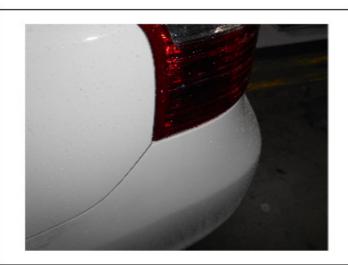
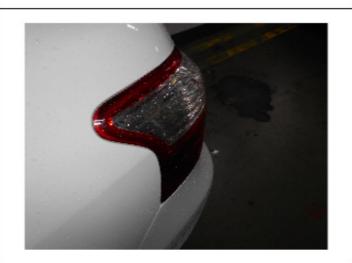
INSPECTION

Qty	Description of Parts	Condition	Estimate By Workshop (\$))	Our Adjusted (\$)
	REPLACEMENT OF PARTS			
1	REAR BUMPER	DEFORMED	198.00	198.00
1	REAR BUMPER REFLECTOR R/H	CRACKED	68.00	68.00
1	REAR BUMPER SIDE RETAINER	DEFORMED	65.00	45.00
1	REAR TAIL LAMP R/H	CRACKED	145.00	145.00
1	REAR BOOT COVER RUBBER	TORN	135.00	135.00
1	REAR BOOT COVER LOCK	CUT	88.00	88.00
	LESS 25% DISCOUNT		-	-169.75
			699.00	509.25
	<u>LABOUR</u>			
	PANEL BEATING & RESTRAIGHTEN REAR PANEL & REAR BOOT COVER.		280.00	250.00
	RESPRAY PAINTING REAR BOOT COVER,REAR BUMPER & REAR PANEL.		580.00	400.00
			860.00	650.00
	GRAND TOTAL		1,559.00	1,159.25

Γ	RECOMMENDED COST OF LUMP SUM REPAIRS		900.00
	(TO ITS PRE-ACCIDENT CONDITION)
