ASS. REC. BY: JamesREP: CS/EG/20005702/R1/3

## ASSIGNMENT

**Full Report**  
**Registration: SLJ1011S**  
**Printed: 13/05/2020 9:56 AM**

### **Summary Information**

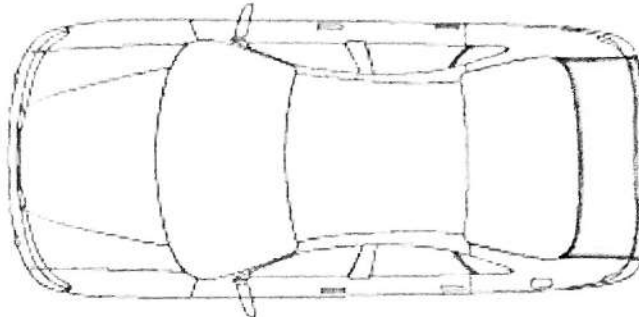
### Damage Areas

Survey held at MOVA (CBM)Des. of Damages: Frt / Rear / O/S / N/S / U/C / Rooftop or

The U/C / Chassis frame / Body Structure affected due to collision.

Code	Description	Time Base 12 WU/h	Price = 45.00 SGD/h	
			WU	Price SGD
NO NUMBER	ADD/TIME FOR MAIN WORK		2.0	7.50
NO NUMBER	R + R REAR CENTRE FLOOR PANEL COVER		2.0	7.50
51 12 656	R + R REAR BUMPER		8.0	30.00
51 12 552	R + R REAR BUMPER CARRIER (BUMPER REMOVED)		5.0	18.75
51 12 657	RENEW REAR BUMPER TRIM (BUMPER REMOVED)		1.0	3.75
51 12 825	R + R RR CTR BUMPER GUIDE		3.0	11.25
66 20 603	ADD/WORK PARK DISTANCE CONTROL		3.0	11.25
51 49 500	R + R TAILGATE TRIM		3.0	11.25
51 13 900)	R + R TAILGATE COVER		2.0	7.50
NO NUMBER	R + R REAR WIRING HARNESS		12.0	45.00
9852	FAULT MEM AFTER REP READ OUT		20.0*	75.00
2711	REAR PANEL REPAIR		20.0*	75.00
2987	TAILGATE TRIM REPAIR		5.0*	18.75
2611	L/R REFLECTOR CHECK			
2612	R/R REFLECTOR CHECK			
<b>Labour Cost</b>		<b>Hrs</b>	<b>WU</b>	
<b>Panel / Mechanical Labour</b>		<b>7.20</b>	<b>86.0</b>	<b>322.50</b>
<b>Total of Labour</b>				<b>322.50</b>

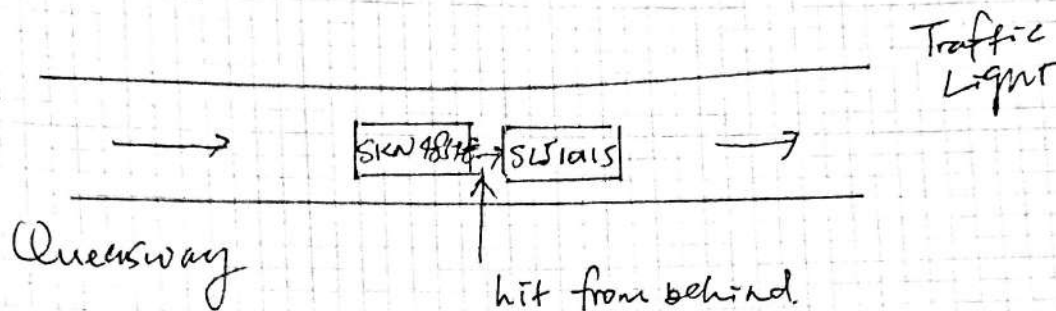
My's car stopped at traffic light. Vehicle plate SKN4851E hit my's car from behind.
