CS/CT120005888/Tif3

ASSIGNMENT

The U/C / Chassis frame / Body Structure affected due to collision.

Vehicle No. SGZ9685U HYUNDAI AVANTE 1.6A

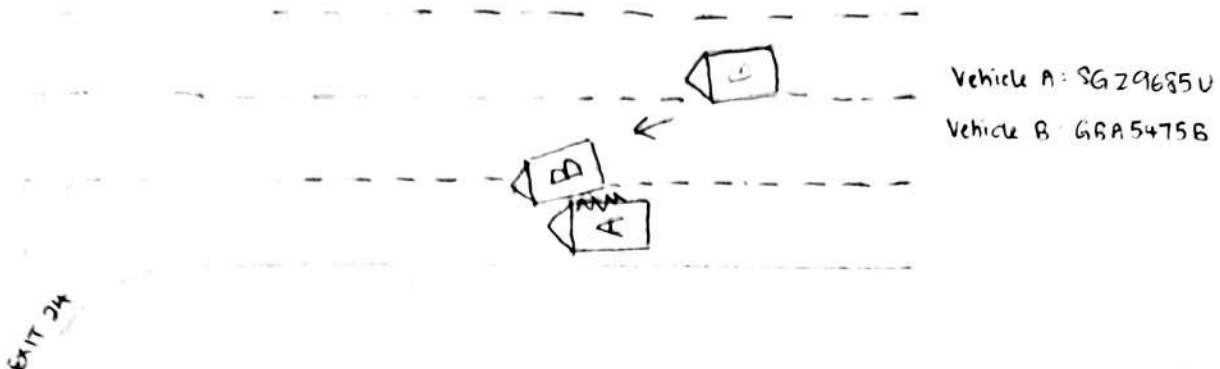
SKETCH PLAN

PIE NEAR EXIT 24 FOR BRE TOWARDS WOODLANDS

At 11:50 am as I was driving along the PIE heading towards Exit 24 for BRE, a beige coloured van suddenly swerved towards my right. I braked a bit for fear of car behind me. I honked several times to alert the van driver. The driver did not slow down. He hit my right side ^{causing me to} ~~swerved~~ & his van hit my passenger side (~~left~~ ^{right rear} side).
