Code: INC4				
<b>1. Policy Particulars :- THIRD PARTY CLAIM</b>				
	<b>Insured Veh.</b>	FBF 3822U	<b>Veh. Inspected</b>	SH 7535K
	<b>Policy No.</b>	5114924823	<b>Coverage (\$)</b>	0.00
	<b>Claim No.</b>	MT/1093880-002	<b>Excess (\$)</b>	0.00
	<b>Assign From</b>		<b>Assign Date</b>	05/06/2020
<b>2. Vehicle Particulars &amp; Condition</b>				
	<b>Make &amp; Model</b>	HYUNDAI I40	<b>c.c</b>	1685
	<b>Engine No.</b>	HIDDEN	<b>Year of Reg.</b>	2017
	<b>Chassis No.</b>	KMHLB41UMHU098177	<b>Colour</b>	BLUE
	<b>Odometer</b>	488511	<b>Steering</b>	IN ORDER
	<b>Brakes</b>	IN ORDER	<b>Modification</b>	STANDARD ALLOY RIM
	<b>General</b>	FAIR		
<b>3. Conditions of Tyres</b>				
		<b>Size</b>	<b>Make</b>	<b>Balance</b>
	<b>R/H Front Tyre</b>	205/60 R16	HANKOOK	6 mm

**ADJUSTMENT ON REPAIR COST FOR VEHICLE NO. SH 7535K**

PHOTOGRAPHS FOR VEHICLE NO. SH 7535K

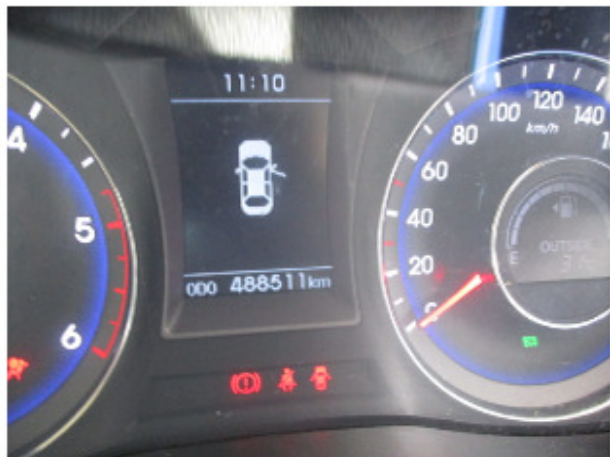
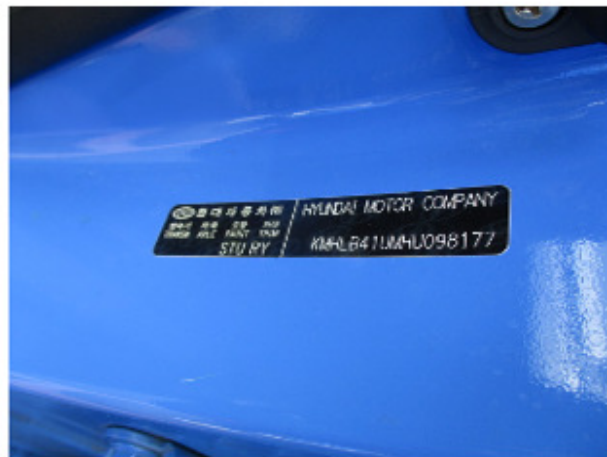
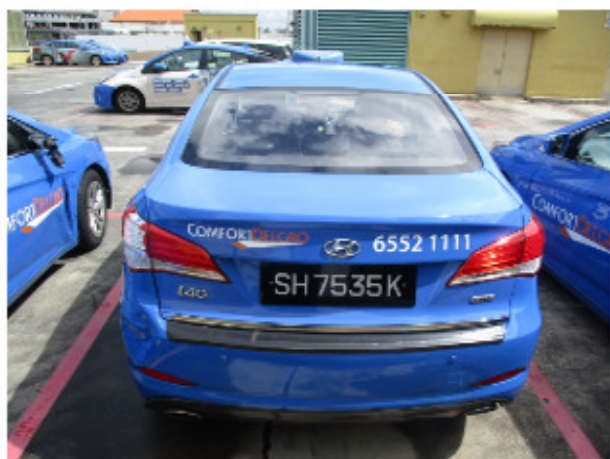
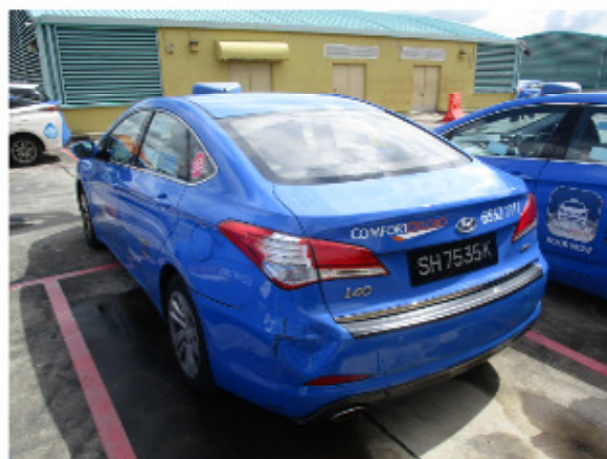
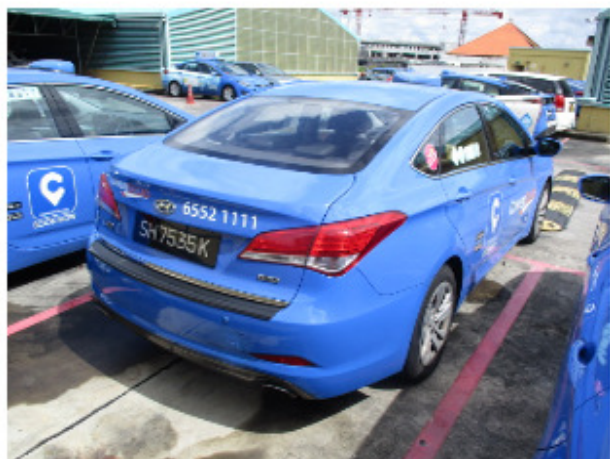
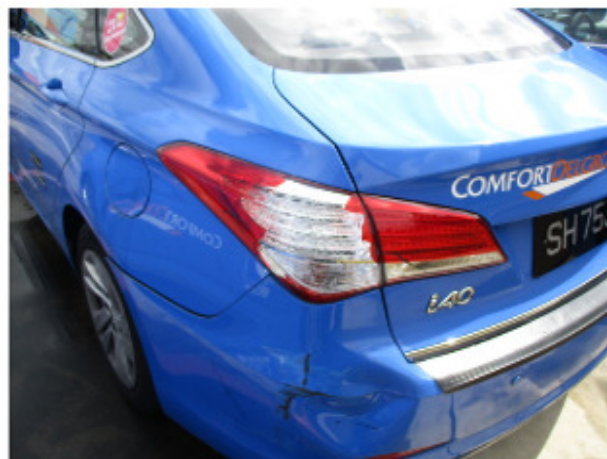
<b>L/H Front Tyre</b>	205/60 R16	HANKOOK	6 mm
	<b>R/H Rear Tyre</b>	205/60 R16	HANKOOK	7 mm
	<b>L/H Rear Tyre</b>	205/60 R16	HANKOOK	7 mm
<b>4. Description of Damages</b>				
	THE VEHICLE SUSTAINED DAMAGES AT THE REAR PORTION. DAMAGES SEE DETAILS.			
<b>5. General Information</b>				
	<b>Accident Date</b>	04/06/2020	<b>Inspection Date</b>	05/06/2020
	<b>Survey held at</b>	COMFORTDELGRO ENGINEERING PTE LTD 59 LOYANG DRIVE SINGAPORE 508969		
<b>5a. Remarks</b>				
	A)THE INSPECTION WAS CONDUCTED ON A"WITHOUT PREJUDICE" BASIS. B)IN ACCORDANCE TO YOUR INSTRUCTIONS, WE HAVE NOT AUTHORISED REPAIRS.			
<b>5b. Estimate Days of Repair</b>				
	ESTIMATED NORMAL PERIOD FOR REPAIR:		<b>2 Working Days</b>

Qty	Description of Parts	Condition	Estimate By Workshop (\$)	Our Adjusted (\$)
<b><u>REPLACEMENT OF PARTS</u></b>				
1	REAR BUMPER COVER	DEFORMED	1,106.00	1,106.00
2	REAR BUMPER BRACKET SIDE LH/RH @\$35.60	NOT NECESSARY	71.20	-
10	REAR BUMPER CLIPS @\$2.20	NECESSARY	22.00	22.00
1	REAR BUMPER REINFORCEMENT	NOT NECESSARY	428.40	-
1	TAIL LAMP LH	CRACKED	697.80	697.80
1	BOOT LAMP LH	NOT NECESSARY	565.60	-
1	REAR BUMPER UNDER COVER	CRACKED	228.00	228.00
2	REAR BUMPER REINFORCEMENT STAY @\$60.30	NOT NECESSARY	160.60	-
	LESS 20% DISCOUNT		-655.92	-410.76
			2,623.68	1,643.04
<b><u>SPECIAL NETT ITEMS</u></b>				
1	REVERSE SENSOR (SN)	NOT NECESSARY	135.70	-
1	REAR BUMPER MAT (SN)	NECESSARY	50.00	50.00

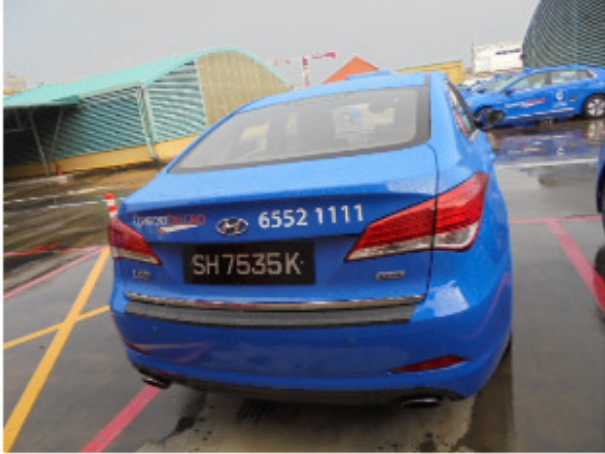
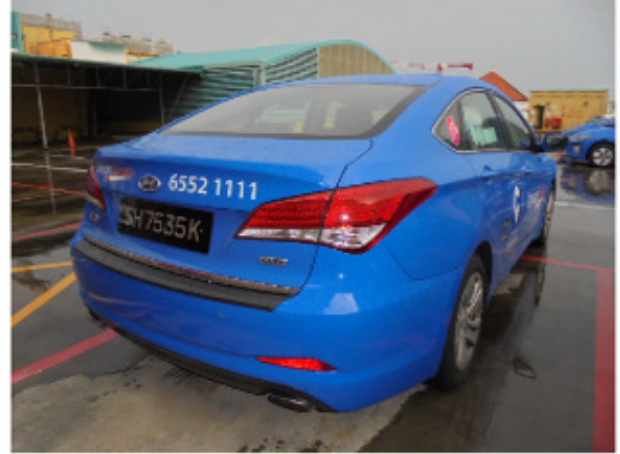
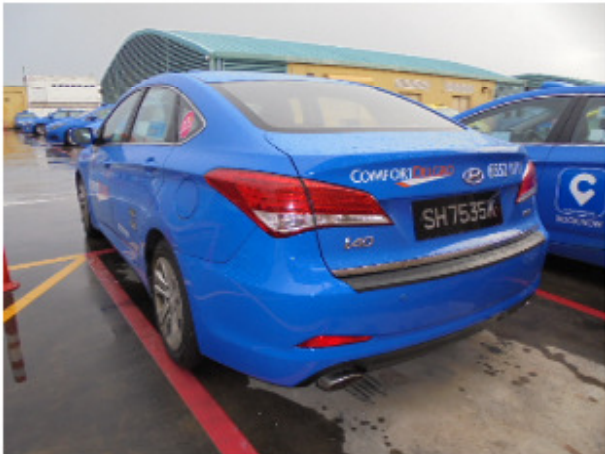
**PHOTOGRAPHS FOR VEHICLE NO. SH 7535K**

**RE-INSPECTION**
