Vehicle No. SLT 8053Y

#### ADJUSTMENT ON REPAIR COST FOR VEHICLE NO. SLT 8053Y

### PHOTOGRAPHS FOR VEHICLE NO. SLT 8053Y

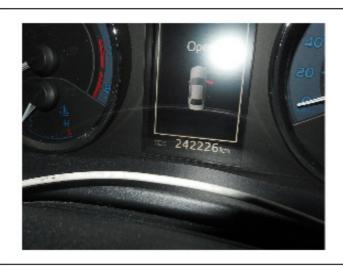
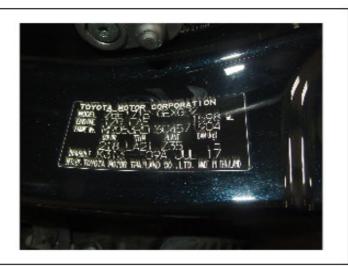
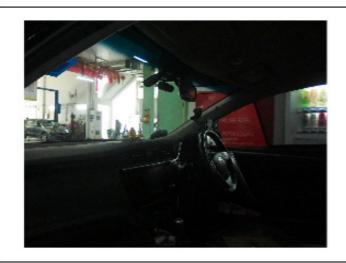
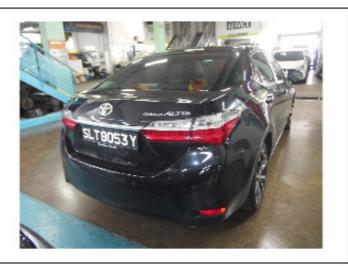
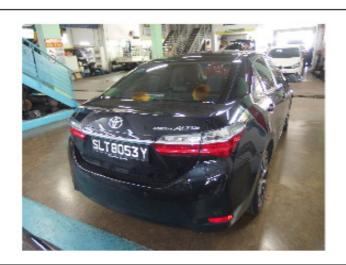
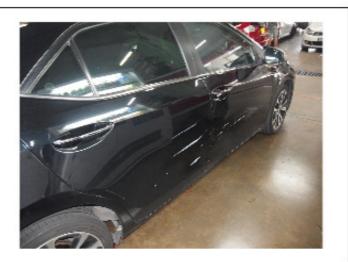
INSPECTION

4.	<u></u>	-	on of Damages				
	THE VEHICLE SUS	STAINED DAMAGES AT THE O/S	BODY.				
	DAMAGES SEE DI	ETAILS.					
5.		General	Information				
	Accident Date	12/06/2020	Inspection Date	12/06/2020			
	Survey held at	FASTECH AUTO PTE LTD					
		1 KAKI BUKIT AVENUE 6 #01-46/48/50 AUTOBAY SINGAPORE 417883					
5a.		Re	emarks				
		N WAS CONDUCTED ON A"WIT E TO YOUR INSTRUCTIONS, W		REPAIRS.			
5b.							
	ESTIMATED NORI	MAL PERIOD FOR REPAIR:	3 Working Days

Qty	Description of Parts	Condition	Estimate By Workshop (\$))	Our Adjusted (\$)
	REPLACEMENT OF PARTS			
1	FRONT DOOR O/S	DENTED / BENT	1,685.10	1,299.10
1	FRONT DOOR OUTER HANDLE O/S	CUT	429.50	306.50
1	FRONT DOOR INNER LOCK O/S	SHORTED	509.10	409.10
1	FRONT DOOR INNER RUBBER O/S	NECESSARY	215.10	215.10
1	FRONT DOOR GLASS REGULATOR O/S	NOT NECESSARY	366.10	-
1	FRONT DOOR GLASS REGULATOR MOTOR O/S	NOT NECESSARY	488.50	-
1	REAR DOOR O/S	TO REPAIR SEE LABOUR	1,485.10	-
1	REAR DOOR INNER RUBBER O/S	NOT NECESSARY	205.10	-
	LESS 25% DISCOUNT		-	-557.45
			5,383.60	1,672.35
	<u>LABOUR</u>			
	TO CHECK WIRING.		50.00	20.00
	TO TRANSFER O/S DOOR MECHANISM.		150.00	60.00
	TO SPRAY RUST PROOFING.		80.00	30.00
	LABOUR FOR PANEL BEATING & REPLACED PARTS. INCLUSIVE OF THE REPAIR OF REAR DOOR O/S.		500.00	300.00
	TO PUTTY & SPRAY PAINTING.		800.00	450.00
			1,580.00	860.00
	GRAND TOTAL		6,963.60	2,532.35

RECOMMENDED COST OF LUMP SUM REPAIRS (TO ITS PRE-ACCIDENT CONDITION)			2,000.00
--	--	--	----------
