National Assessment Centre Services

ADJUSTMENT ON REPAIR COST FOR VEHICLE NO. SH 9983L

PHOTOGRAPHS FOR VEHICLE NO. SH 9983L

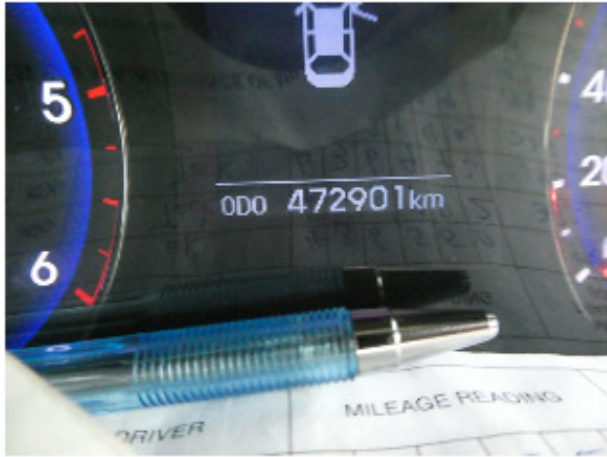
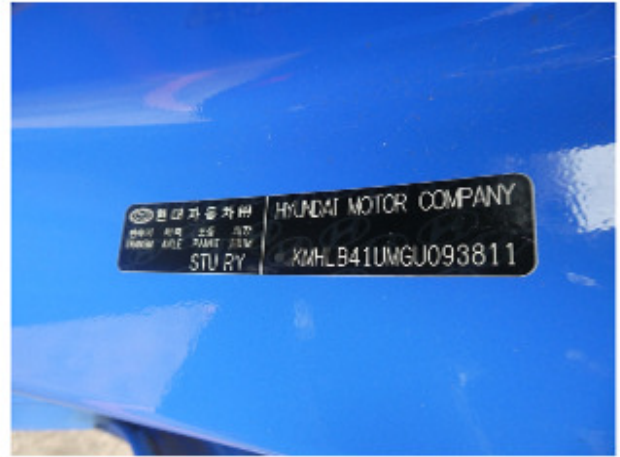
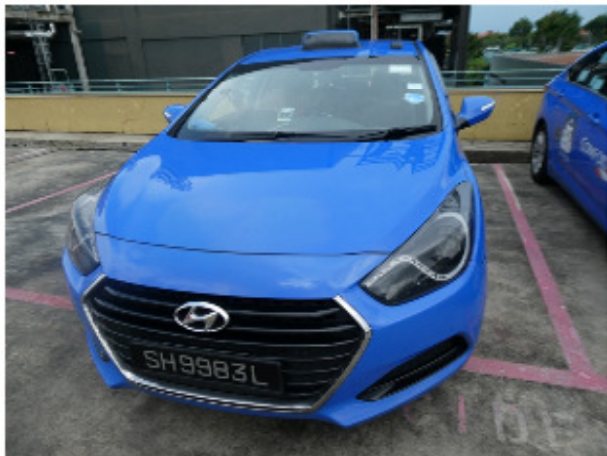
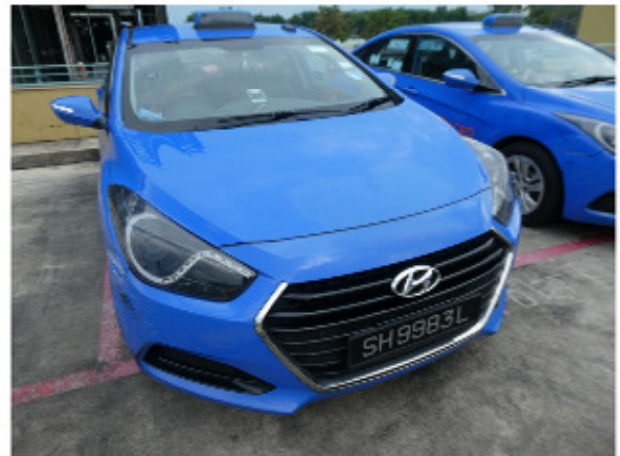
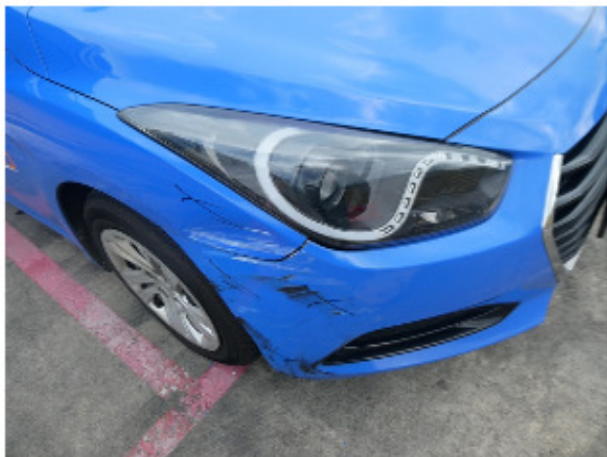
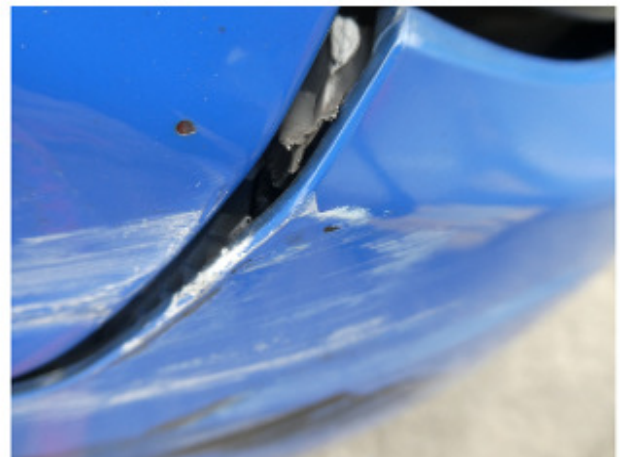
4. Description of Damages				
	THE VEHICLE SUSTAINED DAMAGES AT THE FRONT O/S PORTION. DAMAGES SEE DETAILS.			
5. General Information				
Accident Date	19/06/2020	Inspection Date	19/06/2020	
Survey held at	COMFORTDELGRO ENGINEERING PTE LTD 59 LOYANG DRIVE SINGAPORE 508969			
5a. Remarks				
	A)THE INSPECTION WAS CONDUCTED ON A"WITHOUT PREJUDICE" BASIS. B)IN ACCORDANCE TO YOUR INSTRUCTIONS, WE HAVE NOT AUTHORISED REPAIRS.			
5b. Estimate Days of Repair				
	ESTIMATED NORMAL PERIOD FOR REPAIR:		3 Working Days

Qty	Description of Parts	Condition	Estimate By Workshop (\$)	Our Adjusted (\$)
<u>REPLACEMENT OF PARTS</u>				
1	I40V3 BUMPER W LIP & FOG	DEFORMED	1,052.20	1,052.20
1	I40VC BRKT ASSY-FR BPR UP	NOT NECESSARY	22.40	-
1	I40VC BRACKET-FR BUMPER S	NECESSARY	24.60	24.60
10	HYUNDAI BUMPER COVER CLIP	NECESSARY	22.00	22.00
1	I40VC PANEL-FENDER RH	BENT	663.00	663.00
1	I40V2 GUARD ASSY-FR WHEEL	NOT NECESSARY	174.90	-
1	I40VC CAP ASSY-WHEEL HUB	CUT	112.50	112.50
	LESS 20% DISCOUNT		-414.32	-374.86
			1,657.28	1,499.44
<u>LABOUR</u>				
	PANEL BEATING.		650.00	420.00
	SPRAYPAINT ON AFFECTED AREA.		450.00	400.00
	TUFF COAT ON AFFECTED PARTS.		50.00	30.00
	ADJUST FRONT WHEEL ALIGNMENT.		80.00	80.00
			1,230.00	930.00
GRAND TOTAL			2,887.28	2,429.44
RECOMMENDED COST OF LUMP SUM REPAIRS (TO ITS PRE-ACCIDENT CONDITION) (CONFIRMED)				1,950.00
