1. Policy Particulars :- THIRD PARTY CLAIM				
Insured Veh.	SML 8523M	Veh. Inspected	SHC 2352K	
Policy No.	5115012680	Coverage (\$)	0.00	
Claim No.	MT/1094878-002	Excess (\$)	0.00	
Assign From		Assign Date	22/06/2020

ADJUSTMENT ON REPAIR COST FOR VEHICLE NO. SHC 2352K

PHOTOGRAPHS FOR VEHICLE NO. SHC 2352K

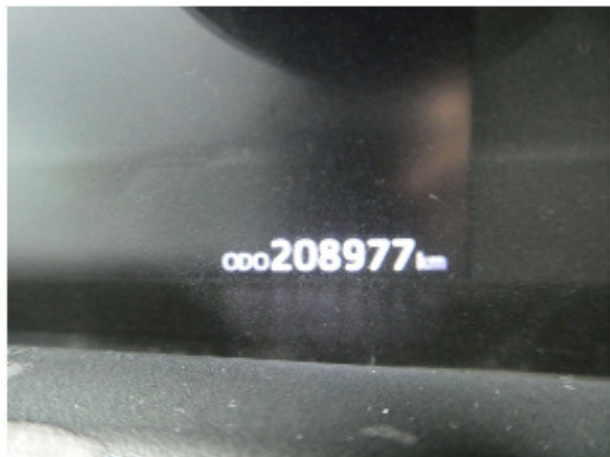
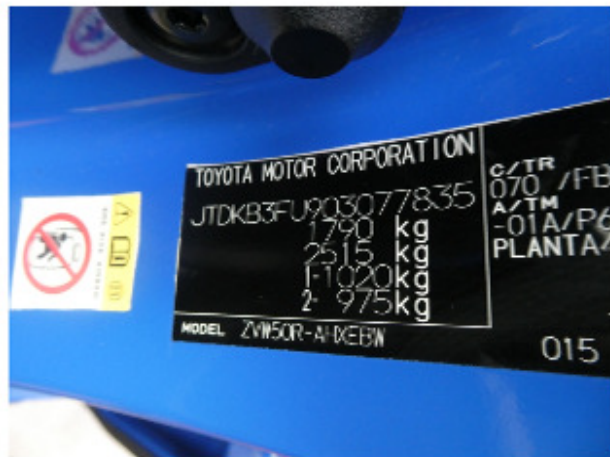
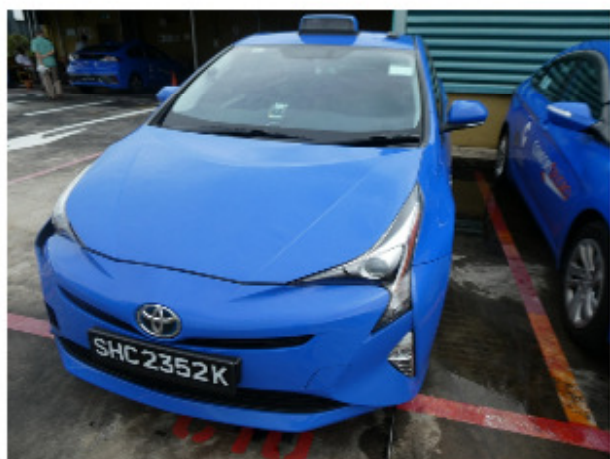
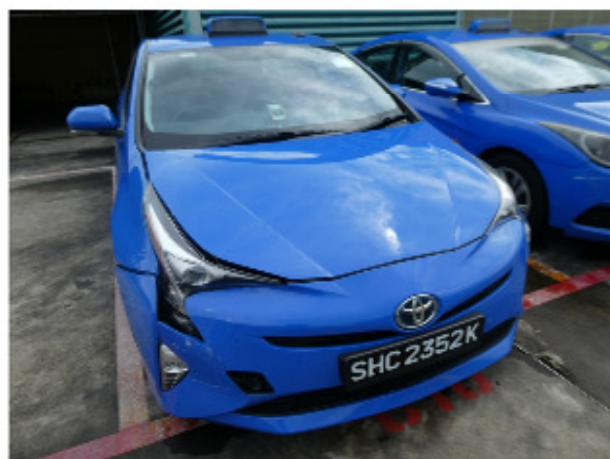
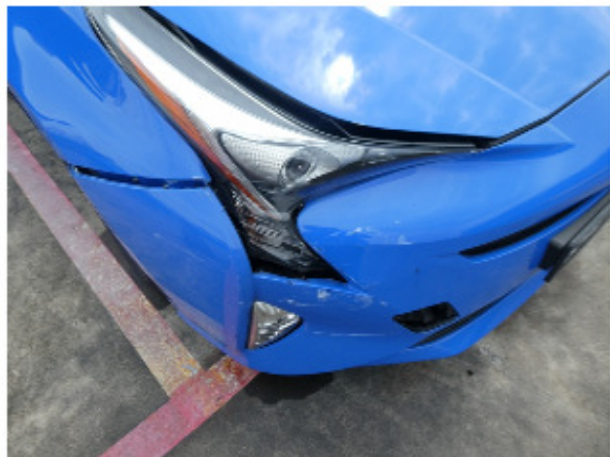
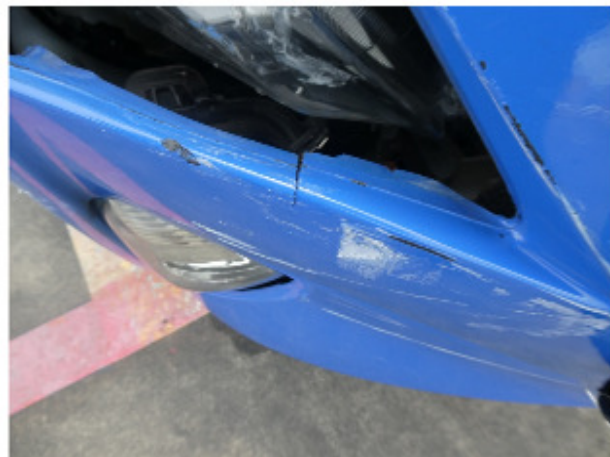
4. Description of Damages				
	THE VEHICLE SUSTAINED DAMAGES AT THE FRONT O/S PORTION. DAMAGES SEE DETAILS.			
5. General Information				
Accident Date	22/06/2020	Inspection Date	22/06/2020	
Survey held at	COMFORTDELGRO ENGINEERING PTE LTD 59 LOYANG DRIVE SINGAPORE 508969			
5a. Remarks				
	A)THE INSPECTION WAS CONDUCTED ON A"WITHOUT PREJUDICE" BASIS. B)IN ACCORDANCE TO YOUR INSTRUCTIONS, WE HAVE NOT AUTHORISED REPAIRS.			
5b. Estimate Days of Repair				
	ESTIMATED NORMAL PERIOD FOR REPAIR:		4 Working Days

Qty	Description of Parts	Condition	Estimate By Workshop (\$)	Our Adjusted (\$)
	<u>REPLACEMENT OF PARTS</u>			
1	COVER FRONT BUMPER	DEFORMED	499.90	499.90
1	COVER FRONT BUMPER HOLE R	MISSING	28.38	28.38
1	HOOD SUB-ASSY	BENT	950.50	950.50
1	FENDER SUB-ASSY FRONT RH	BENT	933.10	933.10
1	EMBLEM SIDE PANEL (HYBRID)	NECESSARY	86.00	86.00
1	LAMP ASSY FOG RH	CRACKED	920.00	920.00
1	UNIT ASSY HEADLAMP RH	CRACKED	3,455.00	3,455.00
1	REINFORCEMENT SUB-ASSY FR	NOT NECESSARY	696.40	-
1	GRILLE SUB-ASSY RADIATOR	NOT NECESSARY	438.00	-
1	SUPPORT FRONT BUMPER SIDE	DEFORMED	76.90	76.90
1	SUPPORT RADIATOR UPPER RH	TO REPAIR SEE LABOUR	76.10	-
1	SUPPORT SUB-ASSY RADIATOR	NOT NECESSARY	234.70	-
1	SUPPORT SUB-ASSY RADIATOR	NOT NECESSARY	361.10	-
1	GRILLE RADIATOR LOWER NO	NOT NECESSARY	163.40	-
1	EMBLEM ASSY RADIATOR GRIL	NOT NECESSARY	88.00	-
1	COVER ENGINE UNDER COVER	NOT NECESSARY	180.00	-
1	ENGINE UNDER COVER NO 1	NOT NECESSARY	457.40	-

LESS 25% DISCOUNT		-2,411.22	-1,737.47
			7,233.66	5,212.31
	<u>LABOUR</u>			
	PANEL BEATING.INCLUSIVE OF THE REPAIR OF SUPPORT RADIATOR UPPER RH.		1,000.00	640.00
	SPRAYPAINT CHARGE.		800.00	600.00
	CHECK ALL LIGHTING.		50.00	30.00
	TO VAC & TOP UP A/C GAS.	NOT NECESSARY	120.00	-
	TUFF COAT ON AFFECTED PARTS.		50.00	30.00
			2,020.00	1,300.00
GRAND TOTAL			9,253.66	6,512.31
RECOMMENDED COST OF REPAIRS (CONFIRMED)				6,512.31
