TEL: 6841 0055 FAX: 6841 6315

ADJUSTMENT ON REPAIR COST FOR VEHICLE NO. SHC 1400L

PHOTOGRAPHS FOR VEHICLE NO. SHC 1400L

INSPECTION

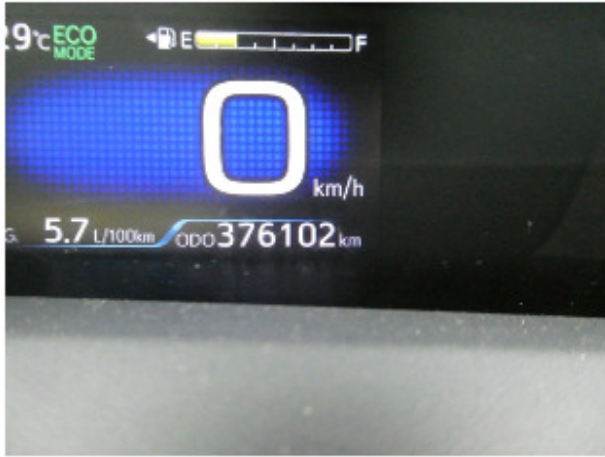
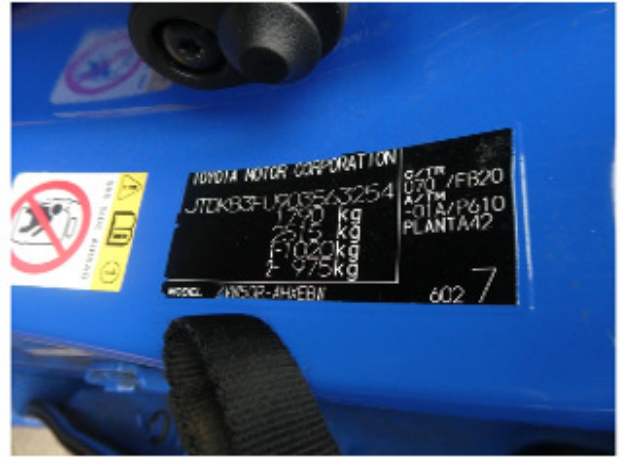
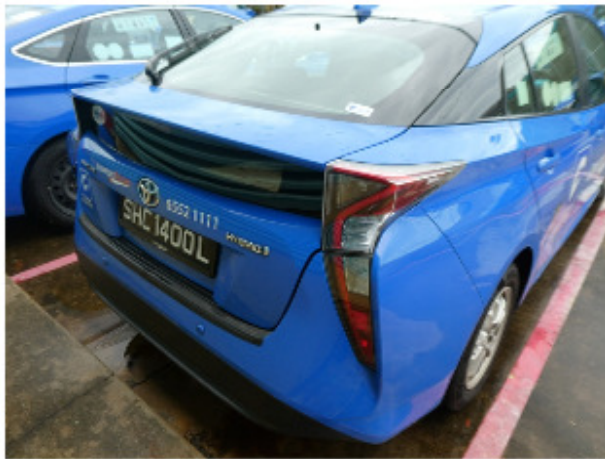
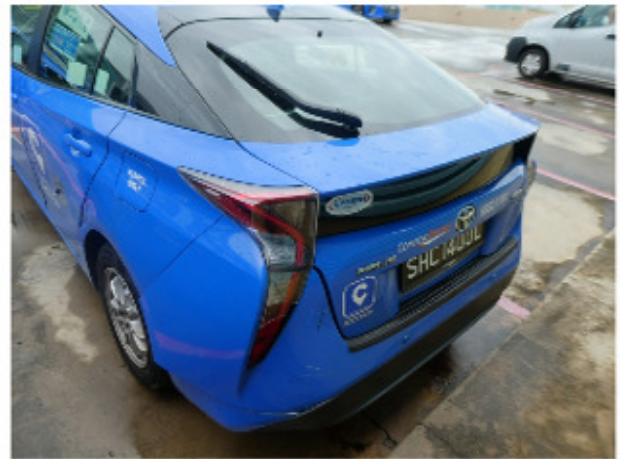
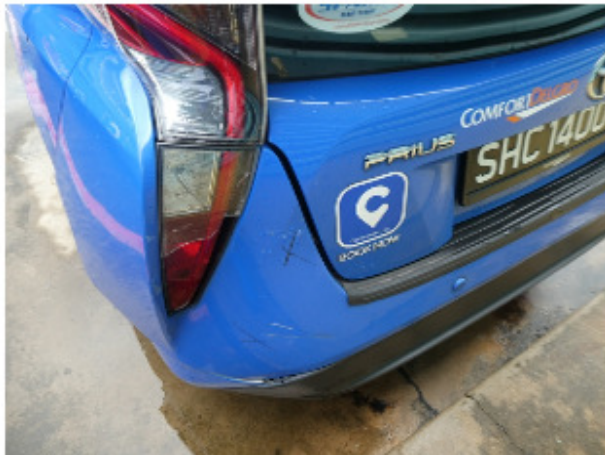
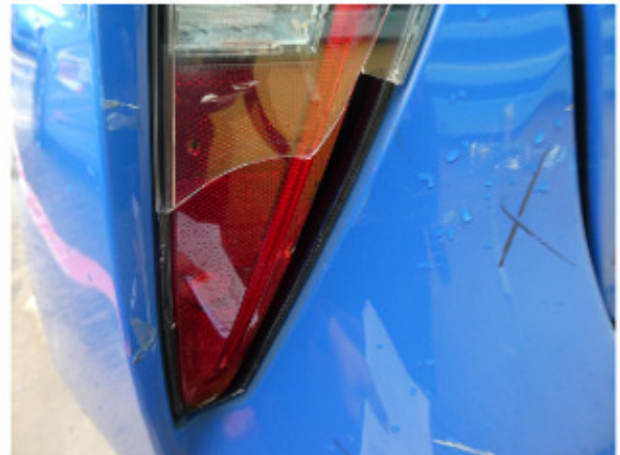
4. Description of Damages				
	THE VEHICLE SUSTAINED DAMAGES AT THE REAR N/S PORTION. DAMAGES SEE DETAILS.			
5. General Information				
Accident Date	22/06/2020	Inspection Date	23/06/2020	
Survey held at	COMFORTDELGRO ENGINEERING PTE LTD 59 LOYANG DRIVE SINGAPORE 508969			
5a. Remarks				
	A)THE INSPECTION WAS CONDUCTED ON A"WITHOUT PREJUDICE" BASIS. B)IN ACCORDANCE TO YOUR INSTRUCTIONS, WE HAVE NOT AUTHORISED REPAIRS.			
5b. Estimate Days of Repair				
	ESTIMATED NORMAL PERIOD FOR REPAIR: 2 Working Days

Qty	Description of Parts	Condition	Estimate By Workshop (\$)	Our Adjusted (\$)
	<u>REPLACEMENT OF PARTS</u>			
1	COVER REAR BUMPER	DEFORMED	458.60	458.60
1	GUARD-REAR BUMPER CENTER	DEFORMED	552.60	552.60
1	REINFORCEMENT SUB-ASSY RE	NOT NECESSARY	318.80	-
10	BUMPER PIECE	NECESSARY	22.00	22.00
1	RETAINER RR BUMPER SIDE L	NECESSARY	112.70	112.70
1	LENS & BODY RR COMBINATIO	NOT NECESSARY	557.90	-
1	LENS AND BODY REAR LAMP L	CRACKED	548.40	548.40
1	FILLER-REAR BUMPER EXTENS	TO REPAIR SEE LABOUR	148.40	-
	LESS 25% DISCOUNT		-679.85	-423.58
			2,039.55	1,270.72
	<u>SPECIAL NETT ITEMS</u>			
1	BUMPER PROTECTOR MAT (SN)	NECESSARY	50.00	50.00
1	FUEL TANK LID (PETROL ONL)(SN)	NOT NECESSARY	20.00	-

70.00	50.00
	<u>LABOUR</u>			
	PANEL BEATING.INCLUSIVE OF THE REPAIR OF FILLER-REAR BUMPER EXTENS.		400.00	320.00
	SPRAYPAINT CHARGE.		300.00	200.00
	CHECK ALL LIGHTING.		50.00	30.00
	REMOVE/REFIX REVERSE SENSOR.		80.00	30.00
