Vehicle No. SHA 5745B
Insured Veh. FBN 8619R
Claim No. MT/1095490-002
Policy No.
Accident Date 24/06/2020
Inspection Date 25/06/2020

ADJUSTMENT ON REPAIR COST FOR VEHICLE NO. SHA 5745B

PHOTOGRAPHS FOR VEHICLE NO. SHA 5745B

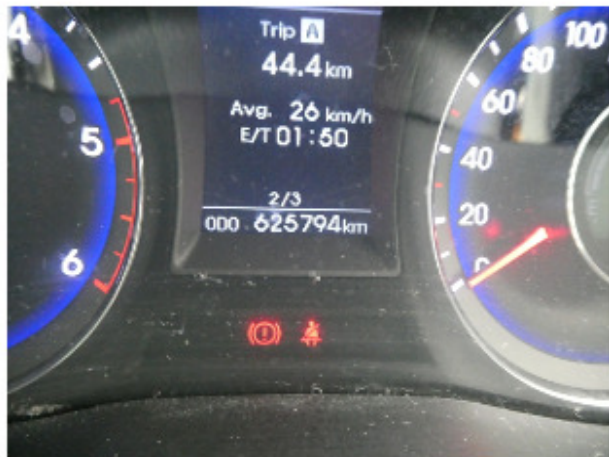
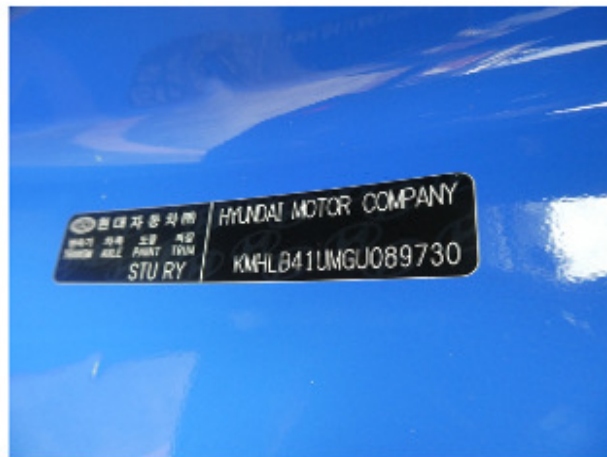
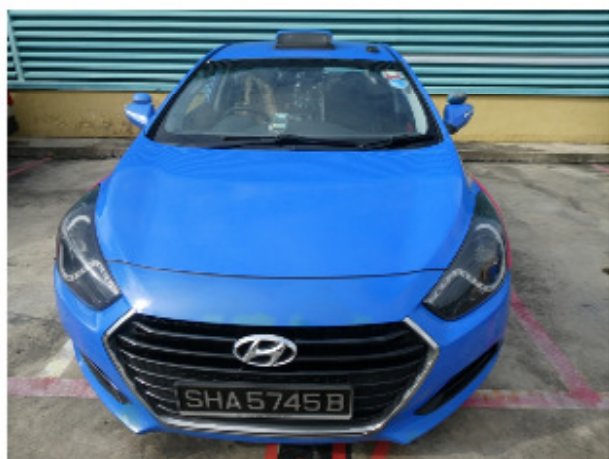
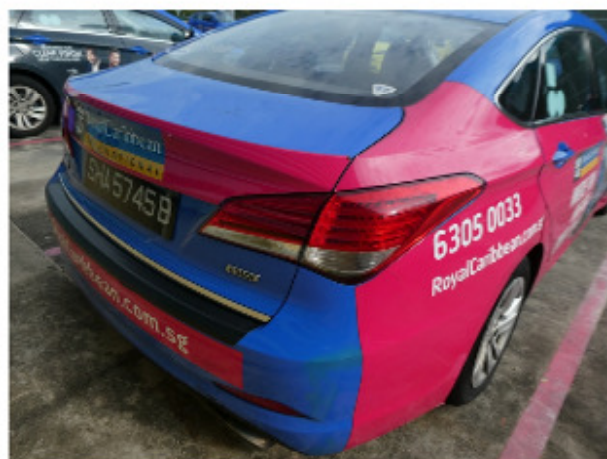
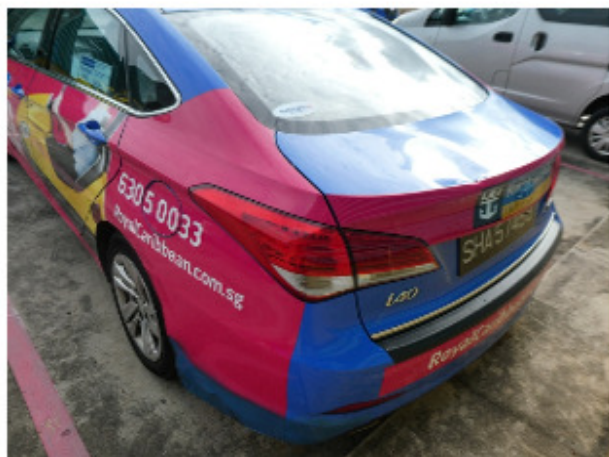
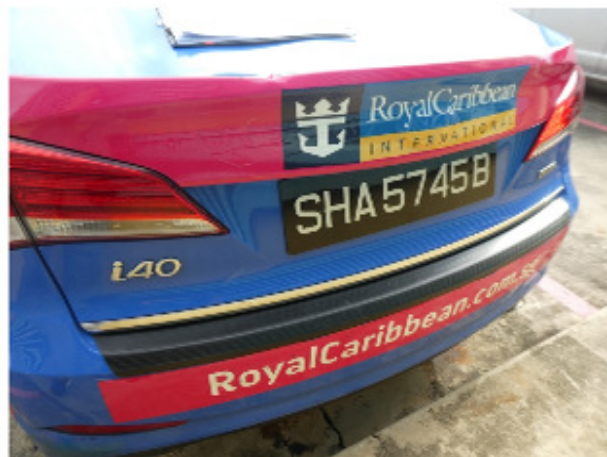
4. Description of Damages				
	THE VEHICLE SUSTAINED DAMAGES AT THE REAR PORTION. DAMAGES SEE DETAILS.			
5. General Information				
Accident Date	24/06/2020	Inspection Date	25/06/2020	
Survey held at	COMFORTDELGRO ENGINEERING PTE LTD 59 LOYANG DRIVE SINGAPORE 508969			
5a. Remarks				
	A)THE INSPECTION WAS CONDUCTED ON A"WITHOUT PREJUDICE" BASIS. B)IN ACCORDANCE TO YOUR INSTRUCTIONS, WE HAVE NOT AUTHORISED REPAIRS.			
5b. Estimate Days of Repair				
	ESTIMATED NORMAL PERIOD FOR REPAIR: 3 Working Days

Qty	Description of Parts	Condition	Estimate By Workshop (\$)	Our Adjusted (\$)
<u>REPLACEMENT OF PARTS</u>				
1	REAR BUMPER COVER	DEFORMED	1,106.00	1,106.00
2	REAR BUMPER BRACKET SIDE LH/RH @\$35.60	NOT NECESSARY	71.20	-
10	REAR BUMPER CLIPS @\$2.20	NECESSARY	22.00	22.00
1	REAR BUMPER REINFORCEMENT	NOT NECESSARY	428.40	-
1	REAR BUMPER UNDER COVER	TO REPAIR SEE LABOUR	228.00	-
2	REAR BUMPER REINFORCEMENT STAY @\$80.30	NOT NECESSARY	160.60	-
1	BOOTLID	BENT	2,174.90	2,174.90
1	BOOTLID CRDI PLATE	NECESSARY	27.90	27.90
1	BOOTLID I-40 PLATE	NECESSARY	21.10	21.10
	LESS 20% DISCOUNT		-848.02	-670.38
			3,392.08	2,681.52
<u>SPECIAL NETT ITEMS</u>				
1	BOOTLID COMFORT LOGO (SN)	NECESSARY	30.00	30.00
1	BOOTLID COMFORT TEL NO (SN)	NECESSARY	30.00	30.00
1	REVERSE SENSOR (SN)	NOT NECESSARY	135.70	-
1	REAR BUMPER MAT (SN)	NECESSARY	50.00	50.00

245.70	110.00
<u>LABOUR</u>				
	PANEL BEATING.INCLUSIVE OF THE REPAIR OF REAR BUMPER UNDER COVER.		540.00	420.00
	SPRAY PAINTING CHARGE.		500.00	400.00
	REMOVE/REFIX REVERSE SENSOR.		60.00	30.00
	TUFF KOTE.		60.00	30.00
	CHECK LIGHTING.		60.00	30.00
			1,220.00	910.00
GRAND TOTAL			4,857.78	3,701.52
RECOMMENDED COST OF LUMP SUM REPAIRS (TO ITS PRE-ACCIDENT CONDITION) (CONFIRMED)				2,950.00
