Vehicle No. SHD 3793J
Insured Veh. SHC 6159B
Claim No. MT/1095505-002
Policy No.
Accident Date 28/06/2020
Inspection Date 29/06/2020

2. Vehicle Particulars & Condition				
Make & Model	TOYOTA PRIUS HYBRID	c.c	1798	
Engine No.	HIDDEN	Year of Reg.	2017	
Chassis No.	JTDKB3FU703569229	Colour	BLUE	
Odometer	316503	Steering	IN ORDER	
Brakes	IN ORDER	Modification	SPORTS RIM	
General	GOOD

ADJUSTMENT ON REPAIR COST FOR VEHICLE NO. SHD 3793J

PHOTOGRAPHS FOR VEHICLE NO. SHD 3793J

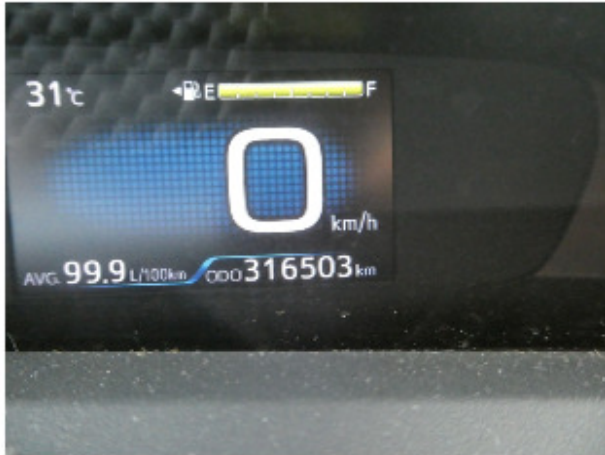
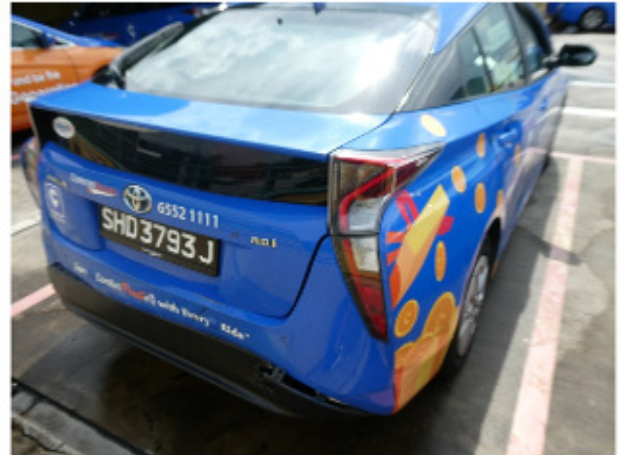
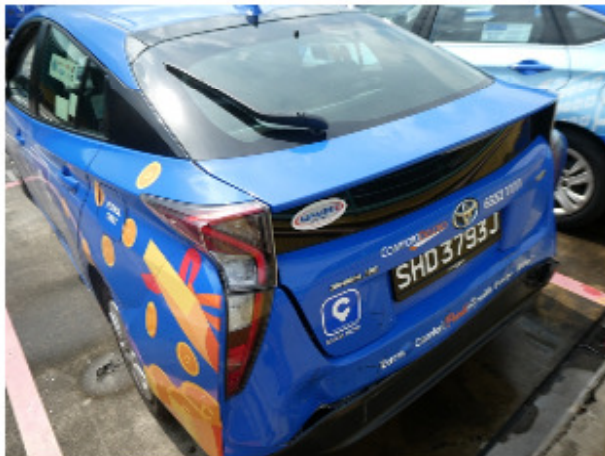
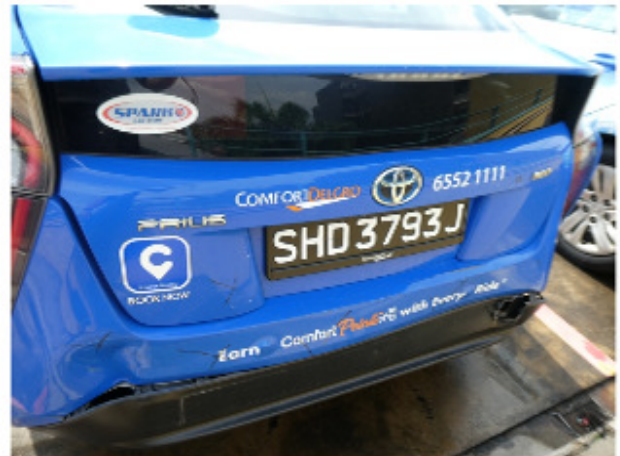
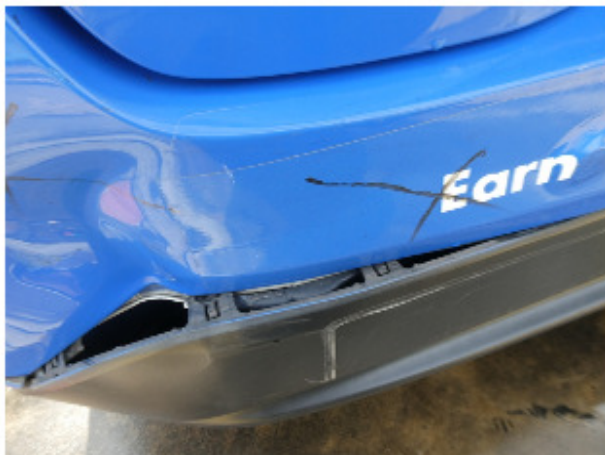
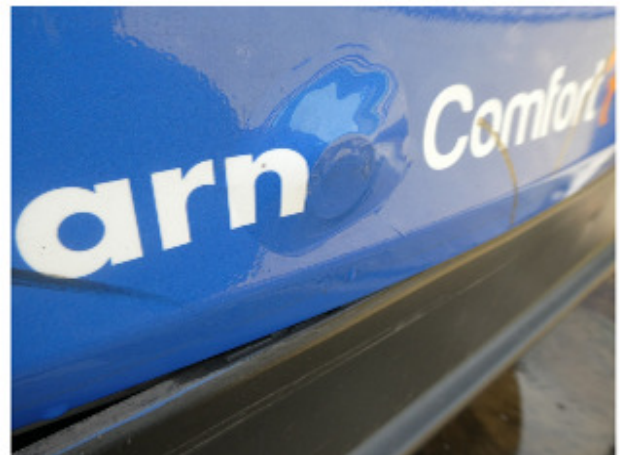
4. Description of Damages				
	THE VEHICLE SUSTAINED DAMAGES AT THE REAR PORTION. DAMAGES SEE DETAILS.			
5. General Information				
Accident Date	28/06/2020	Inspection Date	29/06/2020	
Survey held at	COMFORTDELGRO ENGINEERING PTE LTD 59 LOYANG DRIVE SINGAPORE 508969			
5a. Remarks				
	A)THE INSPECTION WAS CONDUCTED ON A"WITHOUT PREJUDICE" BASIS. B)IN ACCORDANCE TO YOUR INSTRUCTIONS, WE HAVE NOT AUTHORISED REPAIRS.			
5b. Estimate Days of Repair				
	ESTIMATED NORMAL PERIOD FOR REPAIR: 3 Working Days

Qty	Description of Parts	Condition	Estimate By Workshop (\$)	Our Adjusted (\$)
<u>REPLACEMENT OF PARTS</u>				
1	REAR BUMPER	DEFORMED	458.60	458.60
1	REAR BUMPER CENTER-BLACK	DEFORMED	552.60	552.60
1	REAR BUMPER REINFORCEMENT	BENT	318.80	318.80
1	REAR BUMPER EXTENSION RH	TO REPAIR SEE LABOUR	232.00	-
1	REAR BUMPER EXTENSION LH	TO REPAIR SEE LABOUR	232.00	-
1	REAR BUMPER RETAINER RH	NOT NECESSARY	112.70	-
1	REAR BUMPER RETAINER LH	NOT NECESSARY	112.70	-
10	REAR BUMPER CLIPS	NECESSARY	22.00	22.00
1	REAR BUMPER TOW COVER	MISSING	82.70	82.70
1	TAILGATE OUTER GARNISH	TO REPAIR SEE LABOUR	889.70	-
1	TAILGATE HYBRID S	NECESSARY	52.40	52.40
1	TAILGATE PRIUS	NECESSARY	60.80	60.80
1	TAILGATE TOYOTA STAR	NECESSARY	52.90	52.90
	LESS 25% DISCOUNT		-794.98	-400.20
			2,384.92	1,200.60
<u>NETT ITEMS</u>				
1	TAILGATE COMFORTDELGRO (N)	NECESSARY	30.00	30.00
1	TAILGATE 65521111 (N)	NECESSARY	30.00	30.00
1	TAILGATE APPS (N)	NECESSARY	40.00	40.00

Qty	Description of Parts	Condition	Estimate By Workshop (\$)	Our Adjusted (\$)
	LABOUR			
	PANEL BEATING.INCLUSIVE OF THE REPAIR OF REAR BUMPER EXTENSION RH,REAR BUMPER EXTENSION LH AND TAILGATE OUTER GARNISH.		600.00	480.00
	SPRAYPAINT CHARGE.		500.00	400.00
	CHECK ALL LIGHTING.		40.00	30.00
	R/I REVERSE SENSOR.		120.00	30.00
			1,260.00	940.00
GRAND TOTAL			4,107.05	2,602.73
RECOMMENDED COST OF LUMP SUM REPAIRS (TO ITS PRE-ACCIDENT CONDITION) (CONFIRMED)				2,050.00
