ASSIGNMENT

Veh No: SHC 23754 Yr Regn: Dec / 2019  
 Type: M.Car / M.Cycle / Bus / Van / Lorry / Taxi / Prime Mover /  
 Truck / Trailer or \_\_\_\_\_  
 Make: Hyundai Ionig c.c. 1580  
 Colour: Blue A/C: Insured / Std / NI / NA  
 Sp.Reading: 58925 T/Radio: Insured / Std / NI / NA  
 Eng/No: G4LEK4409555  
 C/No: KMHC851CVLU190055  
 Gen. Cond: Good / Fair / Poor / Burnt  
 Steering: in order / Jammed / Leaked / Burnt or \_\_\_\_\_  
 Brake: in order / Jammed / Leaked / Burnt or \_\_\_\_\_  
 Modi: Nil / S/Rim / STD A/Rim or \_\_\_\_\_  
 Tyre Size: F: 195/65 R15  
 R: — " —

Front Rear  
 R/Bal. 5 mm R/Bal. 5 mm  
 L/Bal. 5 mm L/Bal. 5 mm  
 D.O.A. 04/07/2020 D.O.I. 07/08/2020  
 Survey held at Ex Frost Sin Ming  
 Des. of Damages: Frt / Rear / O/S / N/S / U/C / Rooftop or  
O/S Front  
 The U/C / Chassis frame / Body Structure affected due to collision.

## REPAIR ESTIMATE

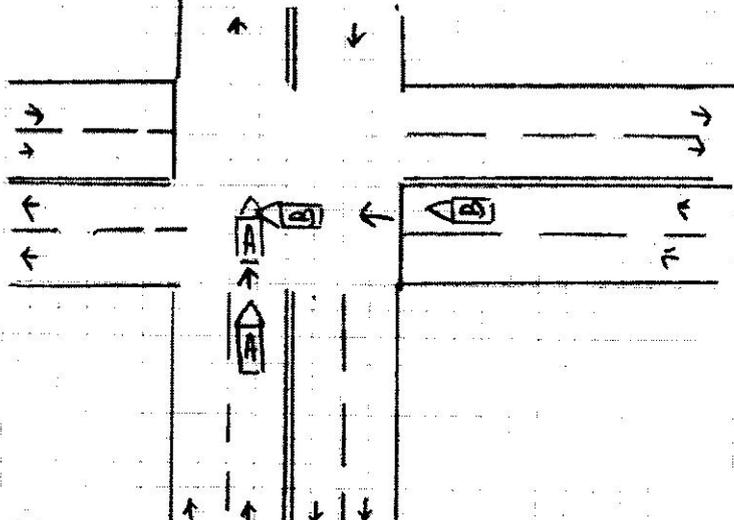
SKETCH PLAN

A - SHC 2375U  
B - SLK 1295J

Along Syed Alwi Road x Townshend Road

On 04.07.2020 at about 21:15 hours I was travelling along Syed Alwi
Road x Townshend Road with no passenger onboard .
While travelling straight , suddenly veh B ( SLK 1295J ) - dash out
from my right without giving to collided into my taxi A - Front Right
Portion .
No injury in this accident .
I have company video and photos at scene to support my claims .
Veh B ( SLK 1295J ) - Mr Han How Heng H/P : 8875 2361
