Ref : CC3/QBE20007352/T1pa3q2

ADJUSTMENT ON REPAIR COST FOR VEHICLE NO. SHC 8775J

PHOTOGRAPHS FOR VEHICLE NO. SHC 8775J

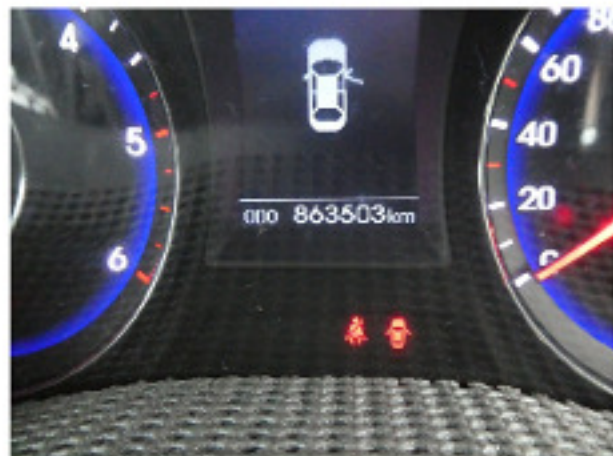
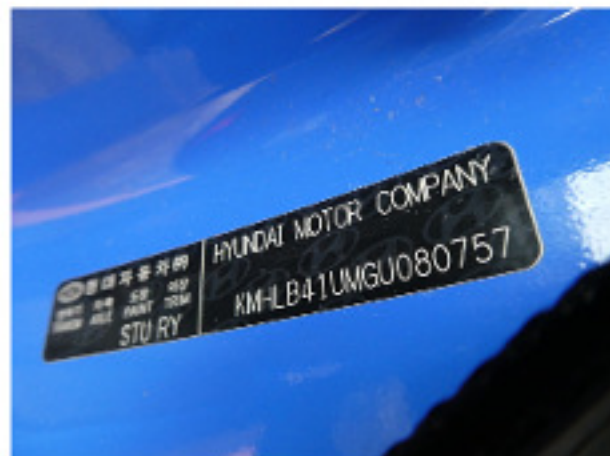
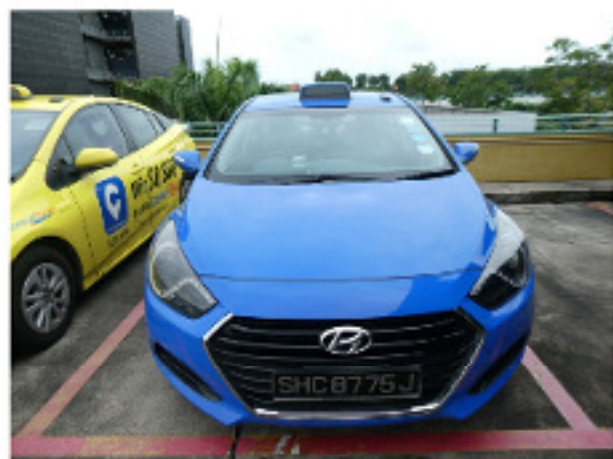
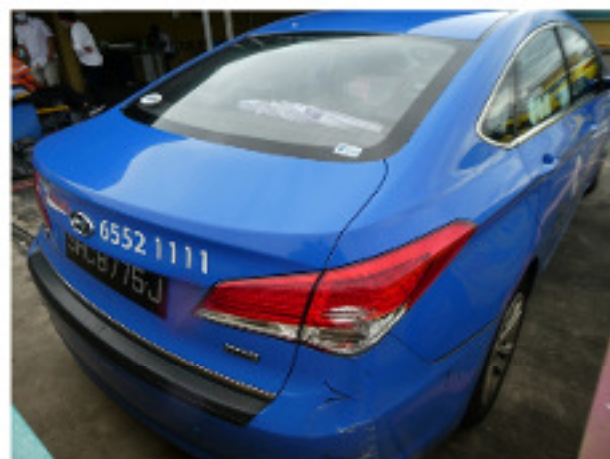
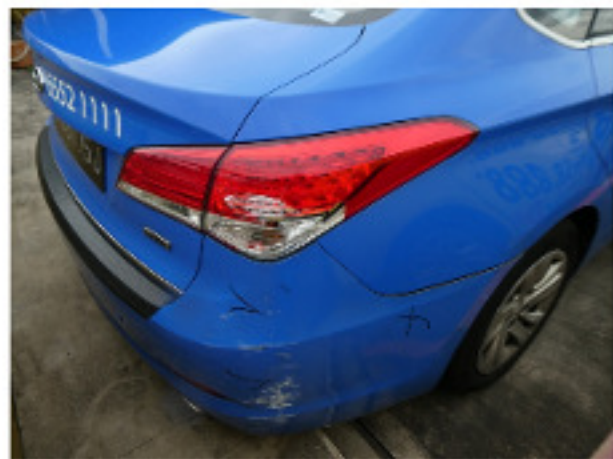
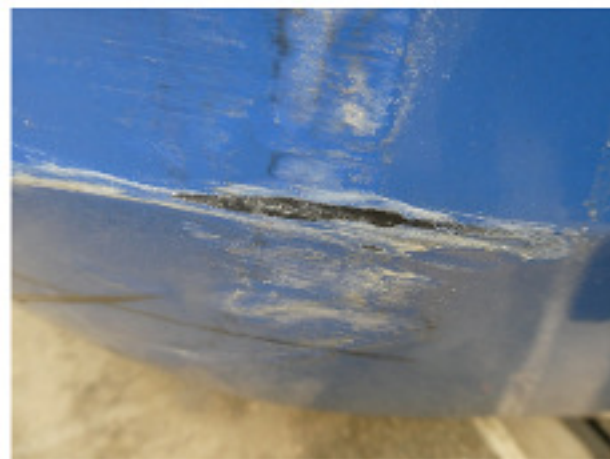
INSPECTION

THE VEHICLE SUSTAINED DAMAGES AT THE REAR O/S PORTION. DAMAGES SEE DETAILS.
--

Qty	Description of Parts	Condition	Estimate By Workshop (\$)	Our Adjusted (\$)
	<u>REPLACEMENT OF PARTS</u>			
1	COVER ASSY -RR BUMPER	DEFORMED	1,106.00	1,106.00
1	LAMP ASSY -RR COMB O/S RH	CRACKED	697.80	697.80
10	HYUNDAI BUMPER COVER CLIP	NECESSARY	22.00	22.00
1	BRKT ASSY -RR BUMPER SIDE	NOT NECESSARY	35.60	-
	LESS 25% DISCOUNT		-465.35	-456.45
			1,396.05	1,369.35
	<u>SPECIAL NETT ITEMS</u>			
1	PROTECTOR MAT (SN)	NECESSARY	50.00	50.00
			50.00	50.00
	<u>LABOUR</u>			
	PANEL BEATING.		300.00	280.00
	SPRAYPAINT CHARGE.		300.00	200.00
	CHECK ALL LIGHTING .		50.00	30.00
	REMOVE/REFIX REVERSE SENSOR .		80.00	30.00
			730.00	540.00
GRAND TOTAL			2,176.05	1,959.35
RECOMMENDED COST OF LUMP SUM REPAIRS (TO ITS PRE-ACCIDENT CONDITION)				1,600.00
