ACCIDENT INVOLVING SMK 3416 C AND GBF 9425 T ON 4 DECEMBER 2019 ALONG JUNCTION CHULIA STREET & SOUTH CANAL ROAD

ACCIDENT VEHICLE INSPECTION REPORT

Report no : 92M0220.ZAW
Vehicle no : SMK3416C

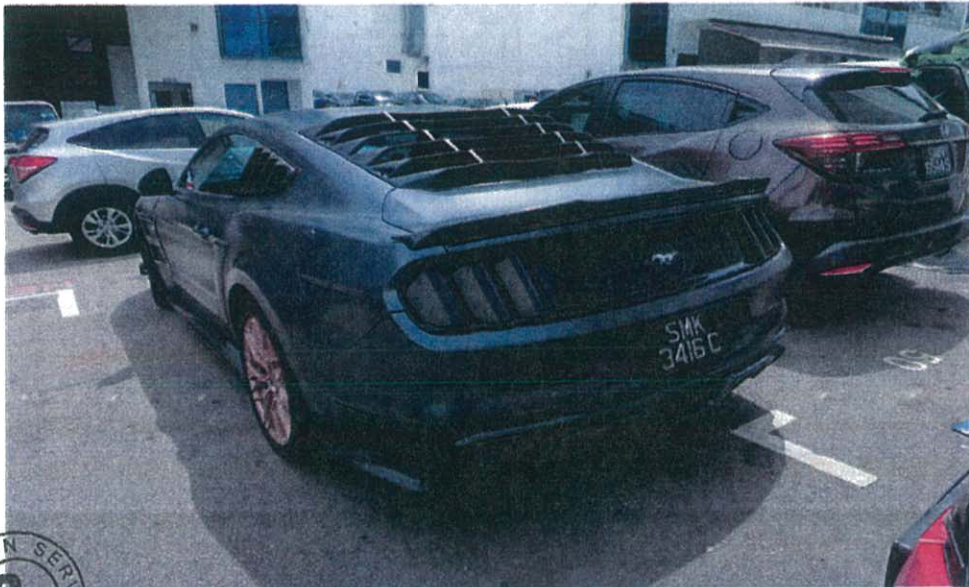
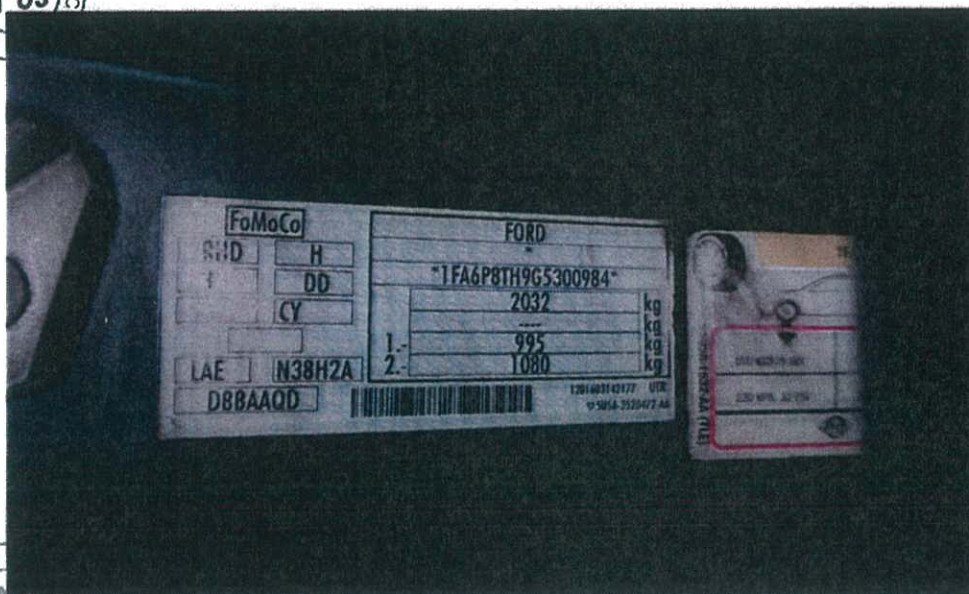
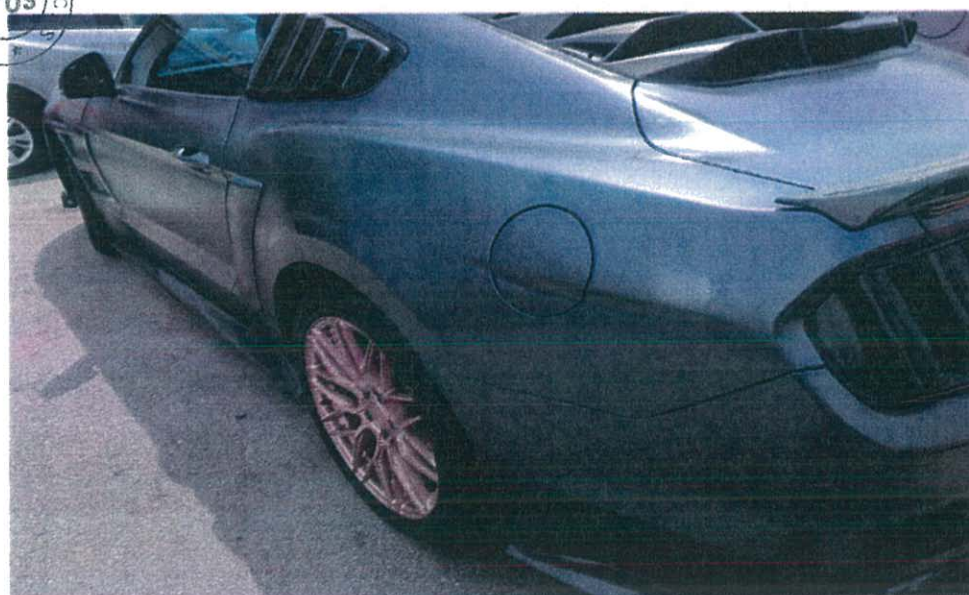
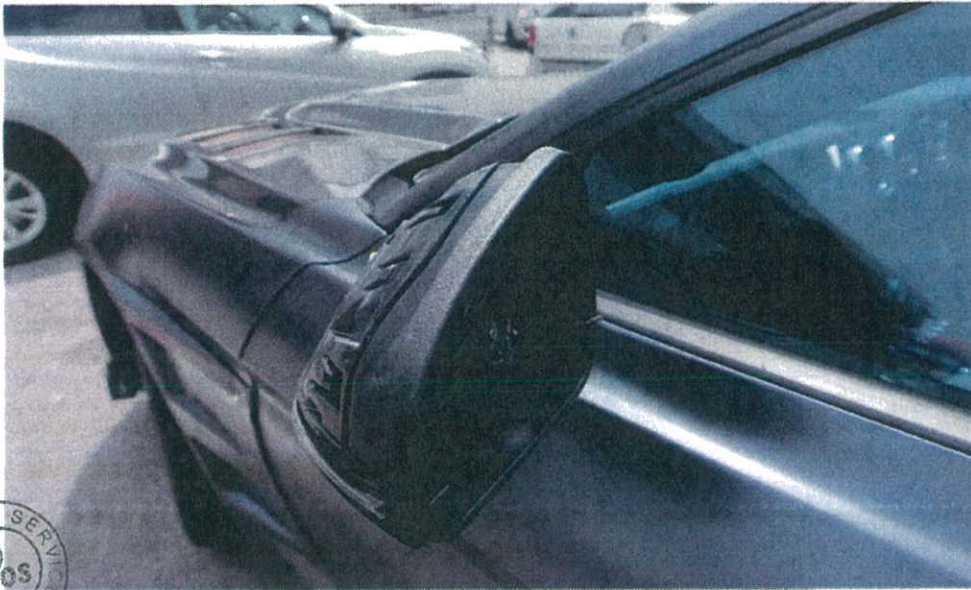
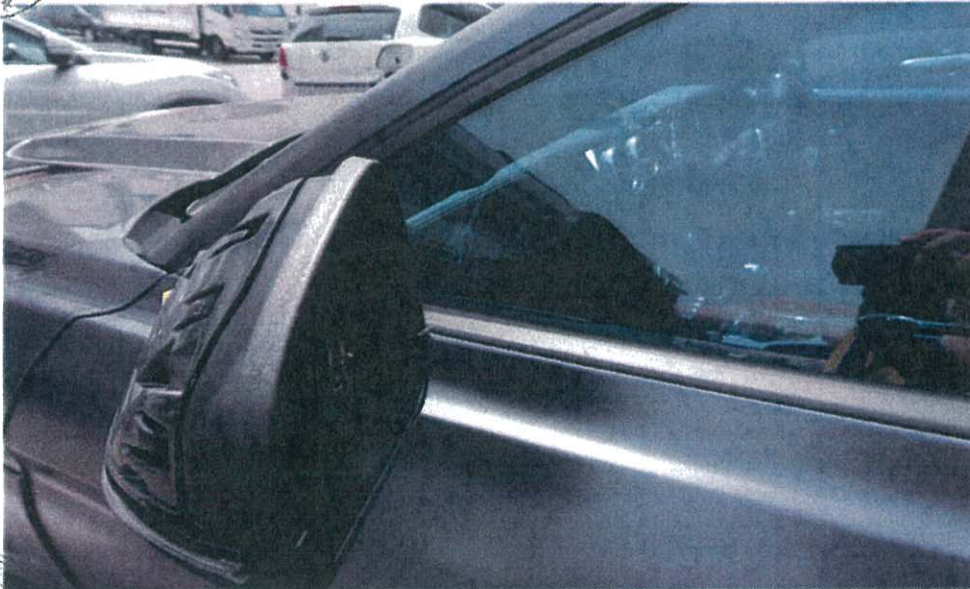
Report no: 92M0220.ZAW

Rear LH fender dented/scraped, LH side mirror broken/cracked, LH side carbon fibre side skirt dented/cracked, etc. Please see para. 8 of this report for more details.

<u>Description</u>	<u>Qty</u>	<u>Assessed Condition</u>	<u>Repairer's Amount</u>	<u>Revised Amount</u>
(Special nett)				
LH side mirror assy	1	broken/cracked	1,250.00	1,250.00
LH side door glass	1	scratched/cut	950.00	950.00
Carbon fibre side skirt – LHS	1	dented/cracked	2,500.00	2,500.00
Total cost of parts:			4,700.00	4,700.00

Cost of repairs : **\$5,300.00** (lump sum)
Estimated no of days : **Four (4)**
