Vehicle No. SMF 9554Z

4.	·	Description	on of Damages			
	THE VEHICLE SU	STAINED DAMAGES AT THE N/S	BODY.			
	DAMAGES SEE D	ETAILS.				
5.		Genera	I Information			
	Accident Date	17/07/2020	Inspection Date	23/07/2020		
	Survey held at	SIANG HUI MOTOR WORKS				
		BLK 3006 UBI ROAD 1 #01-338 SINGAPORE 408700				
5a.		Re	emarks			
	A)THE INSPECTION WAS CONDUCTED ON A"WITHOUT PREJUDICE" BASIS. B)IN ACCORDANCE TO YOUR INSTRUCTIONS, WE HAVE NOT AUTHORISED REPAIRS.					
5b.	b. Estimate Days of Repair					
	ESTIMATED NOR	MAL PERIOD FOR REPAIR:	4 Working Days

ADJUSTMENT ON REPAIR COST FOR VEHICLE NO. SMF 9554Z

PHOTOGRAPHS FOR VEHICLE NO. SMF 9554Z

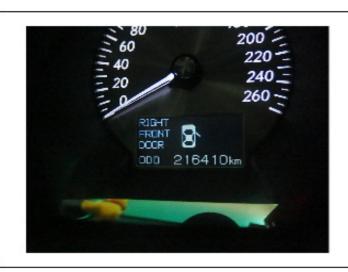
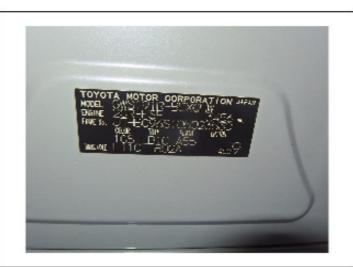
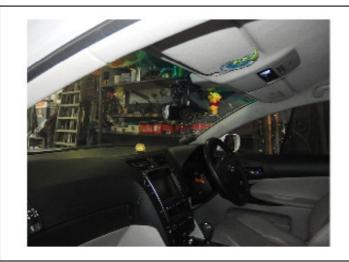
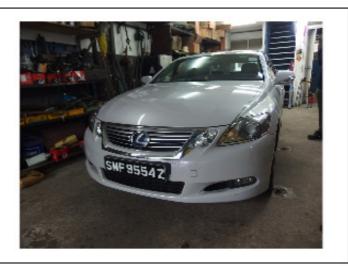
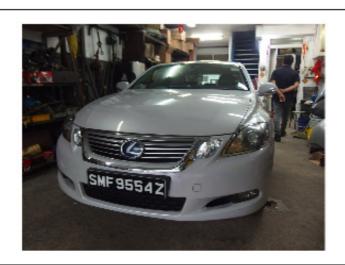
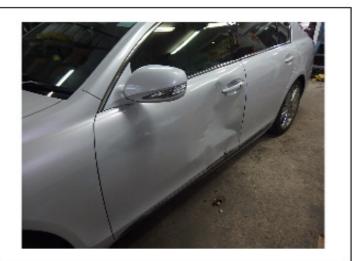
INSPECTION

Qty	Description of Parts	Condition	Estimate By Workshop (\$))	Our Adjusted (\$)
	REPLACEMENT OF PARTS			
1	FRONT DOOR N/S	BADLY DENTED	1,340.50	1,340.50
1	DOOR INNER LOCK N/S	SHORTED / JAMMED	770.40	395.00
1	DOOR OUTER HANDLE N/S	NOT NECESSARY	275.40	-
1	DOOR CHROME MOULDING N/S	CRACKED / BENT	223.50	223.50
1	DOOR W/STRIP N/S	NOT NECESSARY	213.20	-
1	DOOR REGULATOR GEAR N/S	BENT	313.80	313.80
1	DOOR REGULATOR MOTOR N/S	SERVICEABLE	501.30	-
1	REAR DOOR CHROME MOULDING N/S	SCRATCHED	223.50	223.50
	LESS 10% DISCOUNT		-386.16	-249.63
			3,475.44	2,246.67
	SPECIAL NETT ITEMS			
1	REAR WHEEL RIM (SN)	TO REPAIR SEE LABOUR	950.00	-

950.00	-
	<u>LABOUR</u>			
	TO CHECK WHEEL ALIGNMENT.		60.00	60.00
	TO REMOVE,REPLACE FRONT DOOR & REPAIR REAR DOOR & FENDER.INCLUSIVE OF THE REPAIR OF REAR WHEEL RIM.		880.00	400.00
	TO SPRAY PAINTING.		900.00	800.00
	TO CHECK WIRING.	NOT NECESSARY	60.00	
			1,900.00	1,260.00
	GRAND TOTAL		6,325.44	3,506.67

RECOMMENDED COST OF LUMP SUM REPAIRS		2,800.00
(TO ITS PRE-ACCIDENT CONDITION)
