# LKK Auto Consultants Pte Ltd

VEHICLE NO : SHD6763B

**ACCIDENT INVOLVING PC 2425P & SHD 6763B ALONG BALESTIER ROAD  
TOWARDS THOMSON ON 25/08/2018**

## ADJUSTMENT ON REPAIR COST FOR VEHICLE NO. SHD 6763B

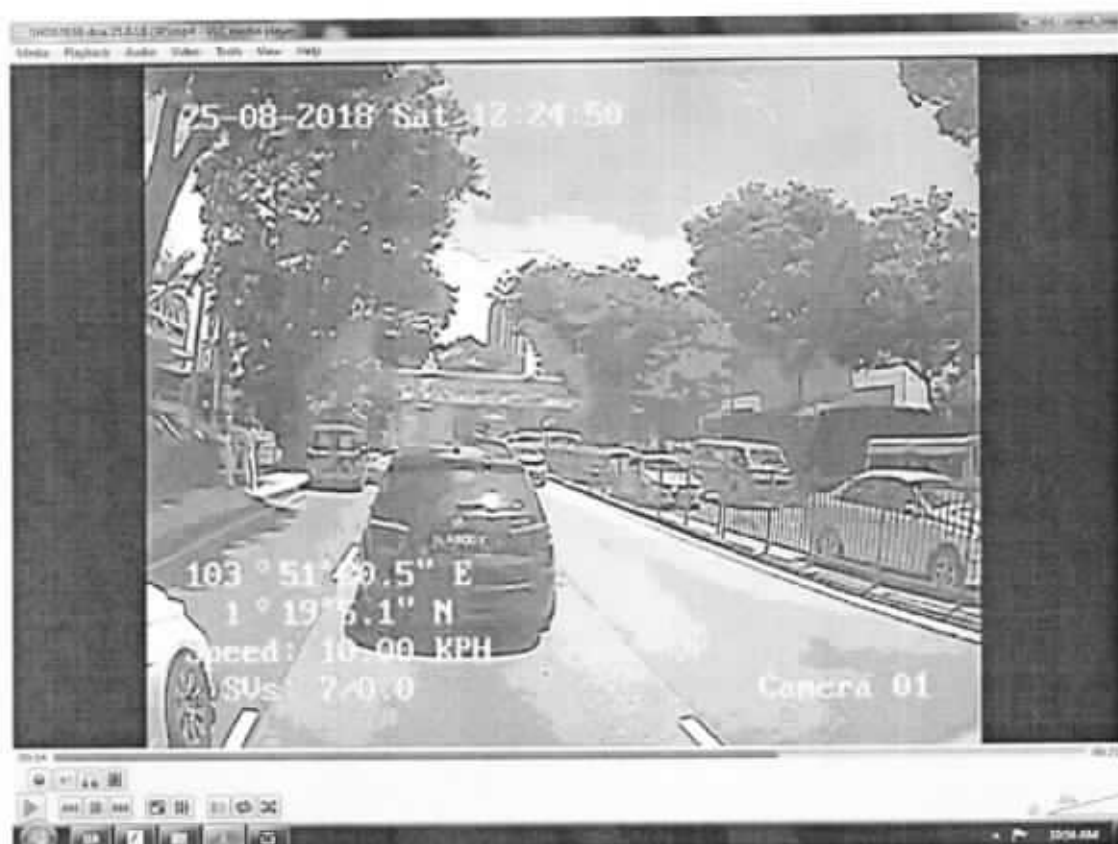
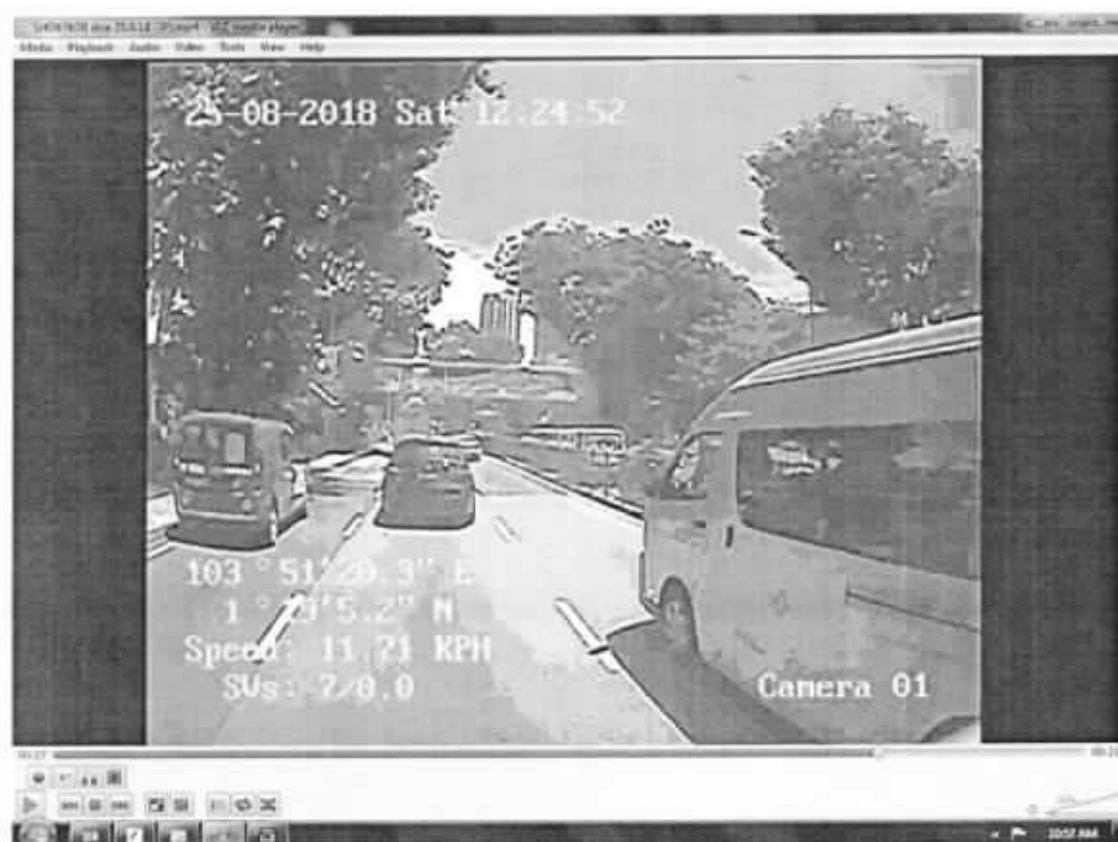
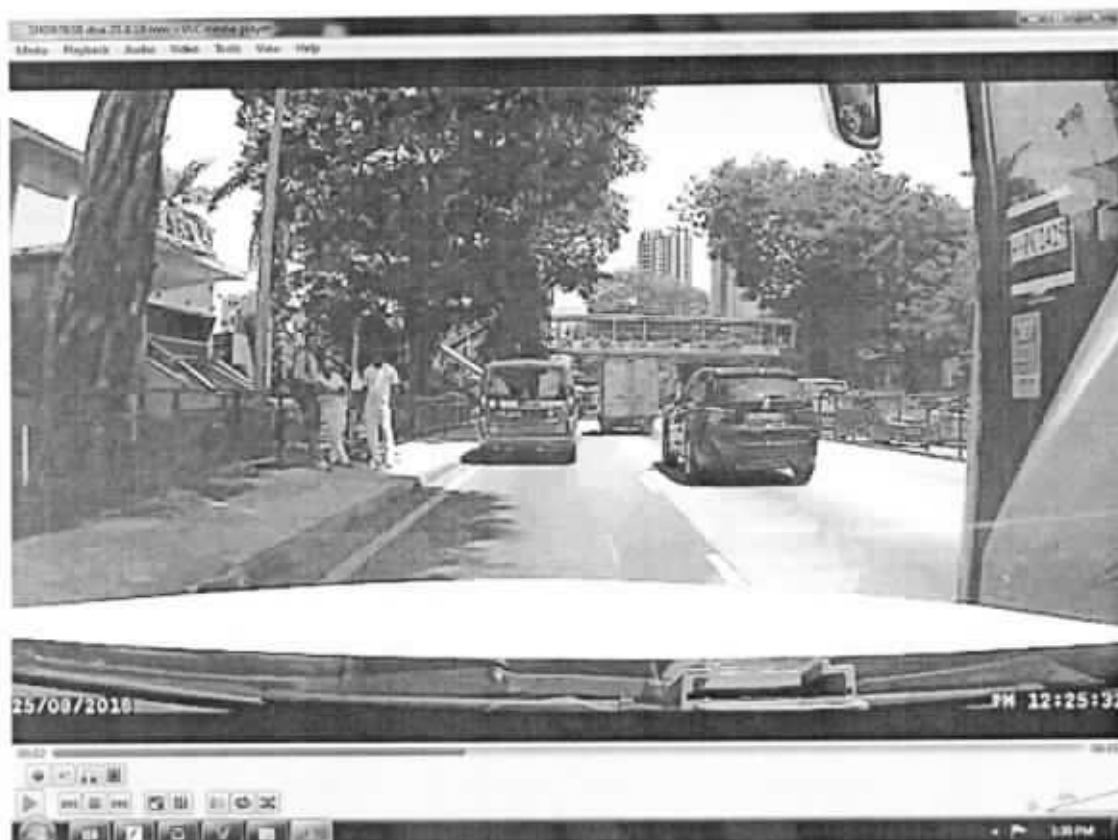
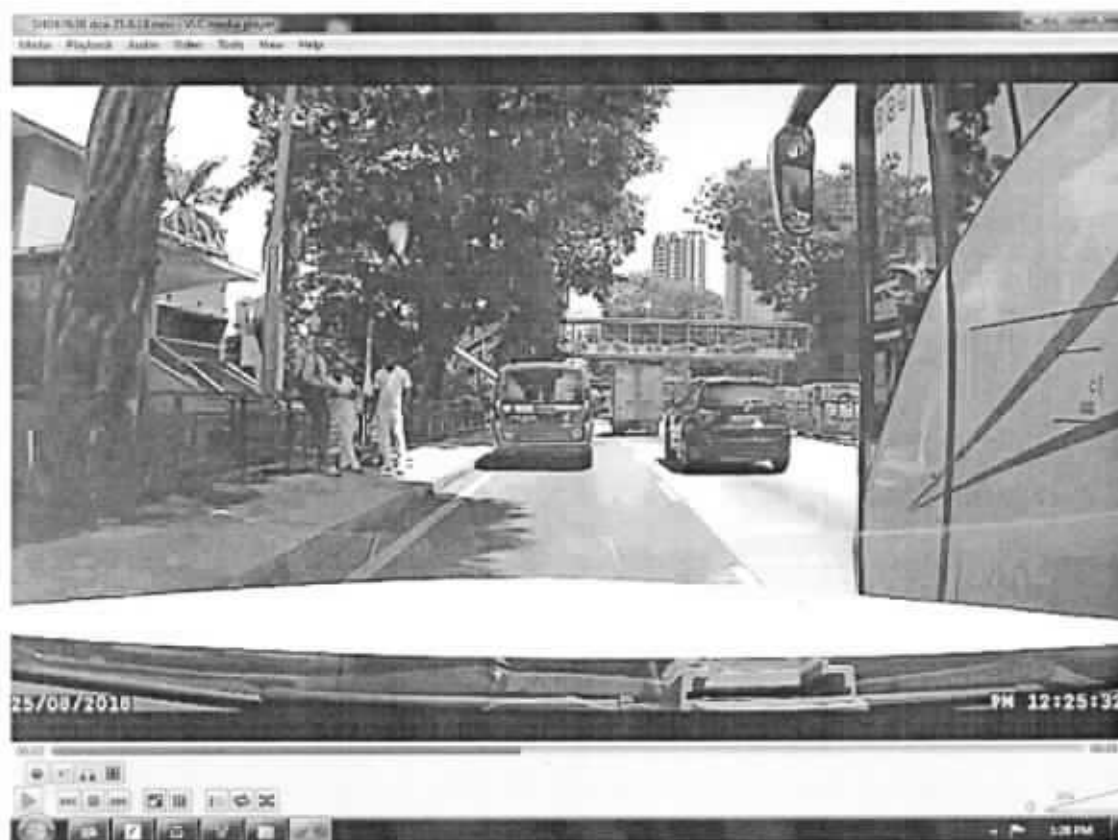
TAXIS VIDEO

Below video screenshots clearly showed taxi travelling within its lane, your principal insured overtook and side-swiped taxi. Kindly settle our PD claim as per BOLA S20.
