Affiliated to Federation Internationale Des Experts En Automobile					
MS FIRST CAPITAL INSURANCE LTD Ref : CC4/FCI20007824/Kds3q2			/Kds3q2			
36 ROBINSON ROAD #16-01 CITY HOUSESINGAPORE 068877		Date: 19-08-2020 Code: FCI2

### ADJUSTMENT ON REPAIR COST FOR VEHICLE NO. SLU 5007X

# PHOTOGRAPHS FOR VEHICLE NO. SLU 5007X

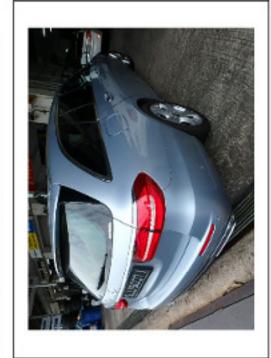
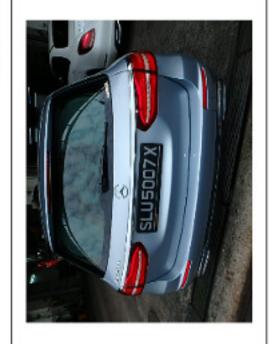
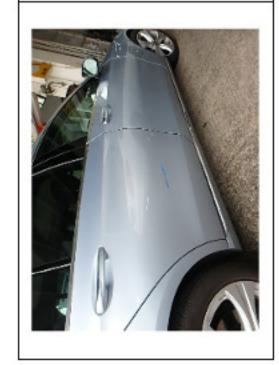
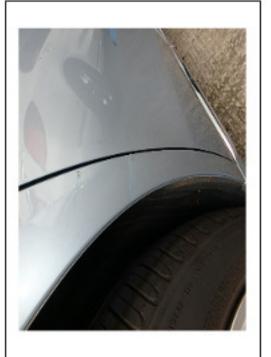
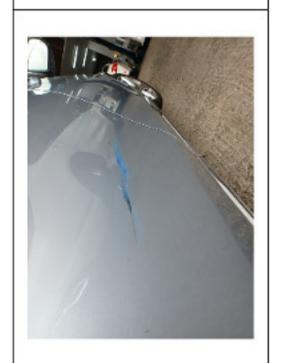
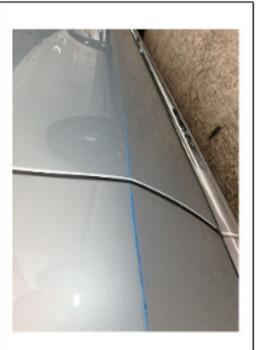
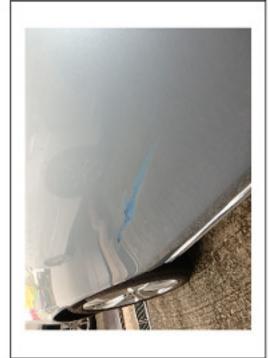
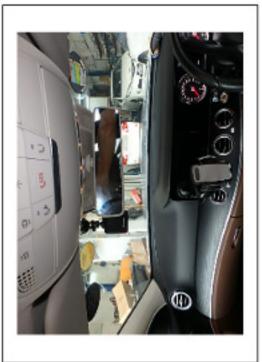
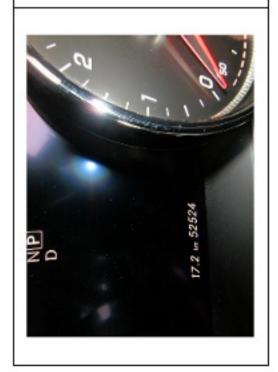
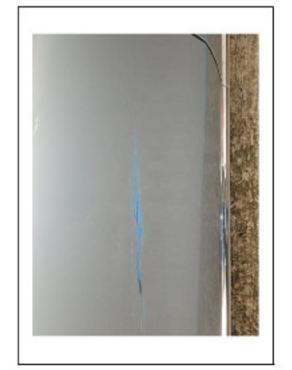
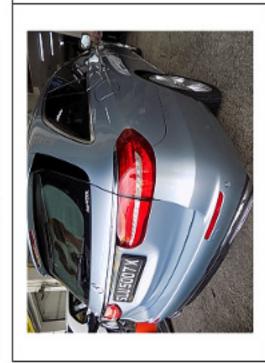
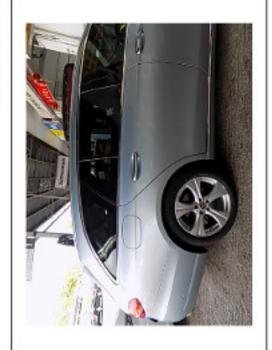
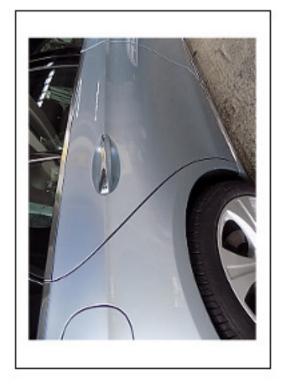
4.		•	on of Damages			
	THE VEHICLE SU	STAINED DAMAGES AT THE O/S	BODY.			
	DAMAGES SEE D	ETAILS.				
5.		General	Information			
	Accident Date	23/07/2020	Inspection Date	11/08/2020		
	Survey held at	irvey held at LIM YEW BOO SPRAY PAINT CO				
		BLOCK 10, SECTOR C SIN MING ROAD INDUSTRIAL ESTATE, #01-10 SINGAPORE 575645.				
5a.		Re	emarks			
	A)THE INSPECTION WAS CONDUCTED ON A"WITHOUT PREJUDICE" BASIS. B)IN ACCORDANCE TO YOUR INSTRUCTIONS, WE HAVE NOT AUTHORISED REPAIRS.					
5b.	b. Estimate Days of Repair					
	ESTIMATED NOR	MAL PERIOD FOR REPAIR:	3 Working Days

Qty	Description of Parts	Condition	Estimate By Workshop (\$))	Our Adjusted (\$)
	LABOUR			
	TO REPAIR & SPRAY RIM.	NOT NECESSARY	120.00	-
	TO REPAIR,PANEL BEAT ON RIGHT REAR FENDER & AFFECTED DOOR IN ORDER TO FACILITATE RESPRAY JOB.		400.00	300.00
	TO PUTTY,PRIMER & SPRAY PAINT ON RIFGT FRT DOOR,REAR DOOR,REAR FENDER & REAR BUMPER USING 2K PAINT.		1,100.00	660.00
			1,620.00	960.00
	GRAND TOTAL		1,620.00	960.00

RECOMMENDED COST OF REPAIRS		960.00
