LKK Auto Consultants Pte Ltd

4. Description of Damages

ADJUSTMENT ON REPAIR COST FOR VEHICLE NO. SLG 8428T

PHOTOGRAPHS FOR VEHICLE NO. SLG 8428T

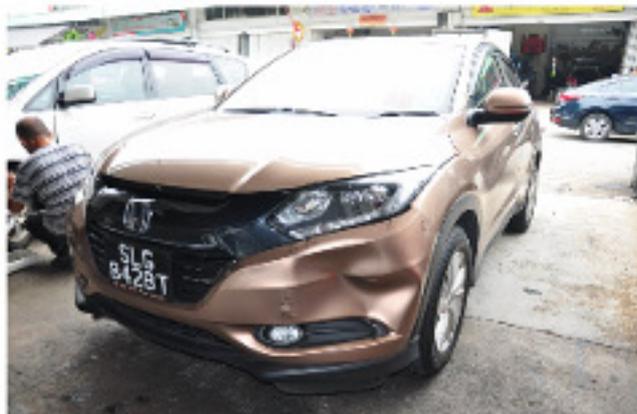
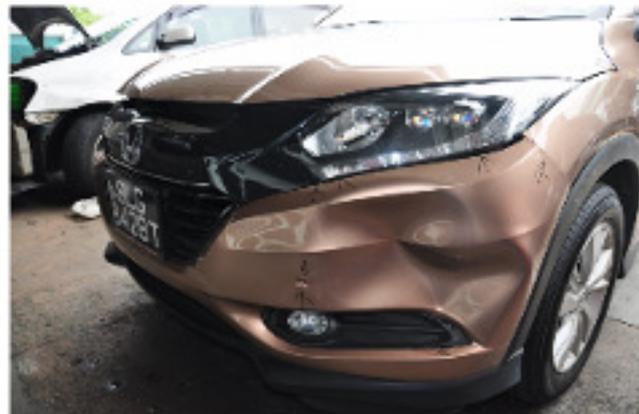
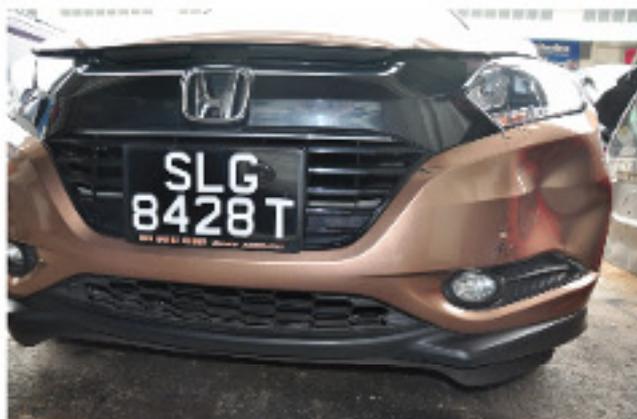
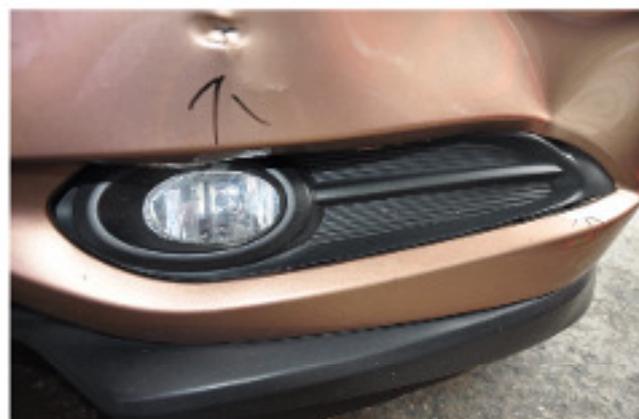
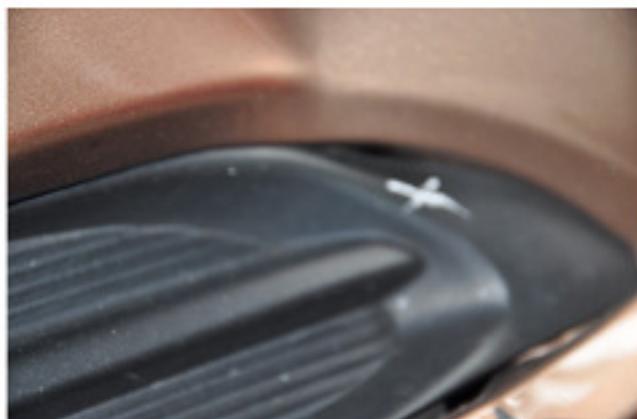
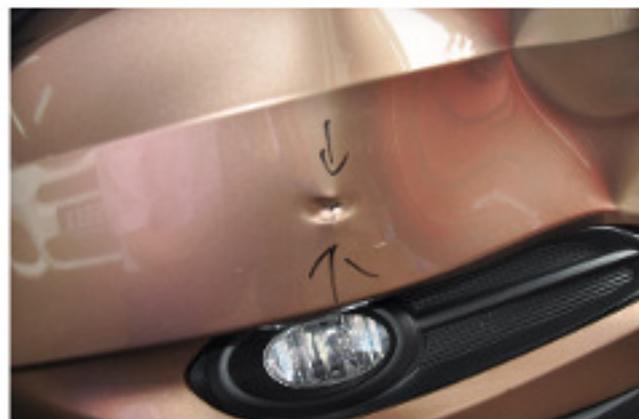
INSPECTION

THE VEHICLE SUSTAINED DAMAGES AT THE FRONT N/S PORTION.
DAMAGES SEE DETAILS.

Qty	Description of Parts	Condition	Estimate By Workshop (\$)	Our Adjusted (\$)
<u>REPLACEMENT OF PARTS</u>				
1	FRONT BUMPER	BENT	801.70	801.70
1	FRONT BUMPER LH SIDE RETAINER	DISTORTED	17.00	17.00
6	FRONT BUMPER CLIPS @\$3.90	NECESSARY	23.40	23.40
1	FRONT BUMPER LH FOG LAMP GARNISH	DENTED	45.00	45.00
1	FRONT LH FENDER WHEEL GARNISH	MTG CRACKED	153.00	153.00
1	LH HEADLAMP (HID)	MTG CRACKED	1,840.50	1,840.50
1	FRONT BUMPER REINFORCEMENT	BENT	360.80	360.80
1	FRONT GRILLE	SERVICEABLE	351.80	-
	LESS 20% DISCOUNT		-718.64	-648.28
			2,874.56	2,593.12
<u>LABOUR</u>				
	REMOVE & REFIX FRT BUMPER ASSY,GRILLE,HEADLAMP,TO KNOCK & REPAIR FRT LH FENDER,FRT SUPPORT PANEL & REALIGN THE SAME.		500.00	400.00
	PUTTY & RESPRAY ON FRT BUMPER,REINFORCEMENT,FRT LH FENDER,FRT SUPPORT PANEL.		700.00	500.00
			1,200.00	900.00
GRAND TOTAL			4,074.56	3,493.12
RECOMMENDED COST OF LUMP SUM REPAIRS (TO ITS PRE-ACCIDENT CONDITION)				2,750.00
