1. Policy Particulars :- THIRD PARTY CLAIM

4. Description of Damages

ADJUSTMENT ON REPAIR COST FOR VEHICLE NO. GBH 5870G

PHOTOGRAPHS FOR VEHICLE NO. GBH 5870G

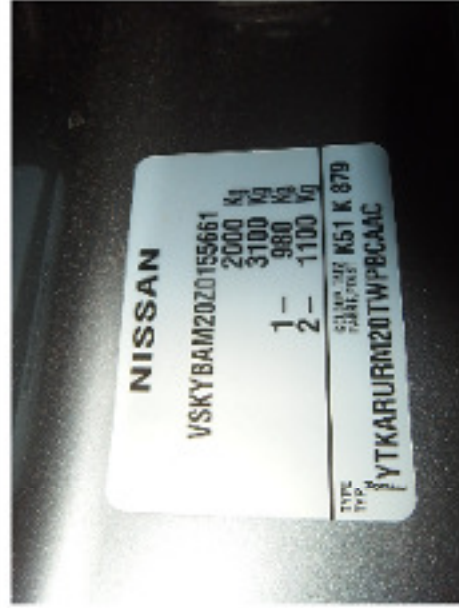
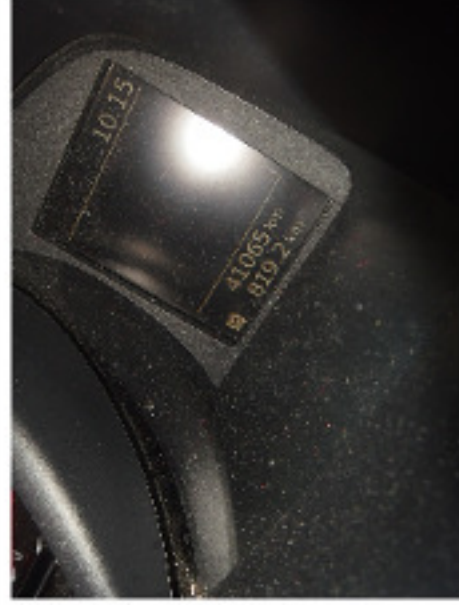
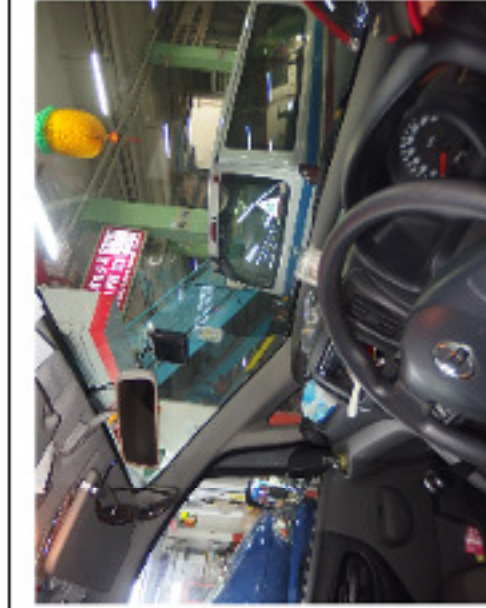
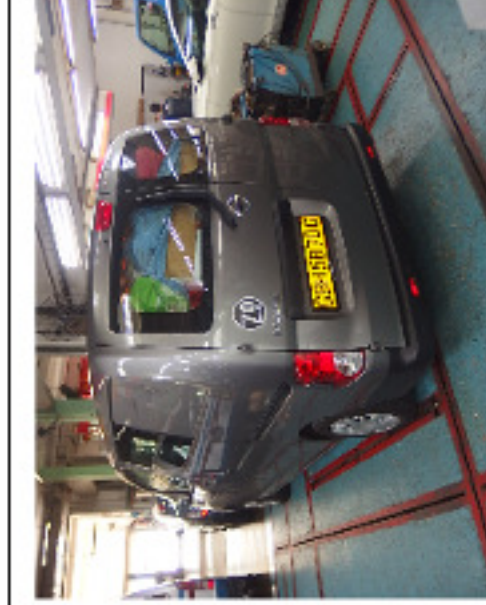
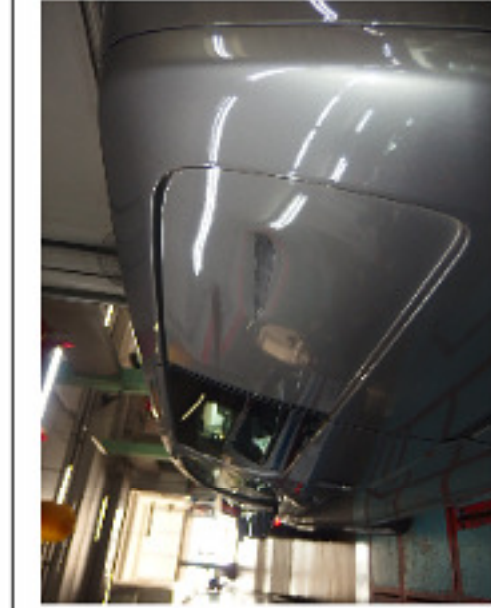
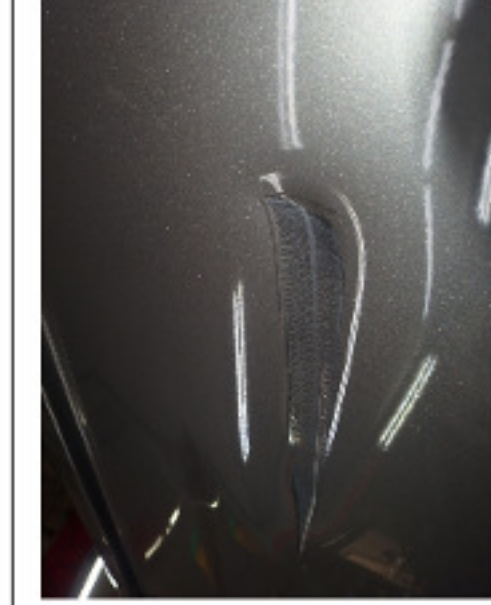
INSPECTION

THE VEHICLE SUSTAINED DAMAGES AT THE N/S REAR PORTION.
DAMAGES SEE DETAILS.

Qty	Description of Parts	Condition	Estimate By Workshop (\$)	Our Adjusted (\$)
<u>REPLACEMENT OF PARTS</u>				
1	REAR FENDER N/S	BADLY DENTED	2,945.10	1,553.00
1	SLIDING DOOR N/S	TO REPAIR SEE LABOUR	1,945.20	-
1	SLIDING DOOR GLASS N/S	CUT	950.00	650.00
	LESS 10% DISCOUNT		-	-220.30
			5,840.30	1,982.70
<u>SPECIAL NETT ITEMS</u>				
1	SLIDING DOOR GLASS SEALANT N/S (SN)	NECESSARY	50.00	40.00
1	SLIDING DOOR GLASS INNER SEAL N/S (SN)	NECESSARY	50.00	30.00

100.00	70.00
<u>LABOUR</u>				
	TO CHECK WIRING.	NOT NECESSARY	50.00	-
	TO DISMANTLE & REPLACED SLIDING DOOR GLASS.		150.00	100.00
	TO SPRAY RUST PROOFING.		80.00	30.00
	LABOUR FOR PANEL BEATING & REPLACED PARTS.INCLUSIVE OF THE REPAIR OF SLIDING DOOR N/S.		1,000.00	600.00
	TO PUTTY & SPRAY PAINTING.		880.00	400.00
			2,160.00	1,130.00
GRAND TOTAL			8,100.30	3,182.70
RECOMMENDED COST OF LUMP SUM REPAIRS (TO ITS PRE-ACCIDENT CONDITION)				2,500.00
