1. Policy Particulars :- THIRD PARTY CLAIM				
Insured Veh.	SME 7644R	Veh. Inspected	SHC 7476D	
Policy No.	5104389063-01	Coverage (\$)	0.00	
Claim No.	MT/1098840-002	Excess (\$)	0.00	
Assign From		Assign Date	04/08/2020

ADJUSTMENT ON REPAIR COST FOR VEHICLE NO. SHC 7476D

PHOTOGRAPHS FOR VEHICLE NO. SHC 7476D

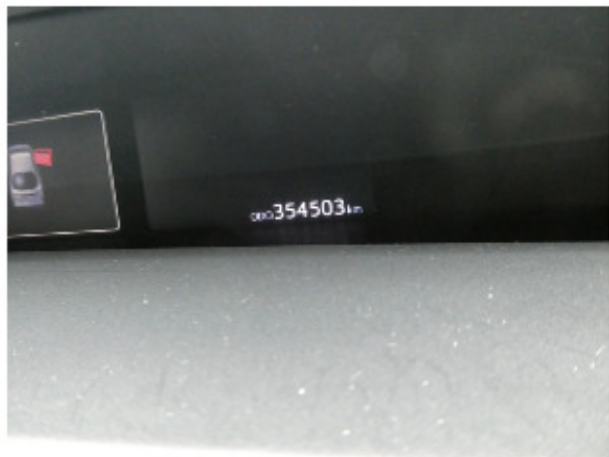
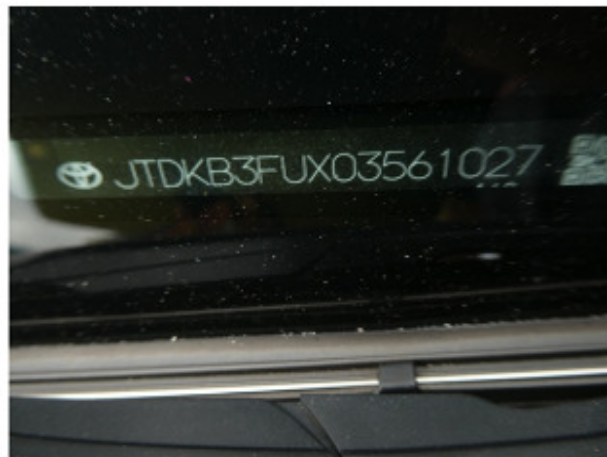
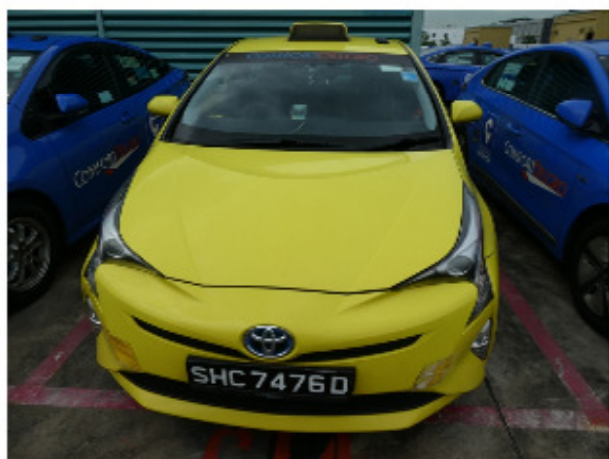
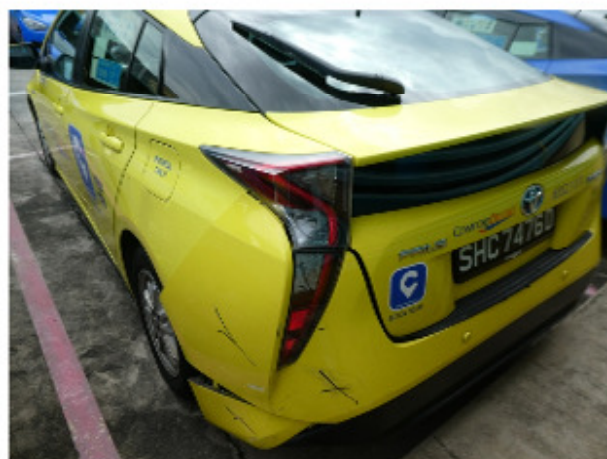
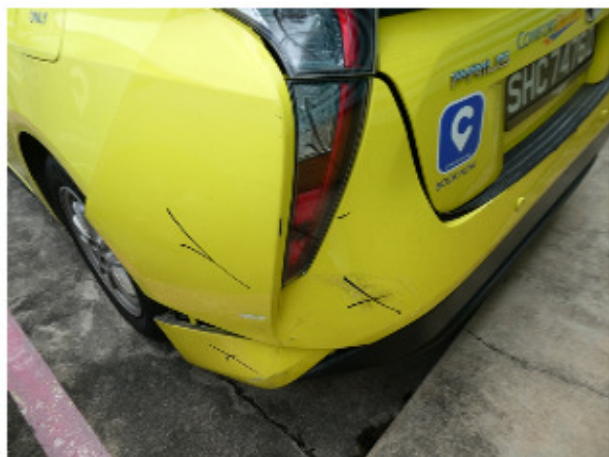
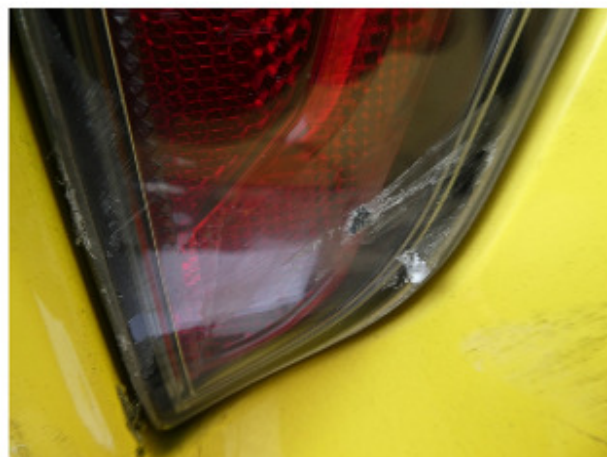
4. Description of Damages				
	THE VEHICLE SUSTAINED DAMAGES AT THE REAR N/S PORTION. DAMAGES SEE DETAILS.			
5. General Information				
Accident Date	03/08/2020	Inspection Date	04/08/2020	
Survey held at	COMFORTDELGRO ENGINEERING PTE LTD 59 LOYANG DRIVE SINGAPORE 508969			
5a. Remarks				
	A)THE INSPECTION WAS CONDUCTED ON A"WITHOUT PREJUDICE" BASIS. B)IN ACCORDANCE TO YOUR INSTRUCTIONS, WE HAVE NOT AUTHORISED REPAIRS.			
5b. Estimate Days of Repair				
	ESTIMATED NORMAL PERIOD FOR REPAIR: 2 Working Days

Qty	Description of Parts	Condition	Estimate By Workshop (\$)	Our Adjusted (\$)
<u>REPLACEMENT OF PARTS</u>				
1	REAR BUMPER	CRACKED	458.60	458.60
1	REAR BUMPER UNDER COVER	DEFORMED	552.60	552.60
1	REAR BUMPER UNDER SIDE LH	DEFORMED	232.00	232.00
1	REAR BUMPER REINFORCEMENT	NOT NECESSARY	318.80	-
10	BUMPER CLIPS	NECESSARY	22.00	22.00
1	REAR BUMPER SIDE RETAINER LH	CRACKED	112.70	112.70
1	TOWING COVER	NOT NECESSARY	82.70	-
1	TAIL LAMP LOWER LH	CRACKED	548.40	548.40
	LESS 25% DISCOUNT		-581.95	-481.58
			1,745.85	1,444.72
<u>NETT ITEMS</u>				
1	REVERSE SENSOR (N)	NOT NECESSARY	135.70	-
	LESS 10% DISCOUNT		-13.57	-

122.13	-
<u>SPECIAL NETT ITEMS</u>				
1	REAR BUMPER MAT (SN)	NECESSARY	50.00	50.00
			50.00	50.00
<u>LABOUR</u>				
	PANEL BEATING.		600.00	480.00
	SPRAY PAINTING.		400.00	400.00
	WIRING.		60.00	30.00
	TUFF KOTE.		60.00	30.00
	REMOVE/REFIX REVERSE SENSOR.		60.00	30.00
			1,180.00	970.00
GRAND TOTAL			3,097.98	2,464.72
RECOMMENDED COST OF LUMP SUM REPAIRS (TO ITS PRE-ACCIDENT CONDITION) (CONFIRMED)				1,950.00
