4. Description of Damages				
	THE VEHICLE SUSTAINED DAMAGES AT THE REAR PORTION. DAMAGES SEE DETAILS.			
5. General Information				
Accident Date	03/08/2020	Inspection Date	04/08/2020	
Survey held at	COMFORTDELGRO ENGINEERING PTE LTD 59 LOYANG DRIVE SINGAPORE 508969			
5a. Remarks				
	A)THE INSPECTION WAS CONDUCTED ON A"WITHOUT PREJUDICE" BASIS. B)IN ACCORDANCE TO YOUR INSTRUCTIONS, WE HAVE NOT AUTHORISED REPAIRS.			
5b. Estimate Days of Repair				
	ESTIMATED NORMAL PERIOD FOR REPAIR: 2 Working Days

ADJUSTMENT ON REPAIR COST FOR VEHICLE NO. SHA 2311P

PHOTOGRAPHS FOR VEHICLE NO. SHA 2311P

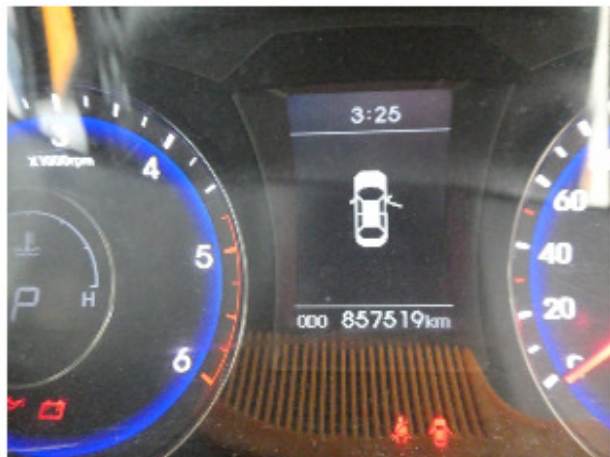
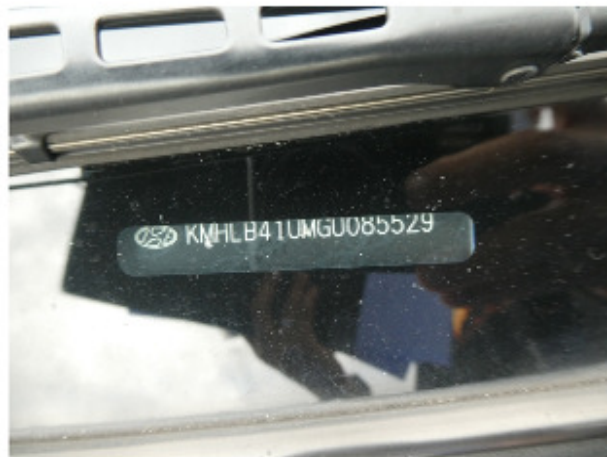
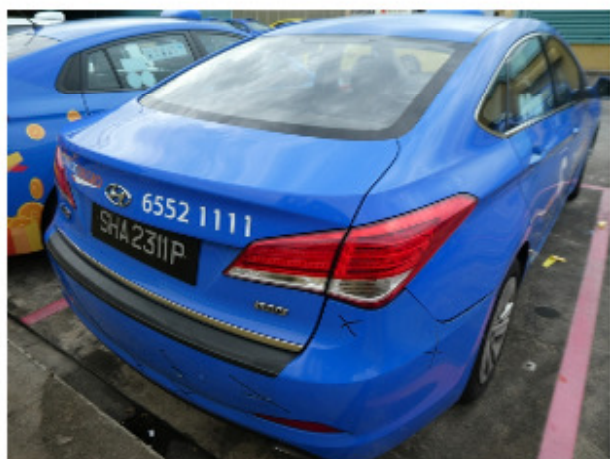
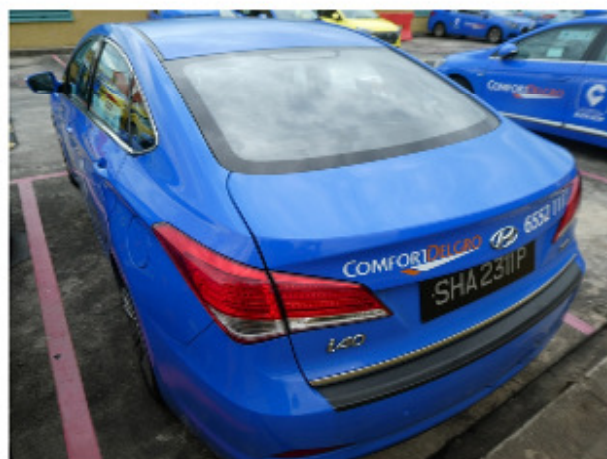
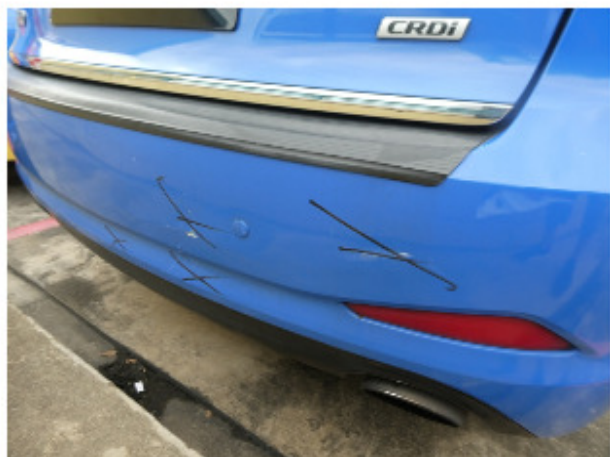
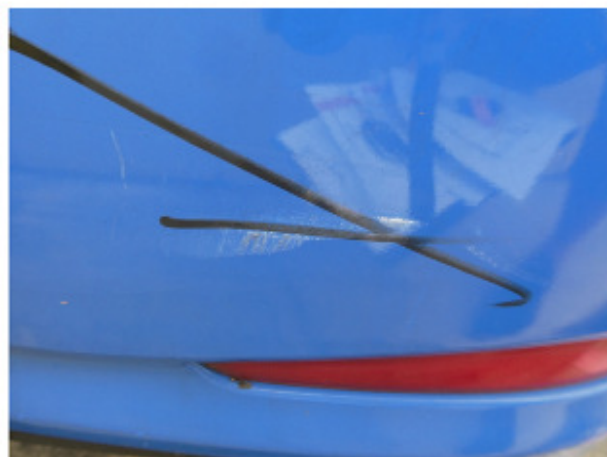
INSPECTION

Qty	Description of Parts	Condition	Estimate By Workshop (\$)	Our Adjusted (\$)
	<u>REPLACEMENT OF PARTS</u>			
1	REAR BUMPER	DEFORMED	1,106.00	1,106.00
1	REAR BUMPER UNDER COVER	CUT	228.00	228.00
1	REAR BUMPER REFLECTOR LAMP (RH)	NOT NECESSARY	31.90	-
1	REAR BUMPER REINFORCEMENT BRACKET (RH)	NOT NECESSARY	80.30	-
1	REAR BUMPER REINFORCEMENT	NOT NECESSARY	428.40	-
10	REAR BUMPER CLIP @\$2.20	NECESSARY	22.00	22.00
1	REAR BUMPER SIDE BRACKET (RH)	NECESSARY	35.60	35.60
1	REAR BUMPER SPONGE	NOT NECESSARY	119.50	-
	LESS 20% DISCOUNT		-410.34	-278.32
			1,641.36	1,113.28
	<u>SPECIAL NETT ITEMS</u>			
1	REAR BUMPER RUBBER MAT (SN)	NECESSARY	50.00	50.00
1	REAR BUMPER REVERSE SENSOR (SN)	NOT WORKING	135.70	135.70

185.70	185.70
	<u>LABOUR</u>			
	PANEL BEATING.		900.00	280.00
	SPRAY PAINTING.		500.00	200.00
	REMOVE/REFIX REVERSE SENSOR.		120.00	30.00
			1,520.00	510.00
	GRAND TOTAL		3,347.06	1,808.98
	RECOMMENDED COST OF LUMP SUM REPAIRS (TO ITS PRE-ACCIDENT CONDITION) (CONFIRMED)			1,450.00
