Vehicle No. SLV 3093D
Insured Veh. SHC 3229C
Claim No. D20003053MFSH
Policy No. D-20094922MFSH
Accident Date 01/08/2020
Inspection Date 06/08/2020

LKK Auto Consultants Pte Ltd

ADJUSTMENT ON REPAIR COST FOR VEHICLE NO. SLV 3093D

PHOTOGRAPHS FOR VEHICLE NO. SLV 3093D

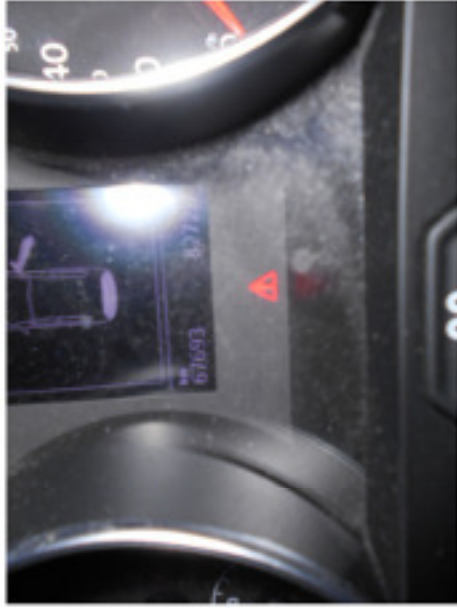
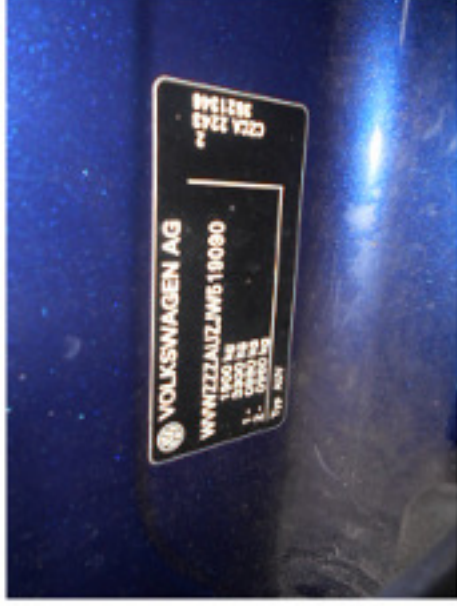
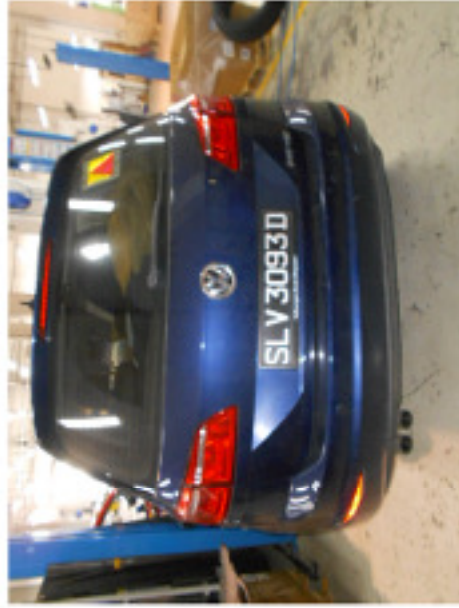
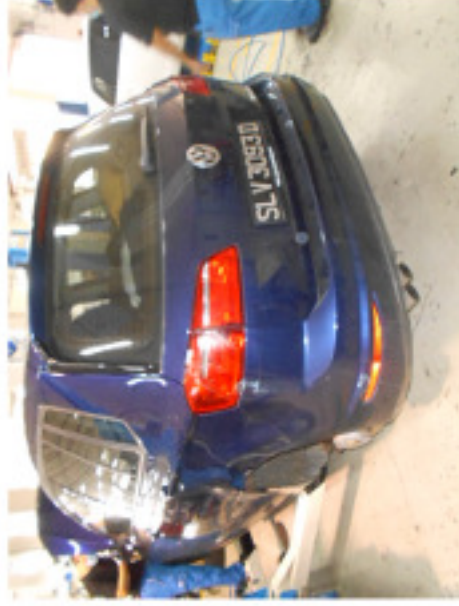
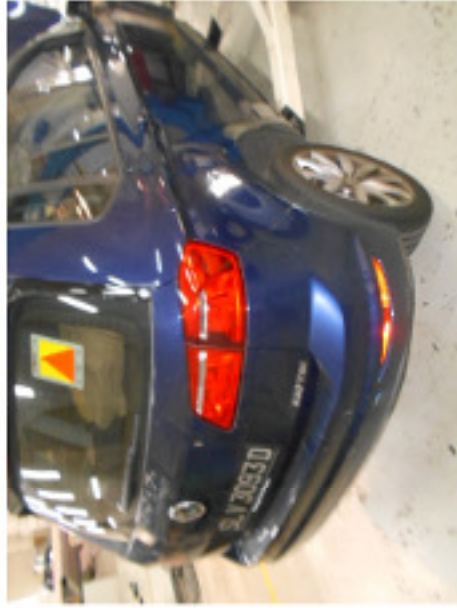
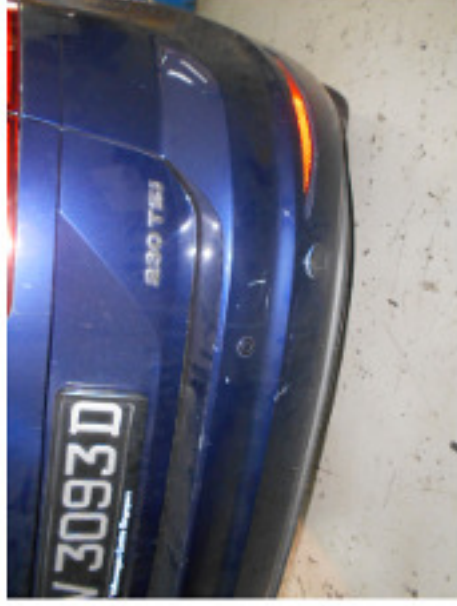
INSPECTION

THE VEHICLE SUSTAINED DAMAGES AT THE REAR PORTION. DAMAGES SEE DETAILS.
--

Qty	Description of Parts	Condition	Estimate By Workshop (\$)	Our Adjusted (\$)
	<u>REPLACEMENT OF PARTS</u>			
1	COVER FOR BUMPER PRIMED REAR BUMPER	DEFORMED	1,175.85	1,175.85
1	REAR DIFFUSOR SATIN BLACK SPOILER	SERVICEABLE	323.62	-
1	BUMPER REINFORCEMENT	SERVICEABLE	619.61	-
1	ATTACHMENT STRIP BUMPER CENTRE BRACKET	SERVICEABLE	63.92	-
1	GUIDE PIECE (TAILLIGHT LOWER BRACKET LH)	SERVICEABLE	37.46	-
1	GUIDE PIECE (TAILLIGHT LOWER BRACKET RH)	SERVICEABLE	37.46	-
1	GUIDE PIECE BUMPER SIDE BRACKET LH	SERVICEABLE	37.46	-
4	BUMPER SIDE BRACKET RH POP-RIVET	NECESSARY	4.36	4.36
1	REVERSE SENSOR	SERVICEABLE	400.00	-
1	GUIDE PIECE BUMPER SIDE BRACKET RH	SERVICEABLE	37.46	-
			2,737.20	1,180.21
	<u>LABOUR</u>			
	DIAGNOTIC AND PROGRAMMING		480.00	480.00
	LABOUR .		2,520.00	840.00
	SPRAY PAINT.		2,400.00	800.00
			5,400.00	2,120.00
GRAND TOTAL			8,137.20	3,300.21

RECOMMENDED COST OF REPAIRS				3,300.21
------------------------------------	--	--	--	-----------------
