ASSIGNMENT

To Inspect Vehicle No:

SYM3062P

Toyota Corolla Altis c.c 1598

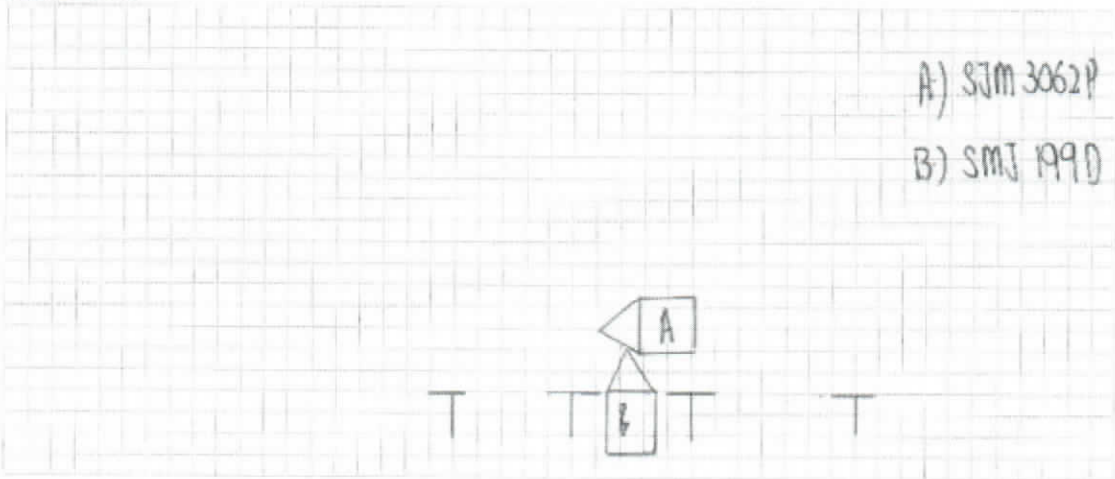
SKETCH PLAN

DESCRIBE CIRCUMSTANCES OF THE ACCIDENT

On 05.08.2020 at about 7pm, I was travelling along Queen Street VRA Carpark. I was travelling straight. Suddenly Vehicle B dashed out the Carpark lot and hit my vehicle.
