## LKK Auto Consultants Pte Ltd

## ADJUSTMENT ON REPAIR COST FOR VEHICLE NO. PA 9704Z

### PHOTOGRAPHS FOR VEHICLE NO. PA 9704Z

### INSPECTION

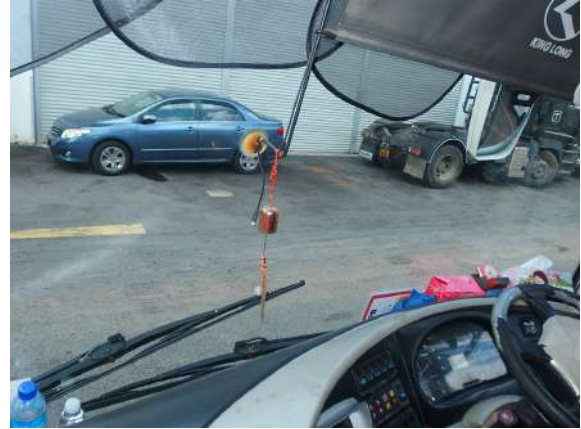
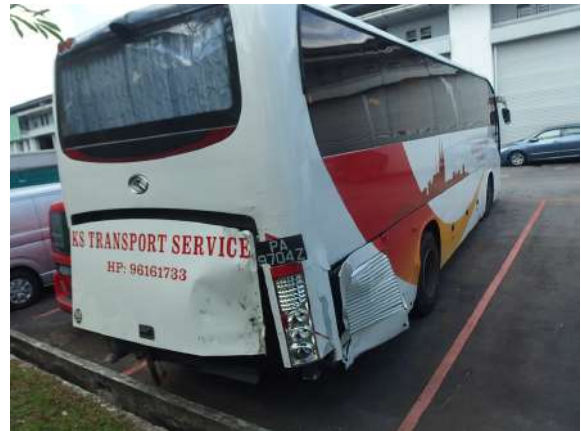
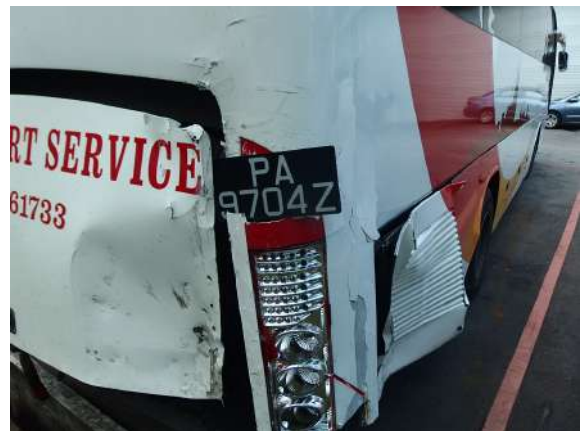
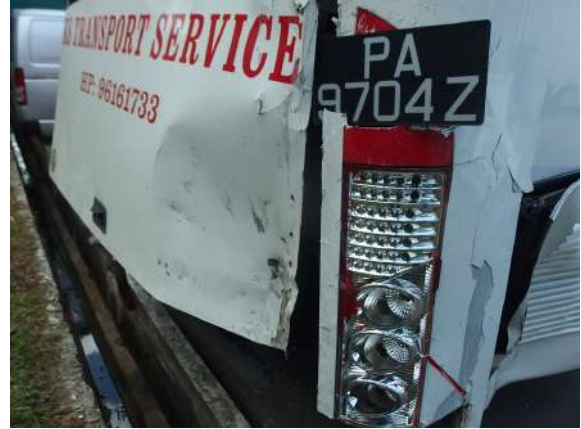
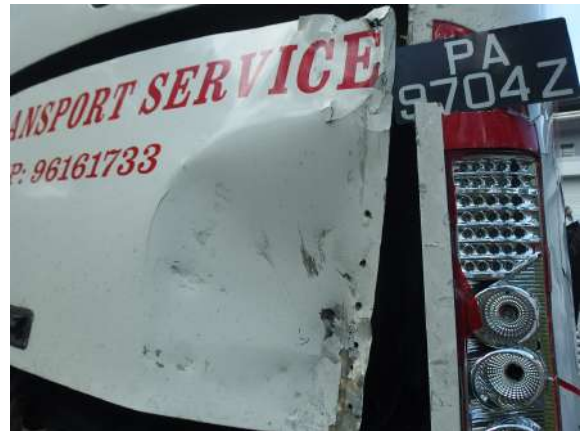
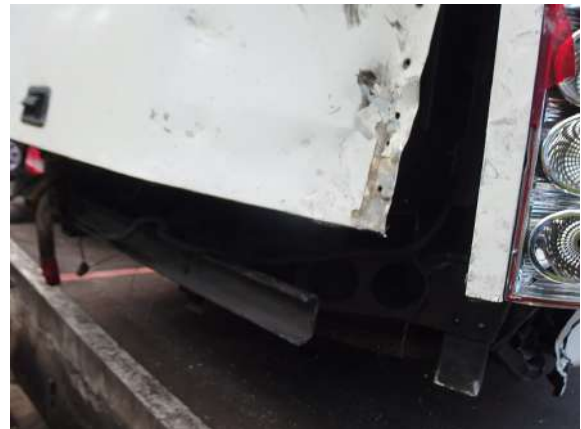
| Affiliated to Federation Internationale Des Experts En Automobile | | | | |
|---|---|---|---|--|
| | THE VEHICLE SUSTAINED DAMAGES AT THE REAR O/S PORTION.<br>DAMAGES SEE DETAILS. | | | |

| Qty | Description of Parts | Condition | Estimate By Workshop (\$) | Our Adjusted (\$) |
|---|---|---|---|---|
| <b>RECOMMENDED COST OF LUMP SUM REPAIRS (TO ITS PRE-ACCIDENT CONDITION)</b> | | | | <b>25,000.00</b> |
