LKK Auto Consultants Pte Ltd

1. Policy Particulars :- THIRD PARTY CLAIM

ADJUSTMENT ON REPAIR COST FOR VEHICLE NO. SG 5812D

PHOTOGRAPHS FOR VEHICLE NO. SG 5812D

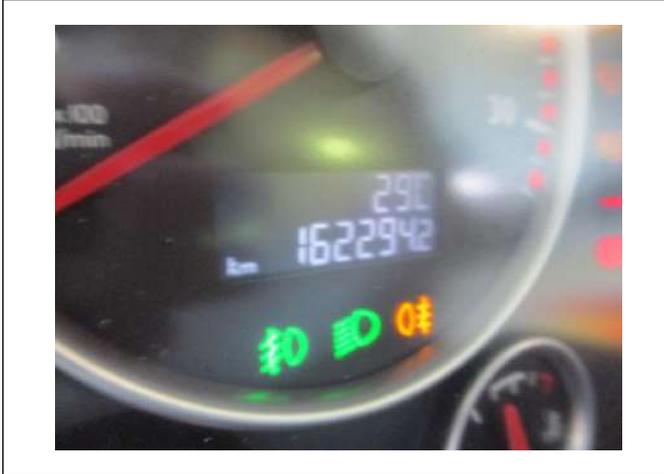
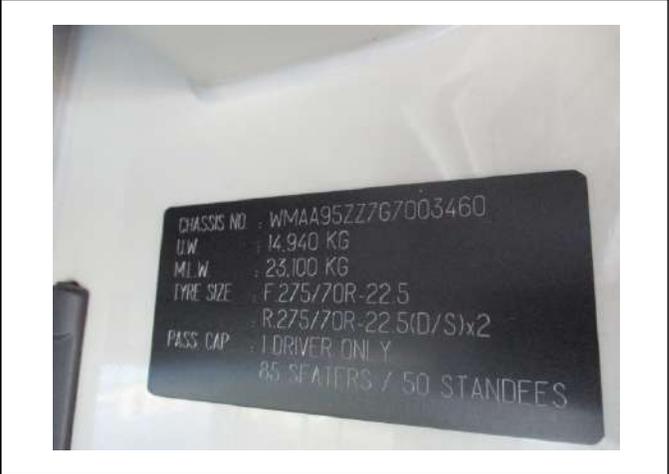
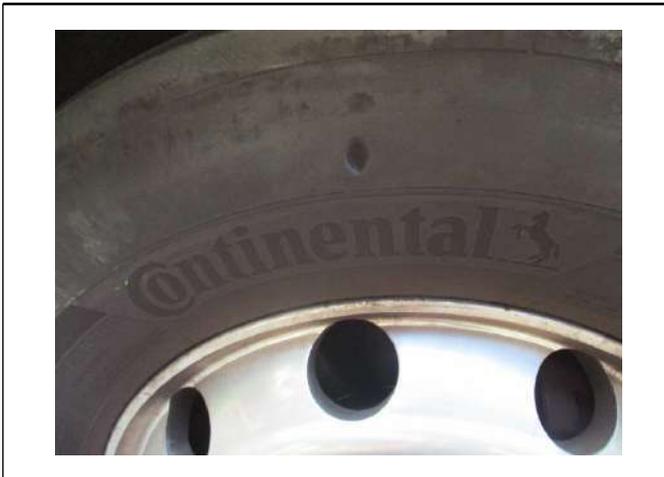
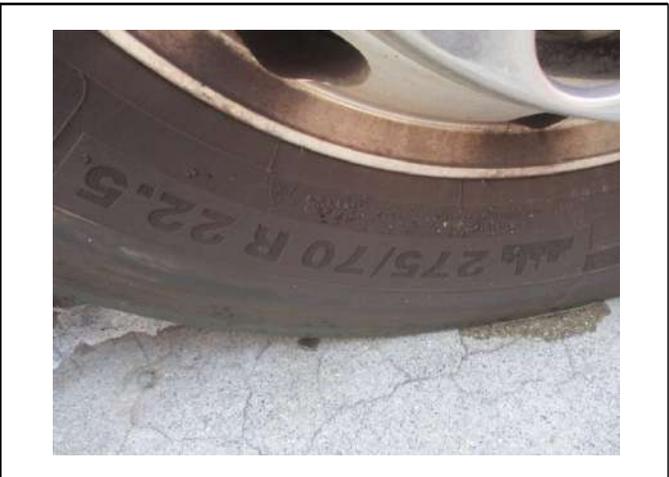
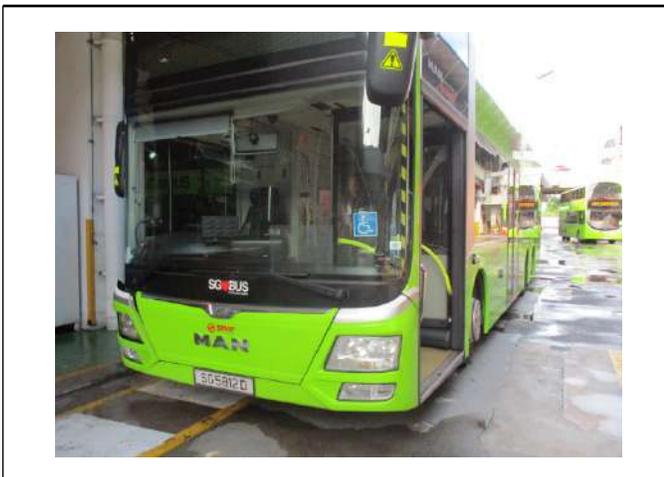
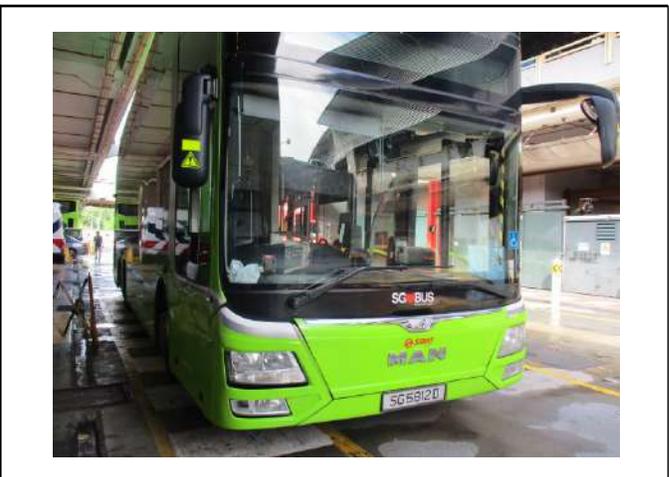
INSPECTION

THE VEHICLE SUSTAINED DAMAGES AT THE O/S BODY.

DAMAGES SEE DETAILS.

Qty	Description of Parts	Condition	Estimate By Workshop (\$)	Our Adjusted (\$)
REPLACEMENT OF PARTS				
1	O/S FRP FRONT HEADLAMP COVER	CRUMPLED	975.00	975.00
1	FRP FRONT DOME	TO REPAIR SEE LABOUR	2,450.00	-
1	BATTERY PANEL	TO REPAIR SEE LABOUR	765.70	-
	LESS 10% DISCOUNT		-	-97.50
			4,190.70	877.50
SPECIAL NETT ITEMS				
1	ALUMINIUM SHEET (SN)	CRUMPLED	480.00	480.00
1	STICKER SMRT (SN)	NECESSARY	75.00	75.00
1	ADHESIVE DIRECT GLAZING (SN)	NECESSARY	37.00	37.00
1	PRIMER (SIKA 206 G+P) (SN)	NECESSARY	80.00	80.00

672.00	672.00
LABOUR				
	TO REMOVE & INSTALL ALL ABOVE ITEMS AND REPAIR OTHERS DAMAGED AFFECTED AREAS.INCLUSIVE OF THE REPAIR OF FRP FRONT DOME AND BATTERY PANEL .		2,650.00	2,120.00
	PROVIDE LABOUR AND MATERIAL TO PUTTY AND RESPRAY ABOVE REPAIR ITEMS.		1,296.00	956.00
			3,946.00	3,076.00
GRAND TOTAL			8,808.70	4,625.50
RECOMMENDED COST OF LUMP SUM REPAIRS (TO ITS PRE-ACCIDENT CONDITION)				4,300.00
