Vehicle No. SHD 6849M

1.	1. Policy Particulars :- THIRD PARTY CLAIM							
	Insured Veh.	GBJ 6988J	Veh. Inspected	SHD 6849M				
	Policy No.	DMCVSNW00055452001	Coverage (\$)	0.00				
	Claim No.	SNM20D202880	Excess (\$)	0.00				
	Assign From		Assign Date	14/08/2020

ADJUSTMENT ON REPAIR COST FOR VEHICLE NO. SHD 6849M

PHOTOGRAPHS FOR VEHICLE NO. SHD 6849M

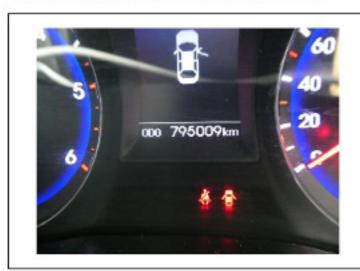
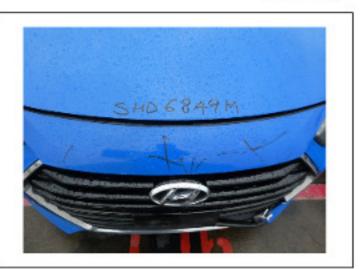
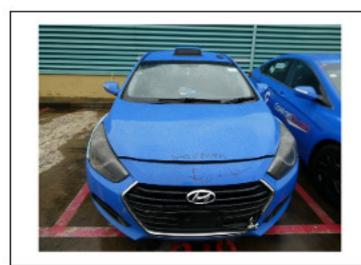
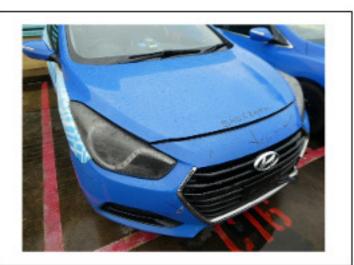
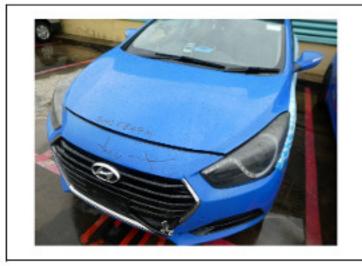
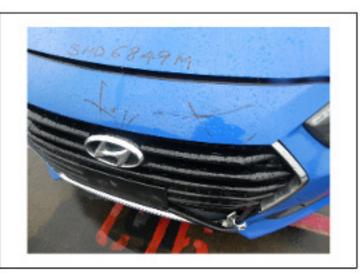
4.		Description	on of Damages					
	THE VEHICLE SU	STAINED DAMAGES AT THE FRO	ONT PORTION.					
	DAMAGES SEE D	ETAILS.						
5.		General	Information					
	Accident Date	13/08/2020	Inspection Date	14/08/2020				
	Survey held at	COMFORTDELGRO ENGINEER	RING PTE LTD					
		59 LOYANG DRIVE SINGAPORE 508969						
5a.		Re	emarks					
	A)THE INSPECTION WAS CONDUCTED ON A"WITHOUT PREJUDICE" BASIS. B)IN ACCORDANCE TO YOUR INSTRUCTIONS, WE HAVE NOT AUTHORISED REPAIRS.							
5b.	5b. Estimate Days of Repair							
	ESTIMATED NORMAL PERIOD FOR REPAIR: 2 Working Days

Qty	Description of Parts	Condition	Estimate By Workshop (\$))	Our Adjusted (\$)
	REPLACEMENT OF PARTS			
1	I40V3 BUMPER W LIP & FOG	DEFORMED	1,052.20	1,052.20
1	I40V3 GRILLE ASSY-RADIATO	CRACKED	1,480.00	1,480.00
1	I40V3 SYMBOL MARK-H	CUT	39.50	39.50
1	I40VC BRKT ASSY-FR BPR UP	NOT NECESSARY	24.60	-
1	I40VC BRACKET-FR BUMPER S	NOT NECESSARY	24.60	-
	LESS 20% DISCOUNT		-524.18	-514.34
			2,096.72	2,057.36
	SPECIAL NETT ITEMS			
1	NO PLATE (SN)	MISSING	25.00	25.00
			25.00	25.00
	LABOUR			
	PANEL BEATING.		300.00	280.00
	SPRAYPAINT CHARGE.		300.00	200.00
	CHECK ALL LIGHTING.		50.00	30.00
			650.00	510.00
	GRAND TOTAL		2,771.72	2,592.36
