## National Assessment Centre Services

Vehicle No. SHC 1566S  
Insured Veh. SKT 2873Z  
Claim No. MT/1100621-002  
Policy No. 5071734289-05  
Accident Date 20/08/2020  
Inspection Date 20/08/2020

## ADJUSTMENT ON REPAIR COST FOR VEHICLE NO. SHC 1566S

PHOTOGRAPHS FOR VEHICLE NO. SHC 1566S

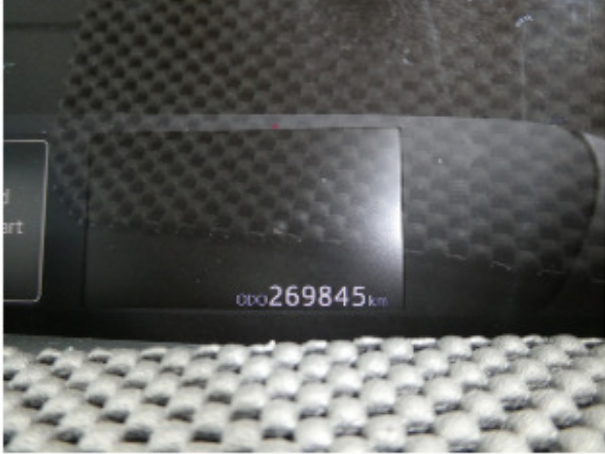
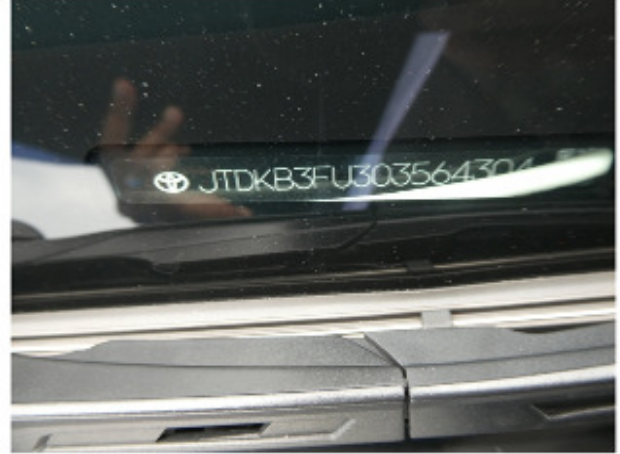
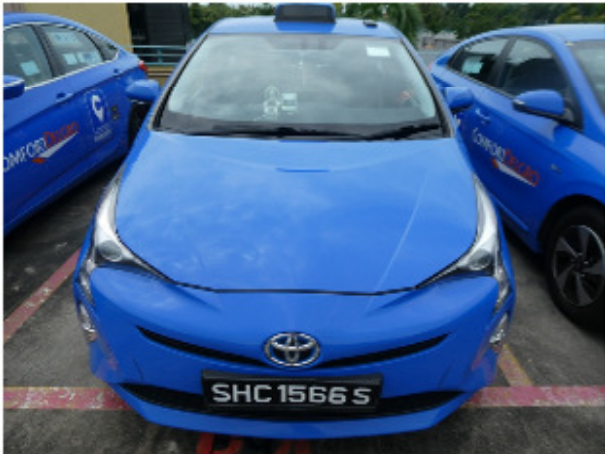
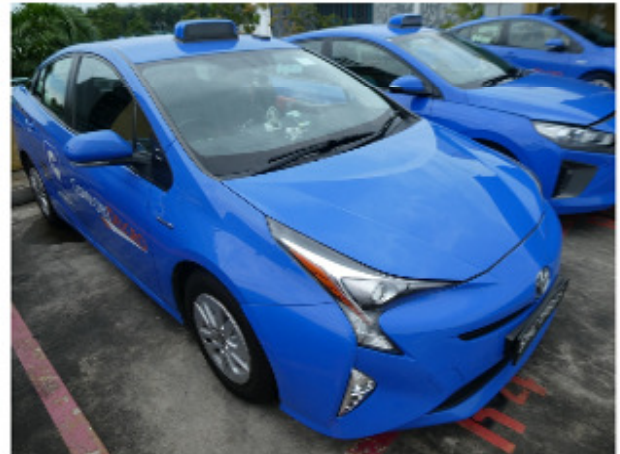
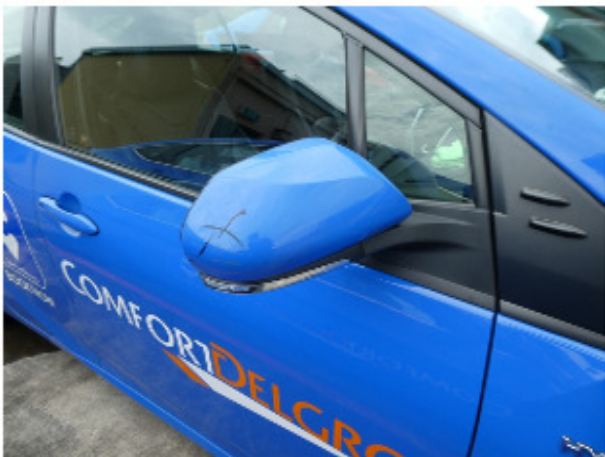
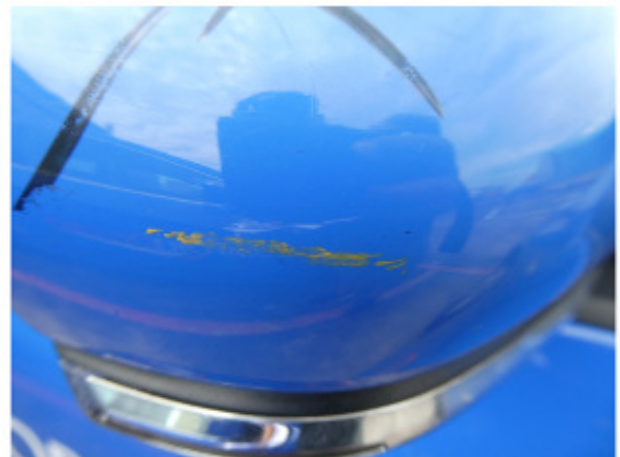
INSPECTION

| THE VEHICLE SUSTAINED DAMAGES AT THE O/S BODY.<br>DAMAGES SEE DETAILS. | | | | |

| Qty | Description of Parts | Condition | Estimate By Workshop (\$) | Our Adjusted (\$) |
|---|---|---|---|---|
| 1 | COVER,OUTER MIRROR RH | CRACKED | 141.90 | 141.90 |

| Qty | Description of Parts | Condition | Estimate By Workshop (\$) | Our Adjusted (\$) |
|---|---|---|---|---|
| | PANEL BEATING.INCLUSIVE OF THE REPAIR OF FRONT DOOR SIDE MIRROR,RH. | | 100.00 | 100.00 |
| | SPRAY PAINTING. | | 100.00 | 100.00 |
| <b>RECOMMENDED COST OF LUMP SUM REPAIRS (TO ITS PRE-ACCIDENT CONDITION) (CONFIRMED)</b> | | | | <b>250.00</b> |
