Reg. No: 199607198R GST Reg. No. 19-9607198-R					
Affiliated to Federation Internationale Des Experts En Automobile						
AUT	UTO & GENERAL INSURANCE (S) PL Ref: CS/AGI20009351/Aqf3q2					
(BUDGET DIRECT INSURANCE) 190 CLEMENCEAU AVENUE #03-01 SINGAPORE SHOPPING CENTRESINGAPORE 239924		Date: 19-10-2020				
			Code: AGI

ADJUSTMENT ON REPAIR COST FOR VEHICLE NO. SLX 8072X

PHOTOGRAPHS FOR VEHICLE NO. SLX 8072X

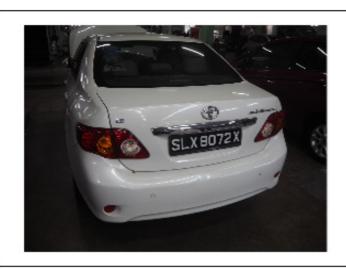
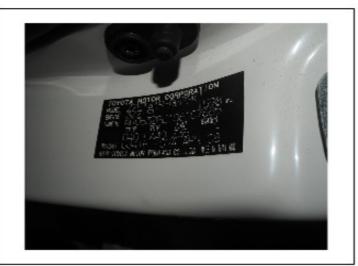
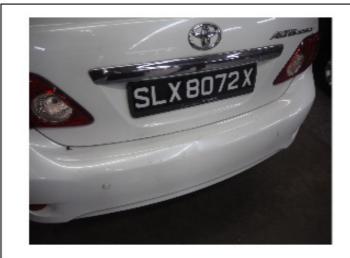
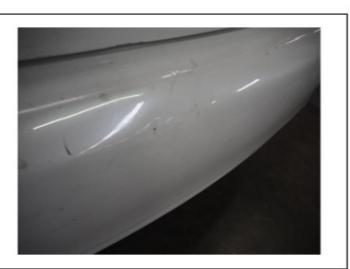
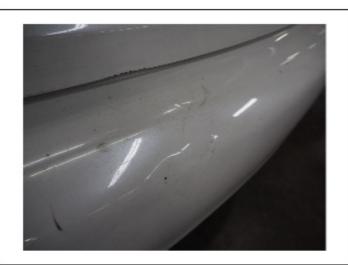
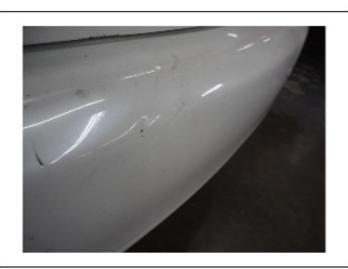
4.		Description	on of Damages			
	THE VEHICLE SU	STAINED DAMAGES AT THE REA	AR PORTION.			
	DAMAGES SEE D	ETAILS.				
5.		General	Information			
	Accident Date	24/08/2020	Inspection Date	03/09/2020		
	Survey held at	1 KAKI BUKIT AVE 6 #01-52	-			
	Repairer	SIN YU SIN WORKSHOP				
5a.		Re	emarks			
	A)THE INSPECTION WAS CONDUCTED ON A"WITHOUT PREJUDICE" BASIS. B)IN ACCORDANCE TO YOUR INSTRUCTIONS, WE HAVE NOT AUTHORISED REPAIRS.					
5b.	ib. Estimate Days of Repair
