ASSIGNMENT

To inspect Vehicle No: SMA 2856A

at Workshop m/s MOVA

Remark: The veh had commenced its repair at the time of inspection.

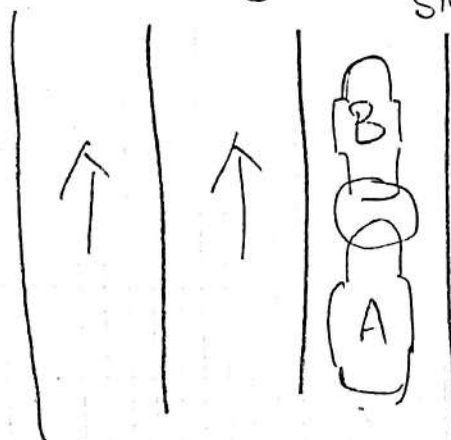
SKETCH PLAN PLE FUND to City

SMA 1496 => B

SMA 2856A $\Rightarrow A$

DESCRIBE CIRCUMSTANCES OF THE ACCIDENT	
LICENSE PLATE: 8MA2836A	ACCIDENT DATE & TIME: 4/9/20 1020am
CONTACT NUMBER: 92770641	E-MAIL ADDRESS: kevin.phuc@icloud.com
LOCATION: PIE Eunos towards City.	
<p>was driving on the right lane, roads were quite jammed. I believe cars in front of car B braked and car B braked late which caused me to jam brake could not stop in time and hit car B.</p>	
<p>NOTE: PLEASE NOTE THAT YOUR INSURER MAY HAVE 14 DAYS TIME FRAME FOR YOU TO SUBMIT AN OWN DAMAGE CLAIM UNDER YOUR OWN POLICY. PLEASE CHECK YOUR POLICY FOR MORE INFORMATION</p>	
Please state:	
<input checked="" type="checkbox"/> Claim Own Policy	<input type="checkbox"/> Claim Third Party
<input type="checkbox"/> Claim OD/TP at other workshop	<input type="checkbox"/> Reporting Only
