Vehicle No. SGG 239J
Insured Veh. SJQ 6863D
Claim No. 20/20/20/VP05/023584
Policy No. Z20VP05026806
Accident Date 25/08/2020
Inspection Date 11/09/2020

ADJUSTMENT ON REPAIR COST FOR VEHICLE NO. SGG 239J

PHOTOGRAPHS FOR VEHICLE NO. SGG 239J

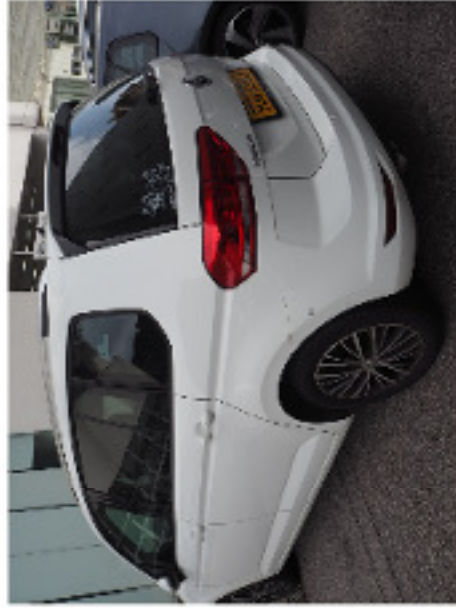
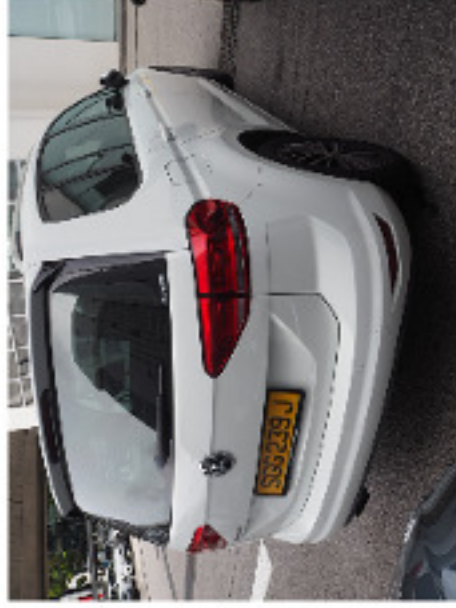
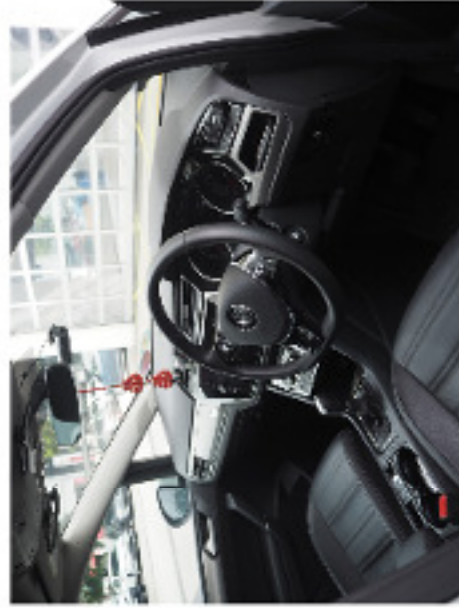
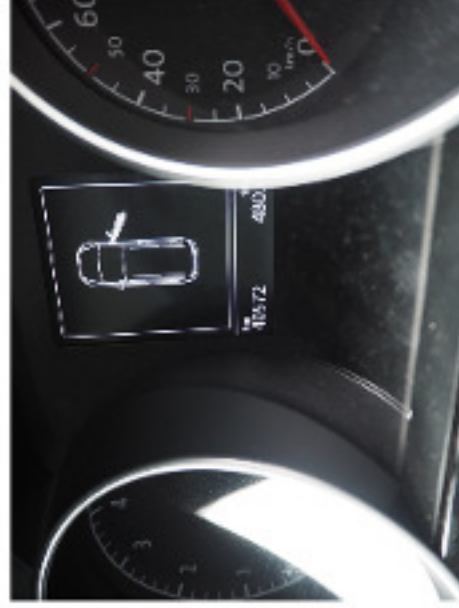
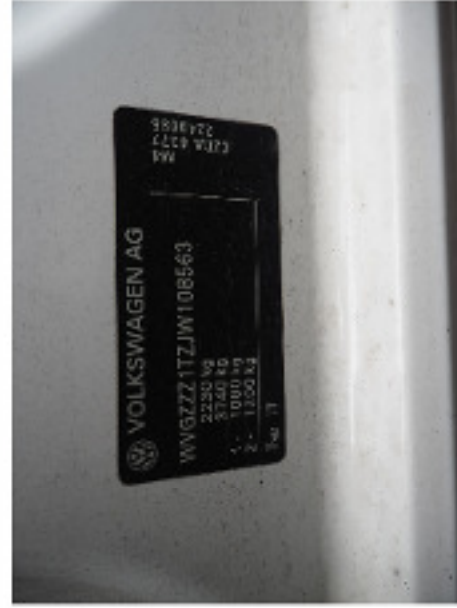
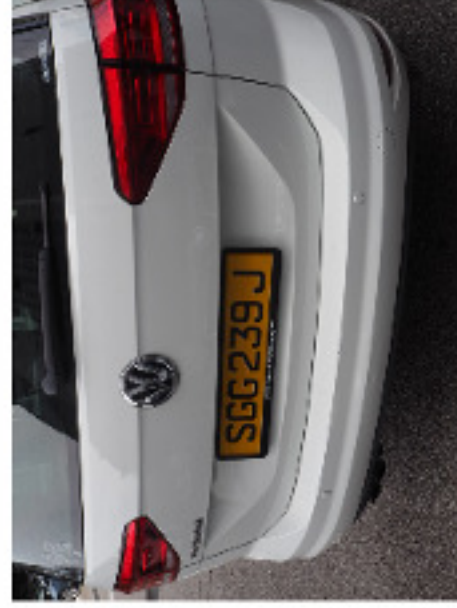
THE VEHICLE SUSTAINED DAMAGES AT THE REAR PORTION. DAMAGES SEE DETAILS.
--

Qty	Description of Parts	Condition	Estimate By Workshop (\$)	Our Adjusted (\$)
	<u>REPLACEMENT OF PARTS</u>			
1	COVER FOR BUMPER PRIMED (SN)	DENTED	1,231.02	1,231.02
1	BUMPER (BUMPER REINFORCEMENT)(SN)	NOT NECESSARY	508.63	-
1	ATTACHMENT STRIP (SN)	NOT NECESSARY	60.62	-
1	GUIDE PIECE (REAR BUMPER LH GUIDE)(SN)	NOT NECESSARY	39.36	-
1	GUIDE PIECE (REAR BUMPER RH GUIDE)(SN)	NOT NECESSARY	39.36	-
1	GUIDE PIECE (BUMPER BRACKET LH)(SN)	NOT NECESSARY	32.03	-
1	GUIDE PIECE (BUMPER BRACKET RH)(SN)	NOT NECESSARY	32.03	-
1	SPOILER SATIN BLACK (SN)	CUT	319.10	319.10
	REVERSE SENSORS (SN)	NOT NECESSARY	400.00	-
			2,662.15	1,550.12
	<u>LABOUR</u>			
	SPRAY PAINTING.		2,400.00	800.00
	LABOUR.		2,520.00	840.00
	DIAGNOSTIC AND PROGRAMMING.		480.00	480.00
	CHECK SHORT CIRCUIT/HARNESS REPAIR.	NOT NECESSARY	280.00	-
			5,680.00	2,120.00
GRAND TOTAL			8,342.15	3,670.12
RECOMMENDED COST OF REPAIRS				3,670.12

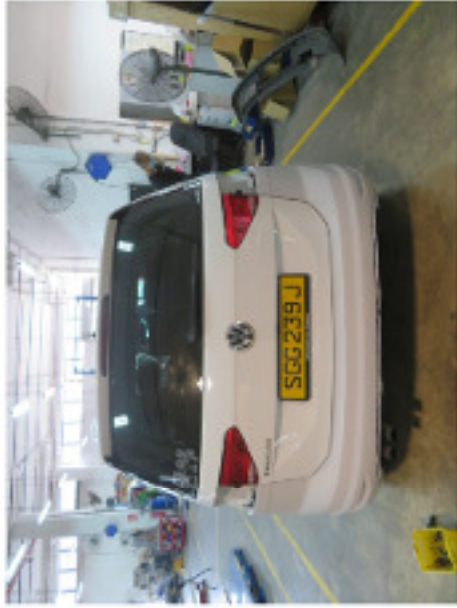
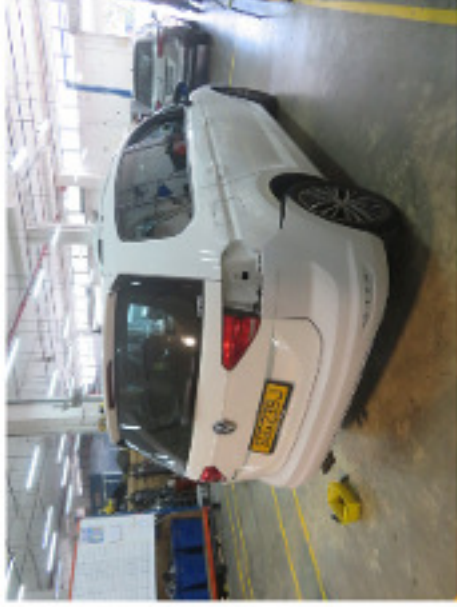
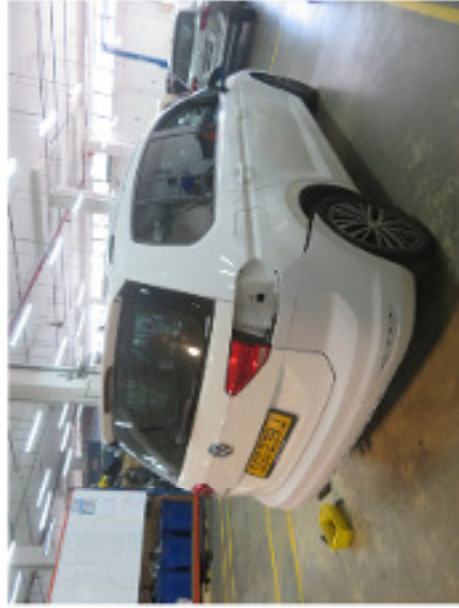
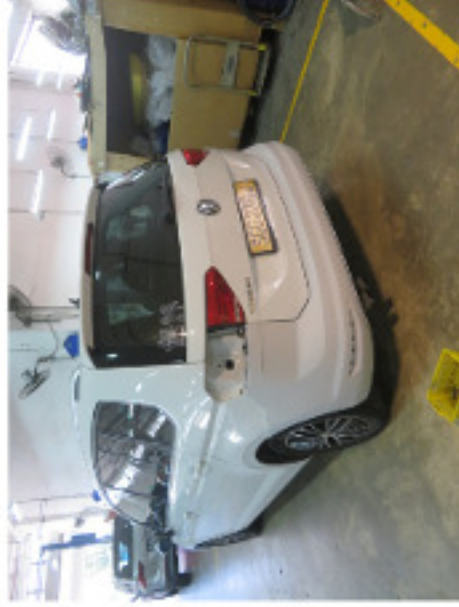
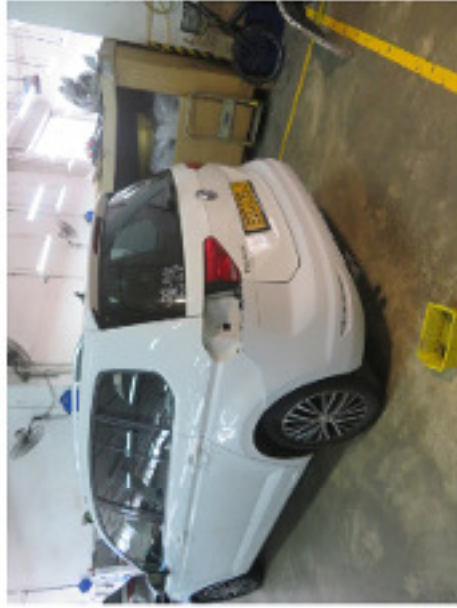
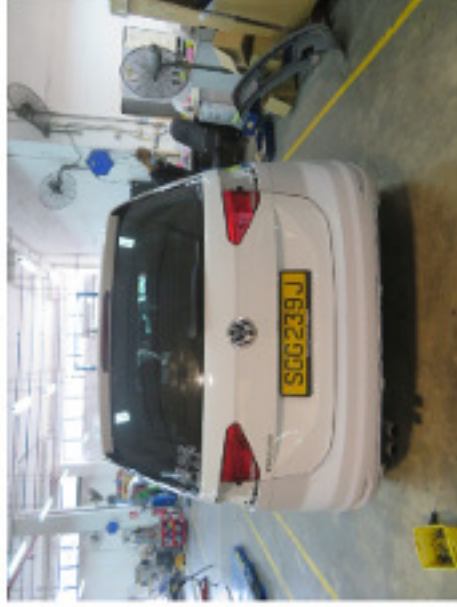
PHOTOGRAPHS FOR VEHICLE NO. SGG 239J

RE-INSPECTION
