Vehicle No. SMU 121U

Claim No. C10007231

ADJUSTMENT ON REPAIR COST FOR VEHICLE NO. SMU 121U

PHOTOGRAPHS FOR VEHICLE NO. SMU 121U

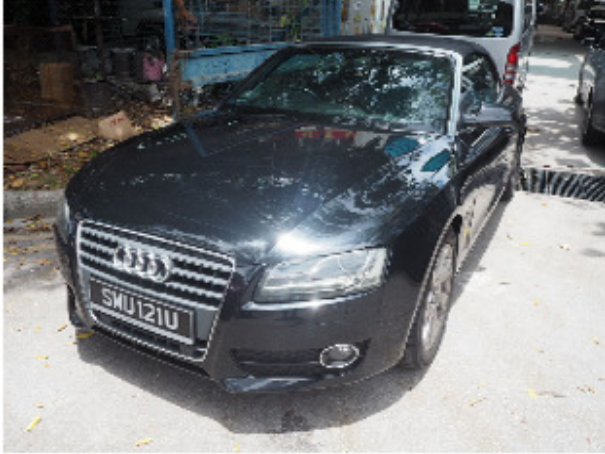
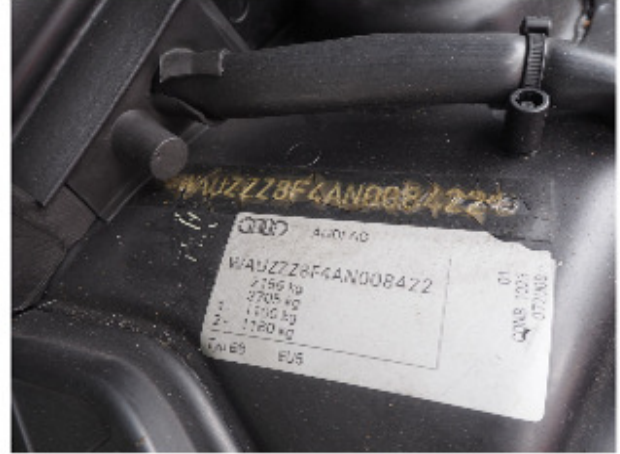
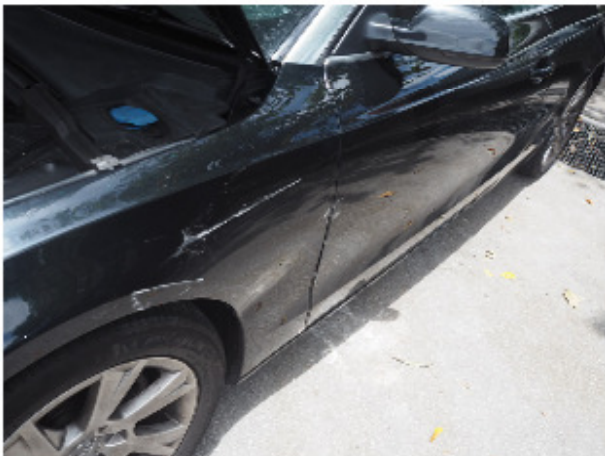
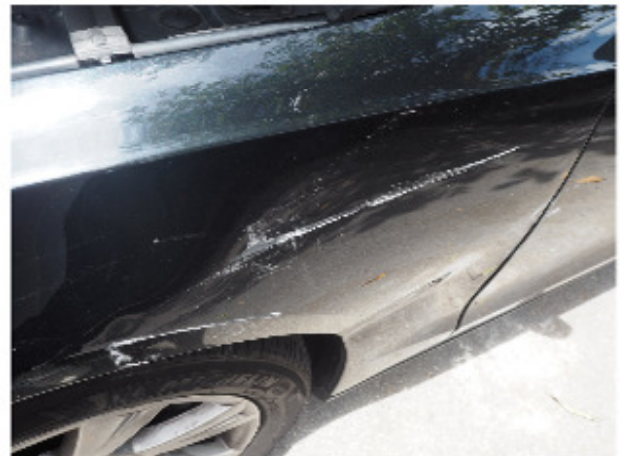
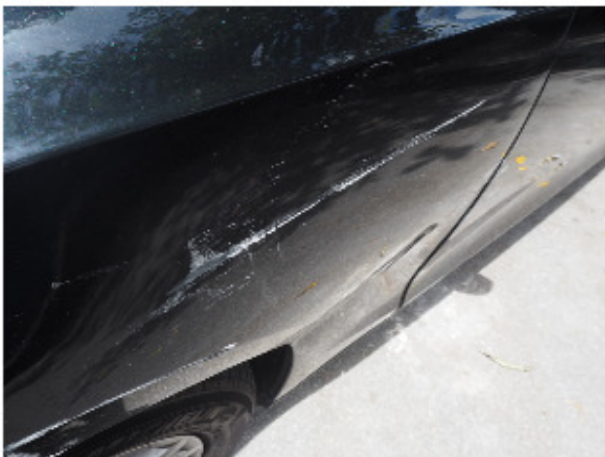
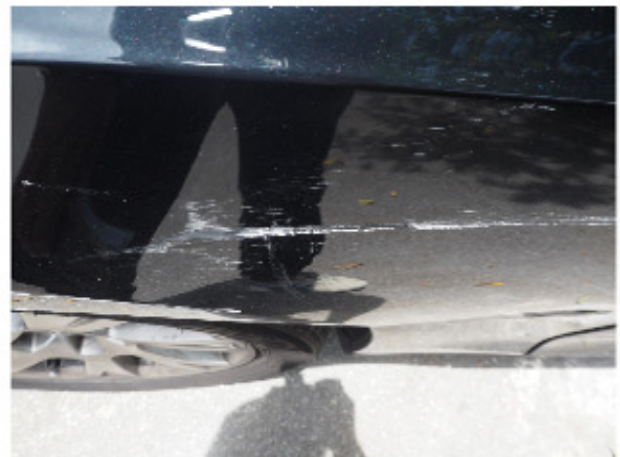
4. Description of Damages				
THE VEHICLE SUSTAINED DAMAGES AT THE N/S BODY. DAMAGES SEE DETAILS.				
5. General Information				
Accident Date	07/09/2020	Inspection Date	09/09/2020	
Survey held at	AUTOMOBILE HUB ENTERPRISE 1 KAKI BUKIT AVENUE 6 #02-11 AUTOBAY SINGAPORE 417883			
5a. Remarks				
A)THE INSPECTION WAS CONDUCTED ON A"WITHOUT PREJUDICE" BASIS. B)IN ACCORDANCE TO YOUR INSTRUCTIONS, WE HAVE NOT AUTHORISED REPAIRS.				
5b. Estimate Days of Repair				
ESTIMATED NORMAL PERIOD FOR REPAIR:		3 Working Days

50.00	-
	<u>LABOUR</u>			
	PANEL BEATING,REMOVE AND REFIT PARTS.INCLUSIVE OF THE REPAIR OF FRONT DOOR LH AND FRONT DOOR WING MIRROR COVER LH.		800.00	500.00
	SPRAY PAINTING TO AFFECTED AREA.		800.00	600.00
	WIRING CHECK.		50.00	30.00
	TUFF COAT.		150.00	50.00
	TO TRANSFER FRONT DOOR FITTINGS.	NOT NECESSARY	150.00	-
	TO PERFORM WHEEL ALIGNMENT.	NOT NECESSARY	150.00	-
			2,100.00	1,180.00
	GRAND TOTAL		9,142.95	2,188.90
	RECOMMENDED COST OF LUMP SUM REPAIRS (TO ITS PRE-ACCIDENT CONDITION)			1,750.00
