VEHICLE INSPECTION REPORT

Report No. : PAS/TP/0100120

Vehicle Registration No. : SJW4189Z
Make & Model : Toyota Corolla Altis
Date of Registration : 17/03/2009
Colour : Met. Blue

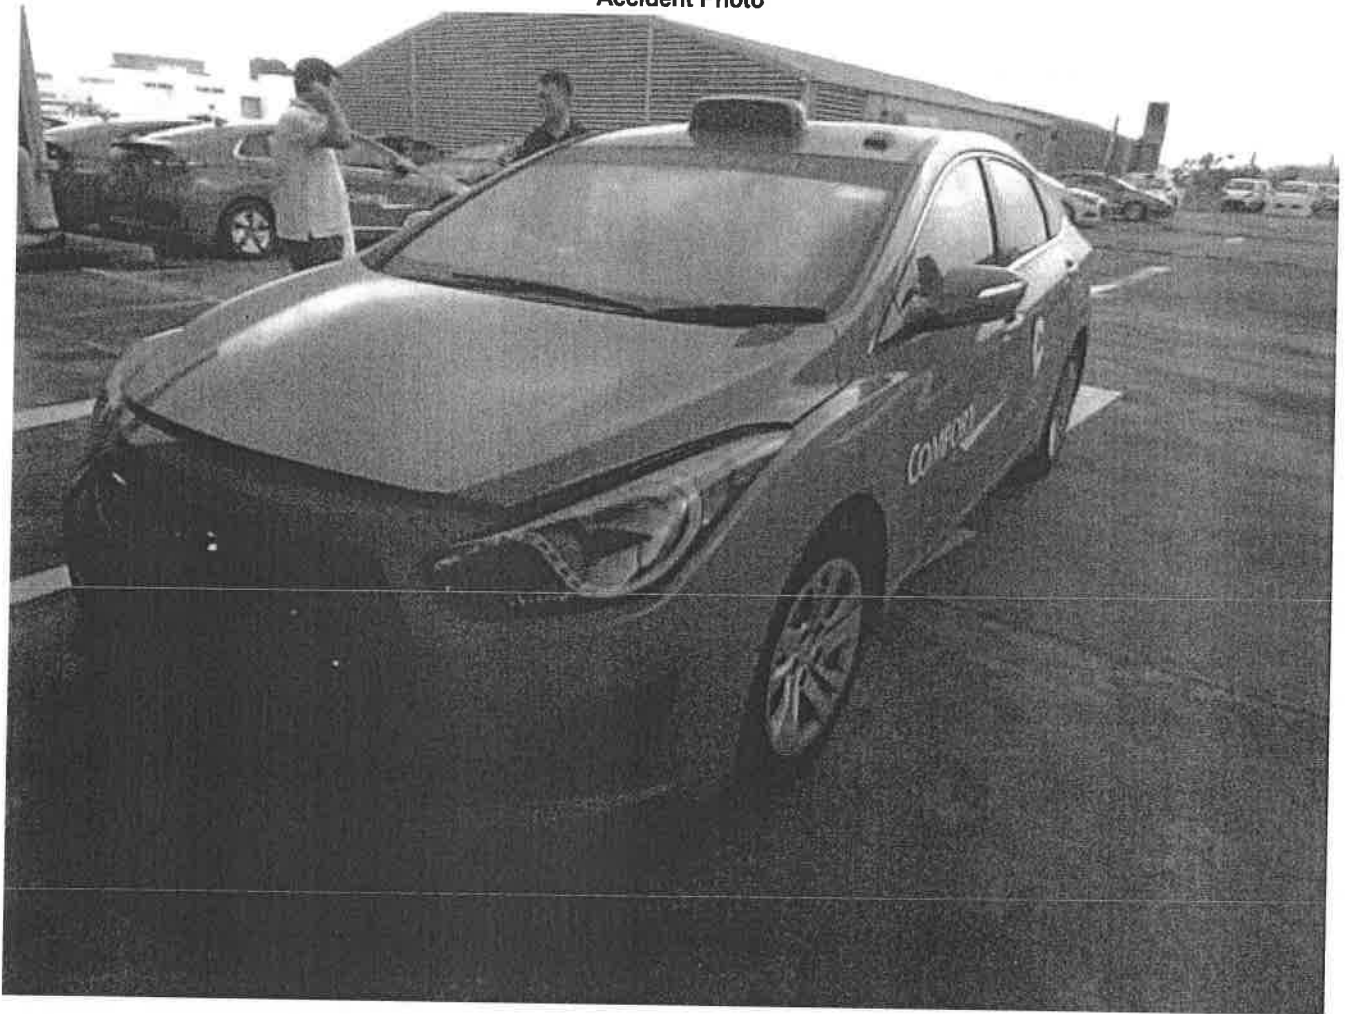
Accident Photo

At the front portion.

The bonnet, front bumper, front support panel, front chassis members, front fenders, RHF apron panel, RHF wheel house, radiator assy, a/c condenser, headlamps, front grilles, etc.

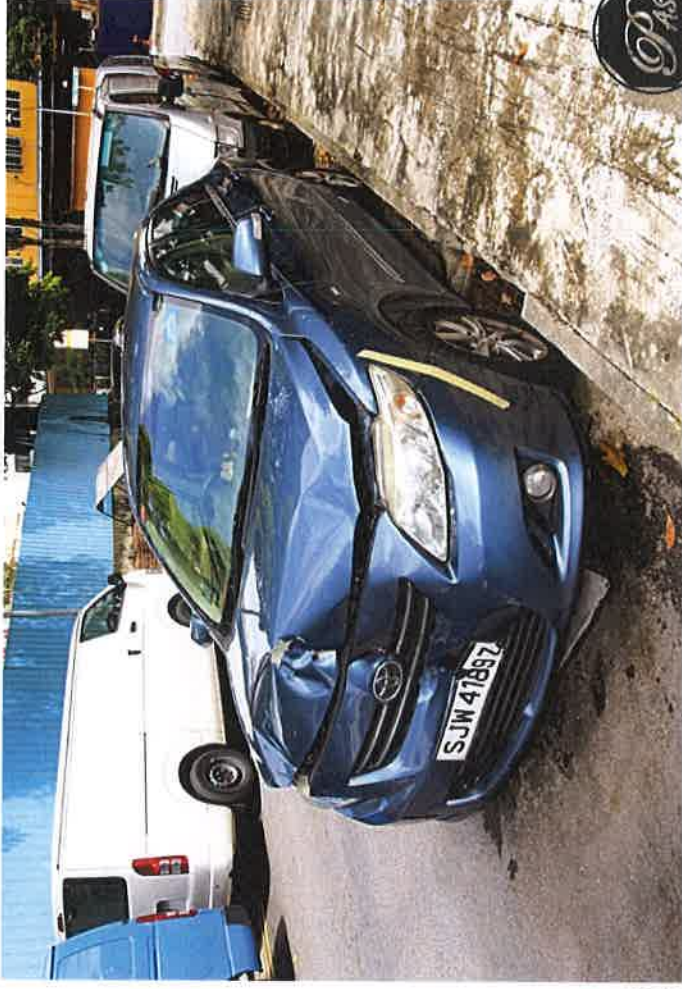
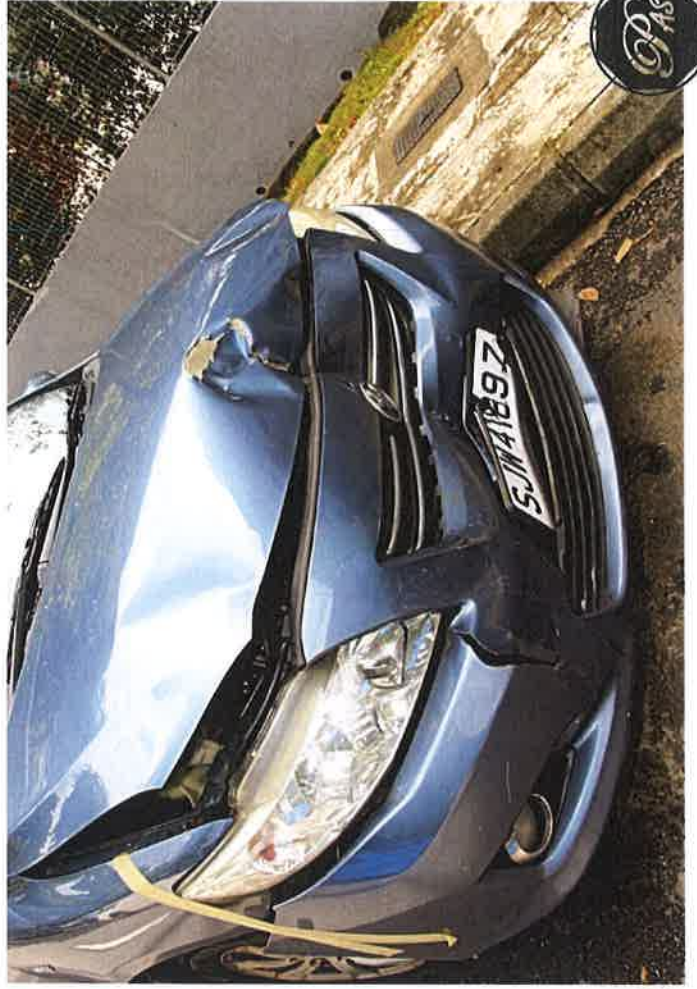
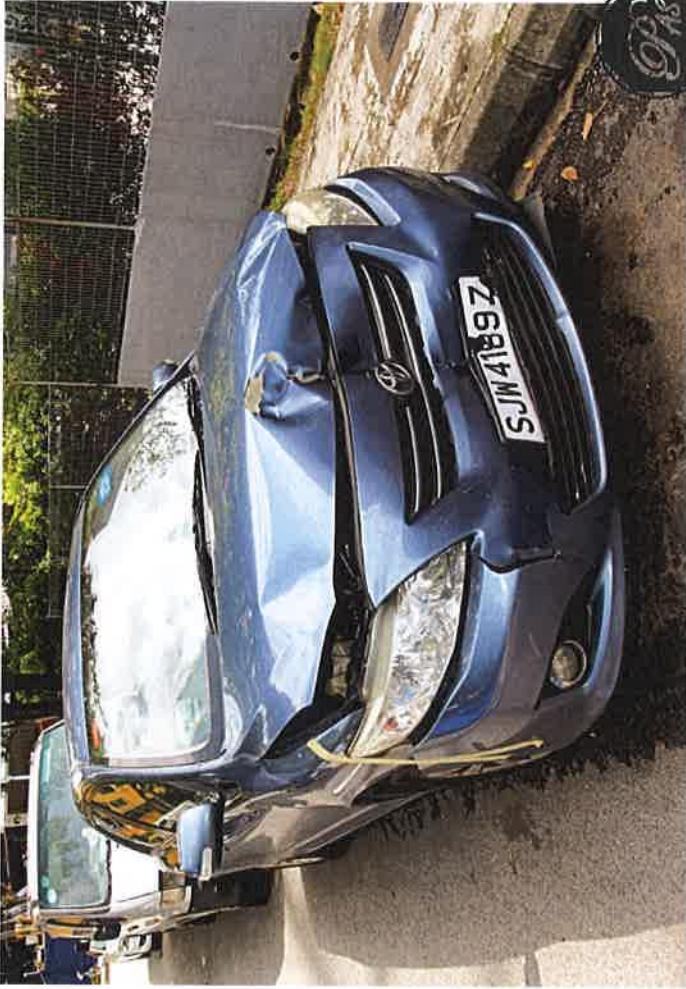
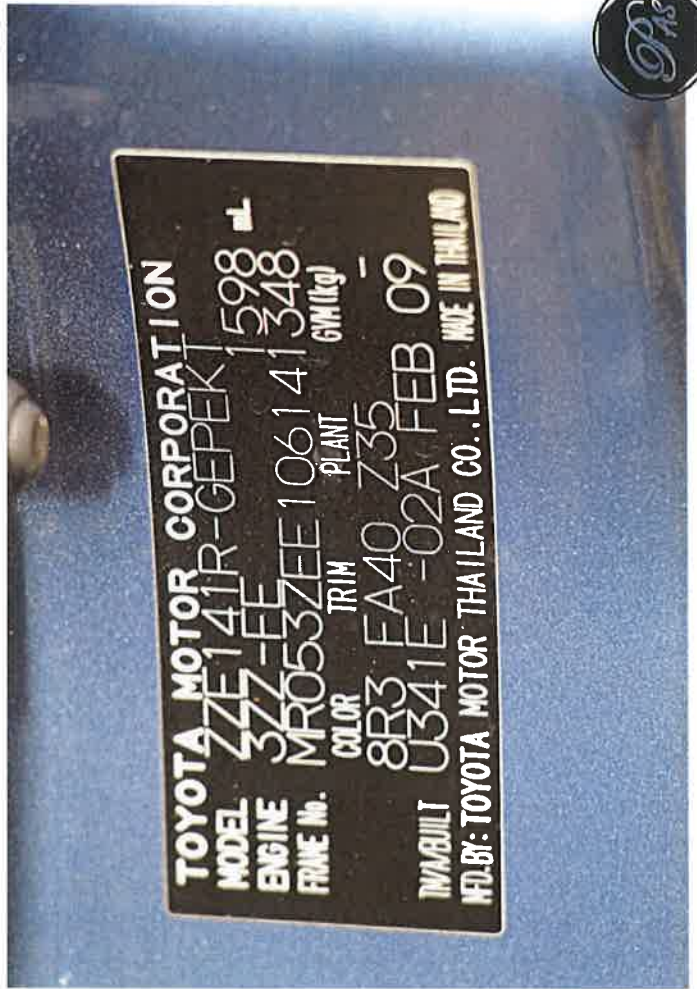
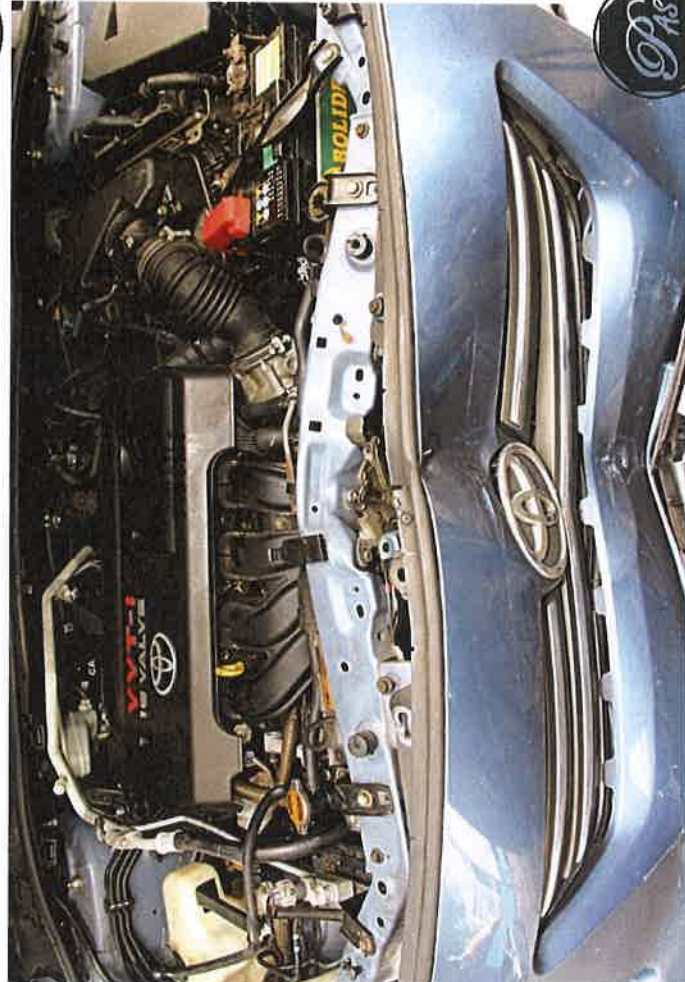
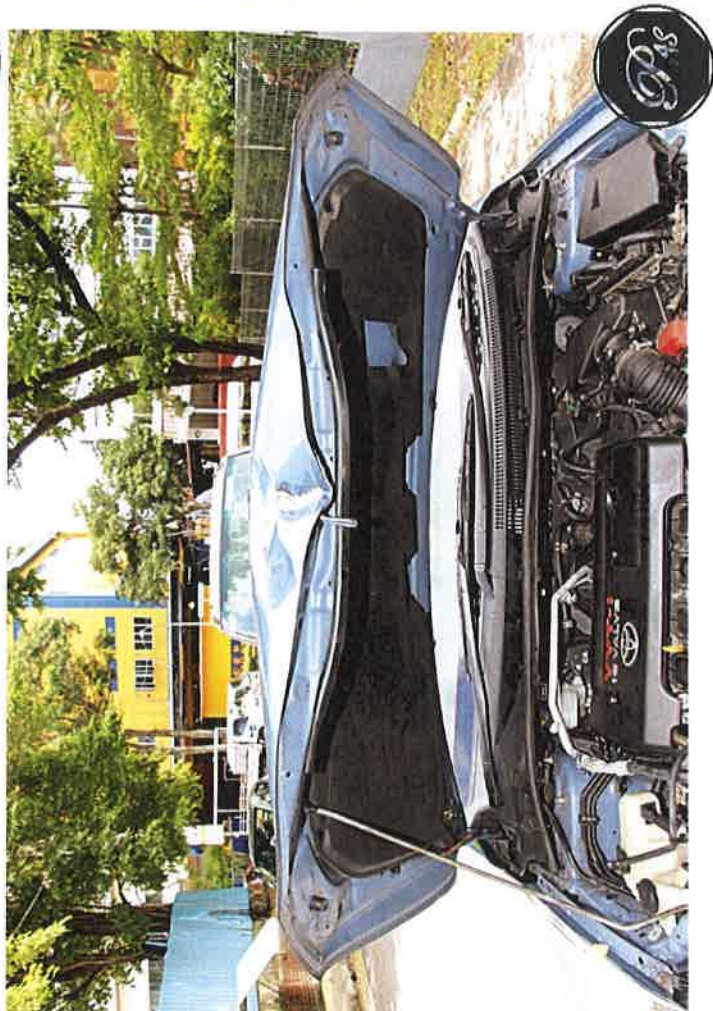
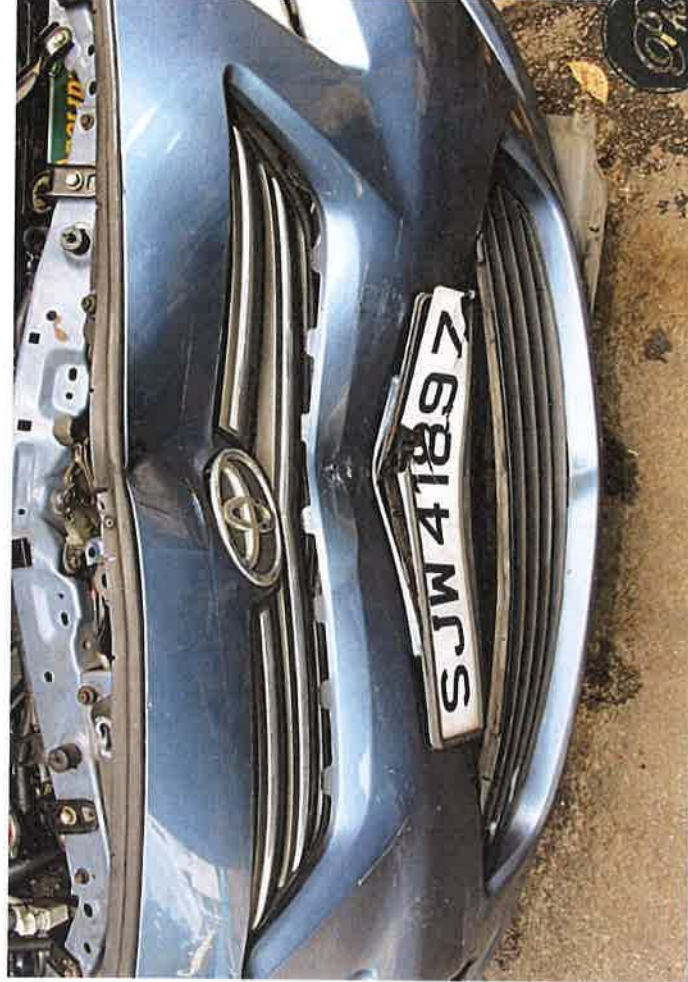
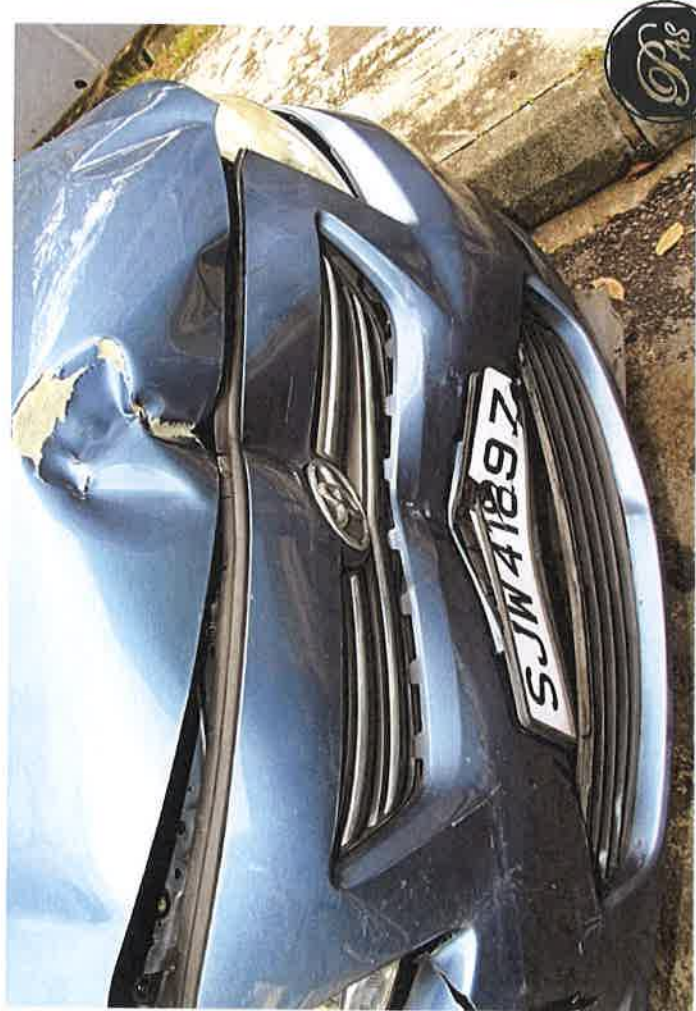
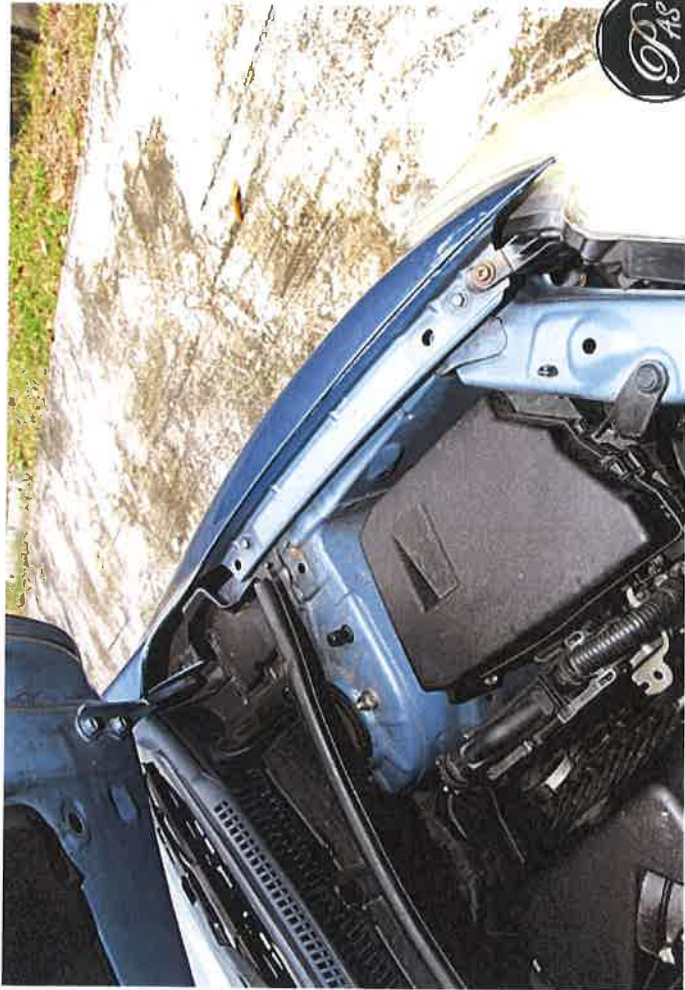
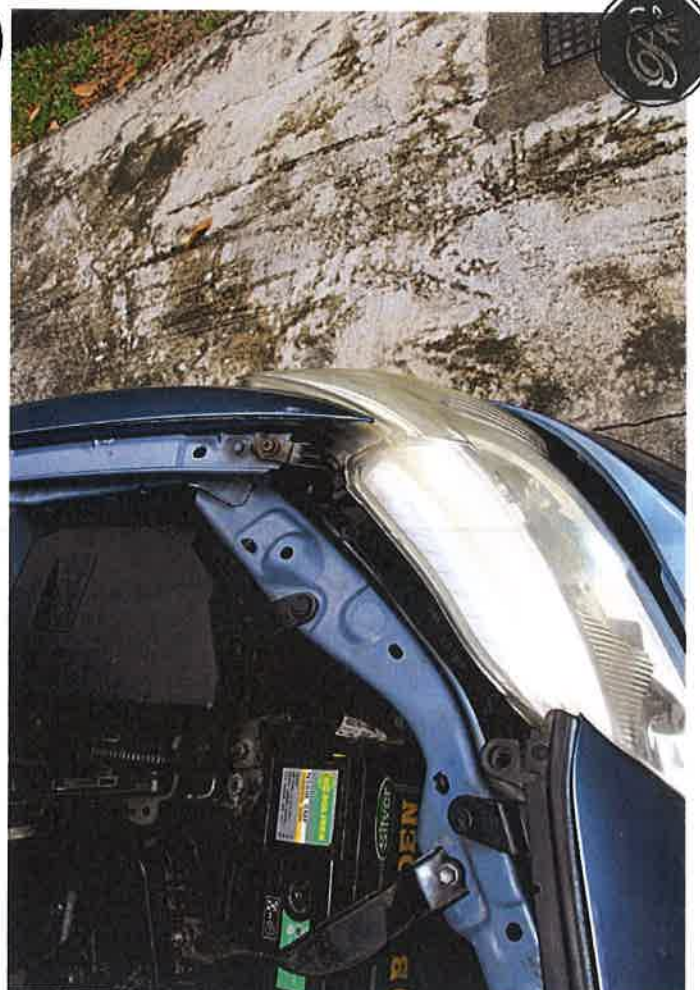
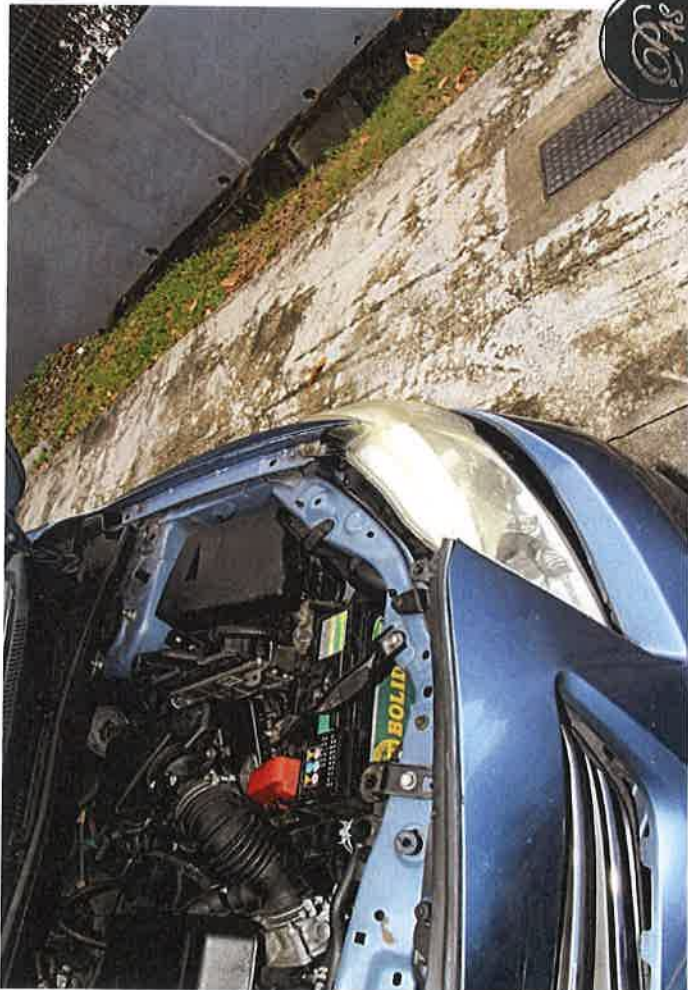
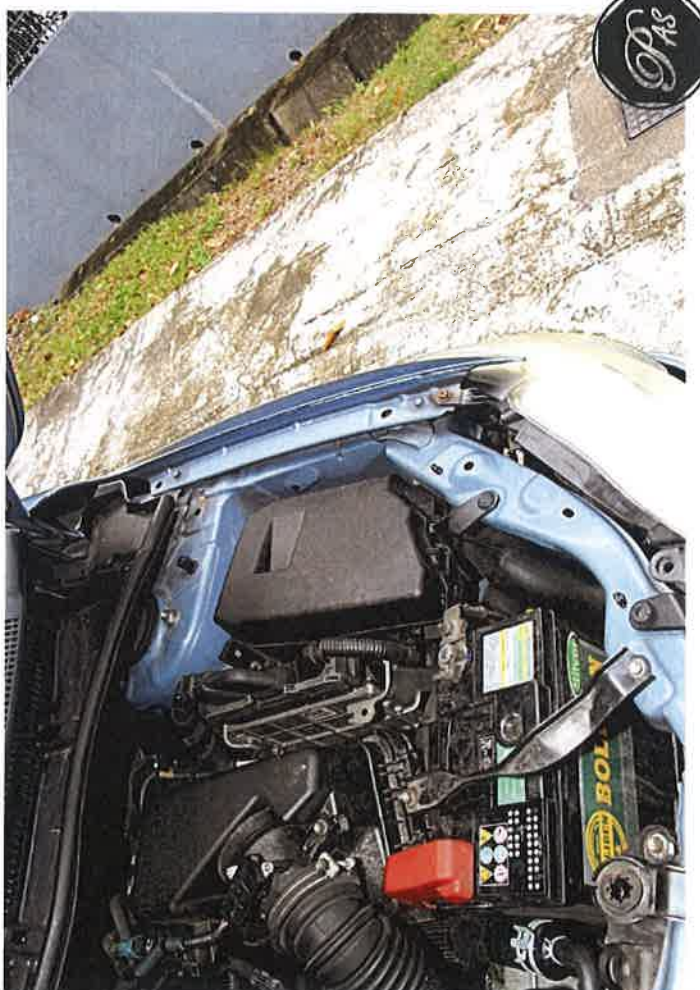
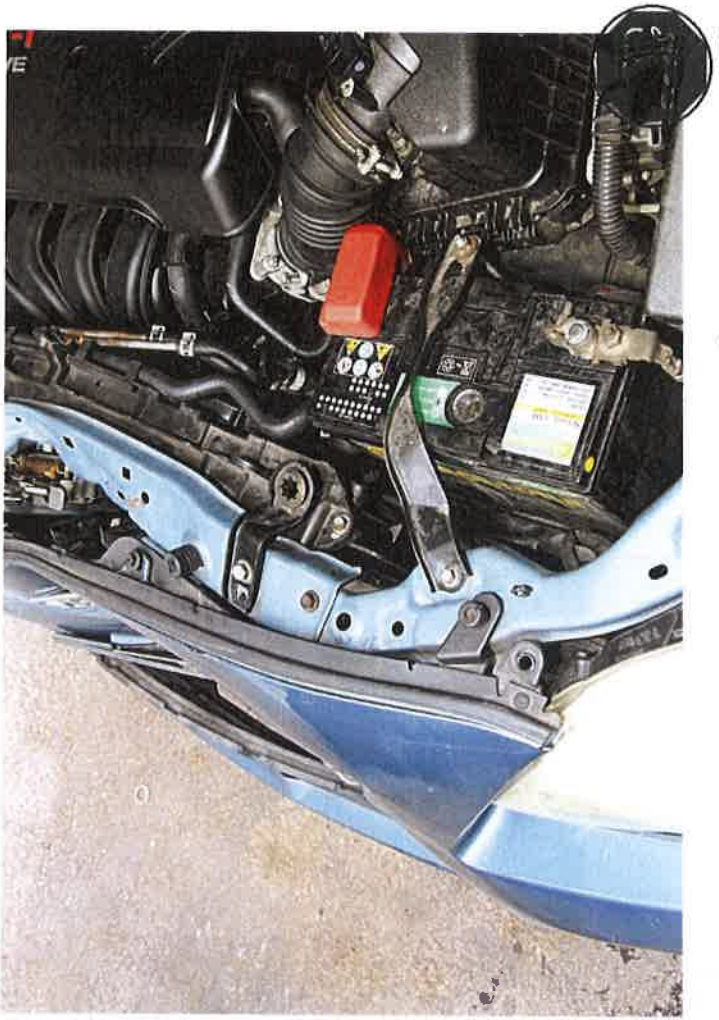
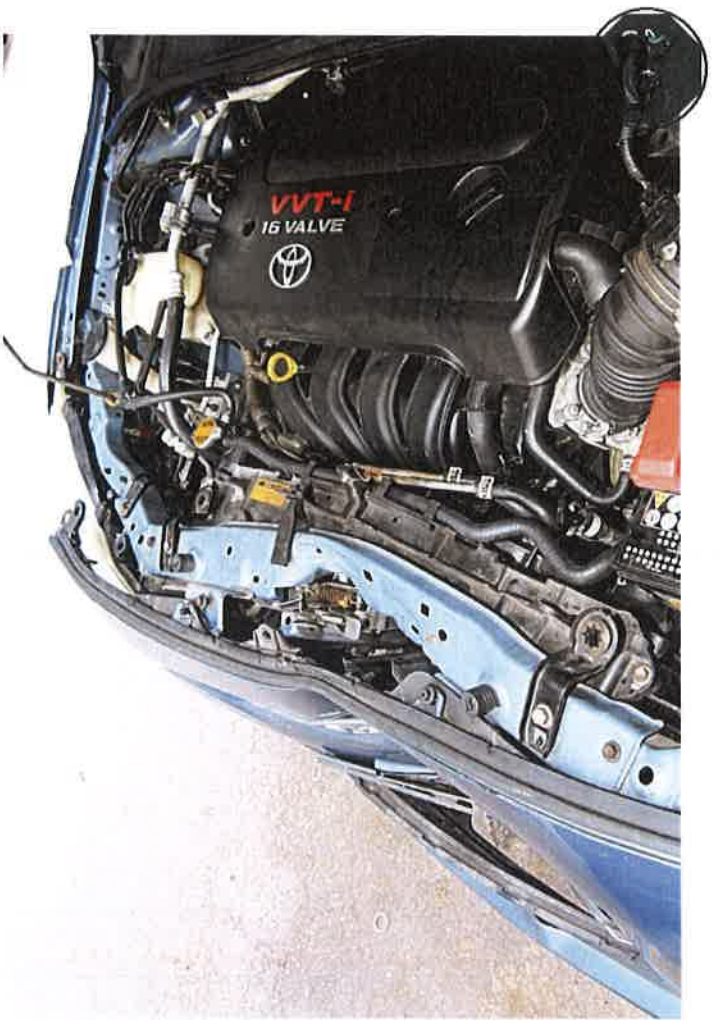
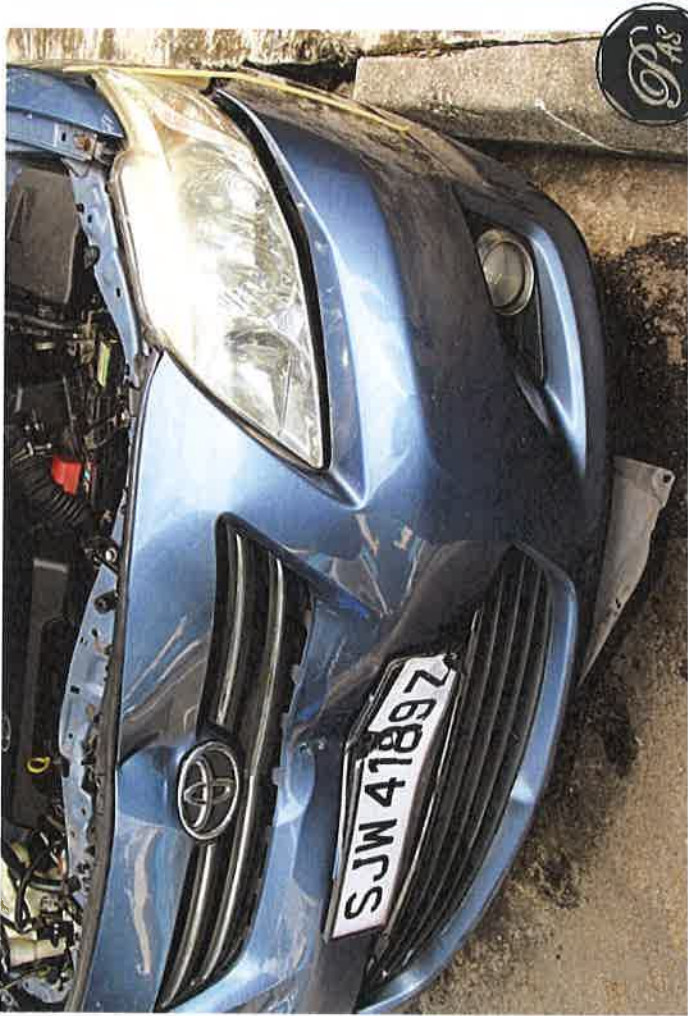
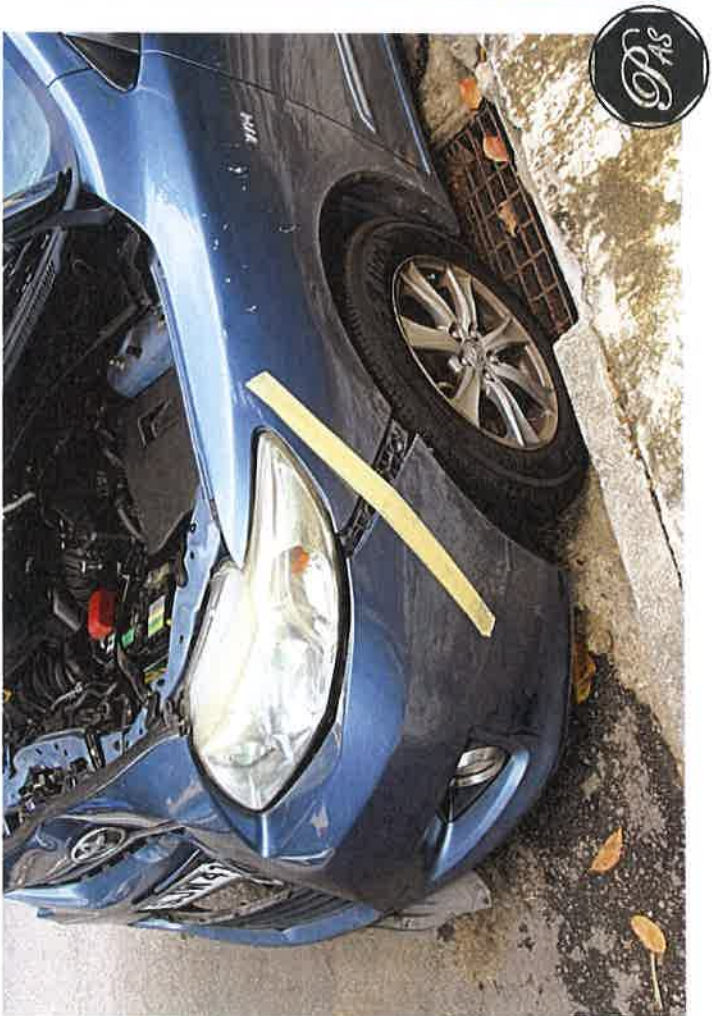
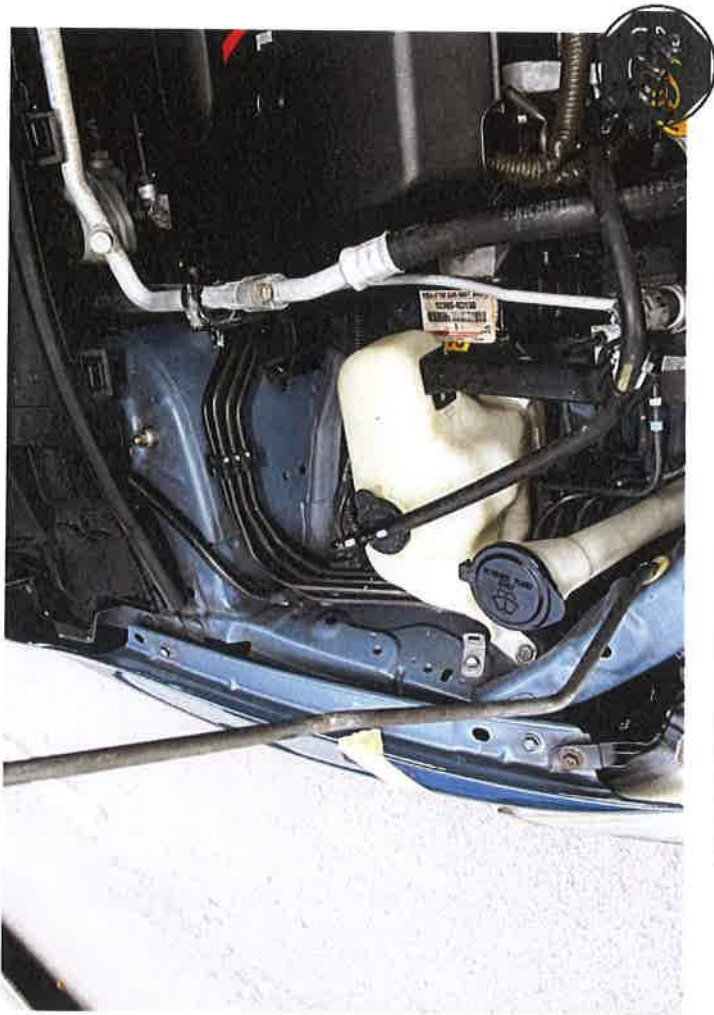
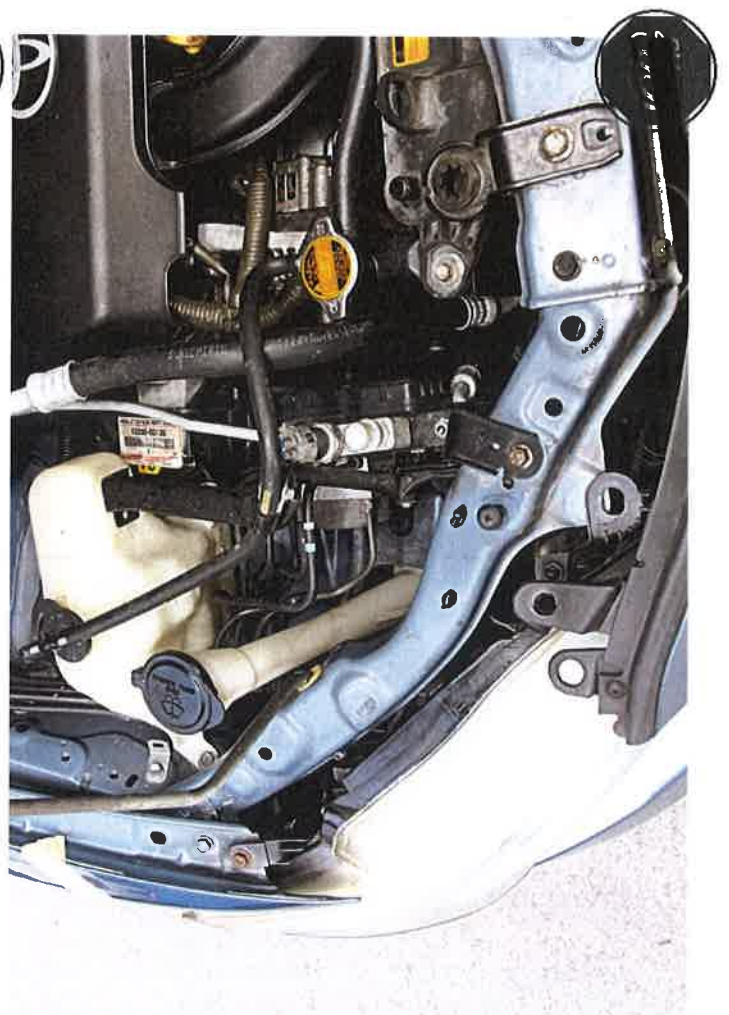
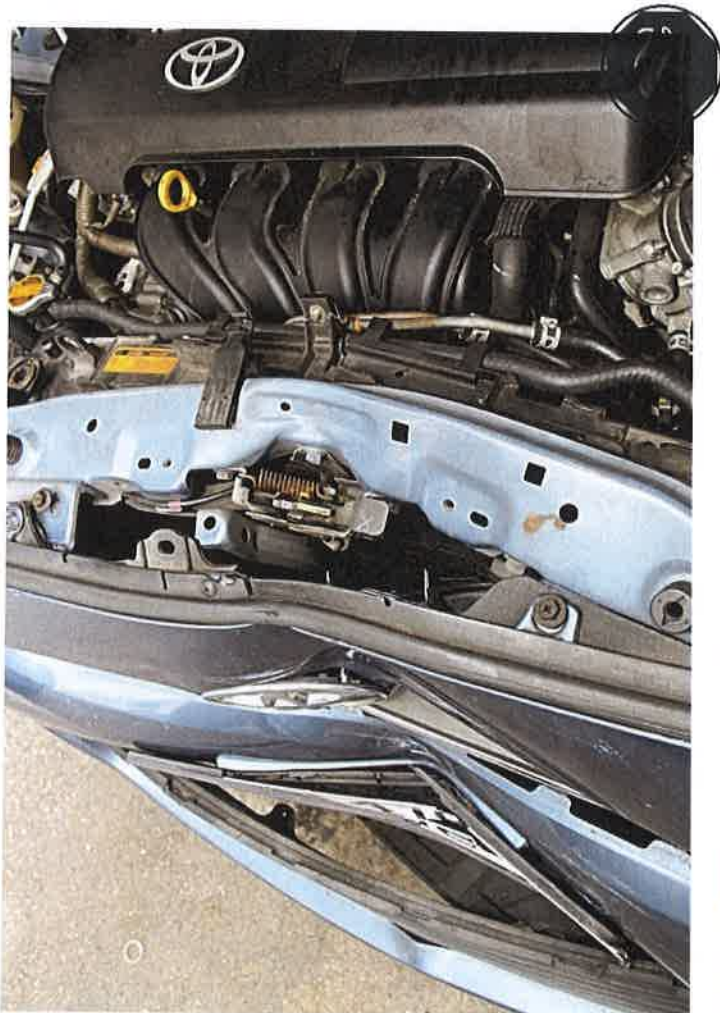
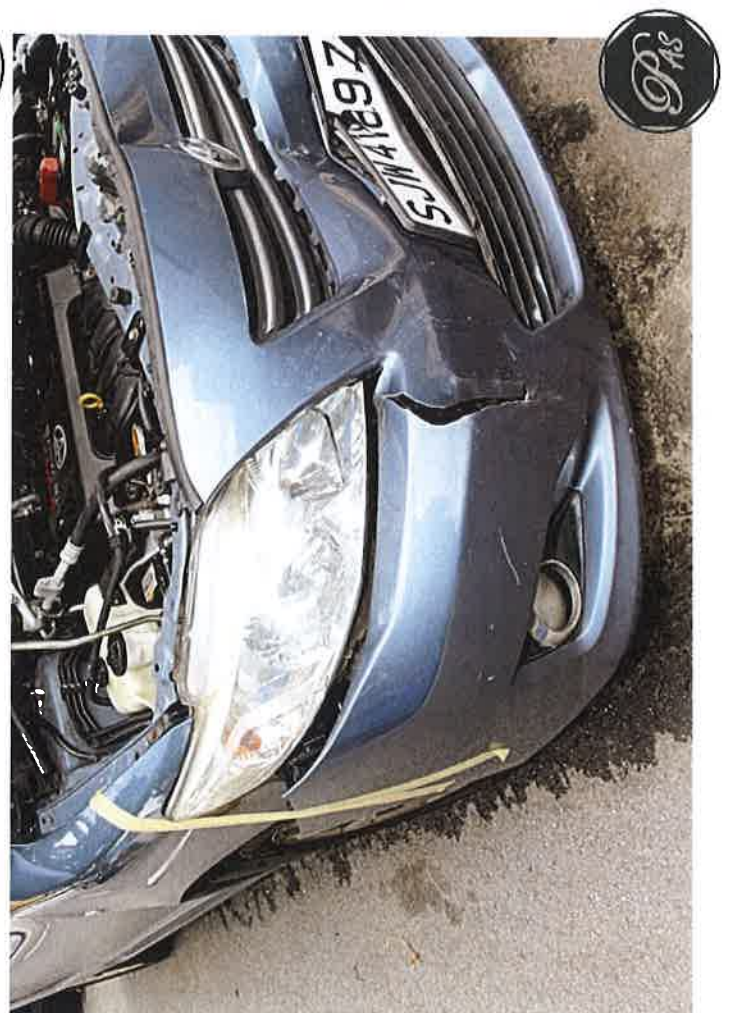
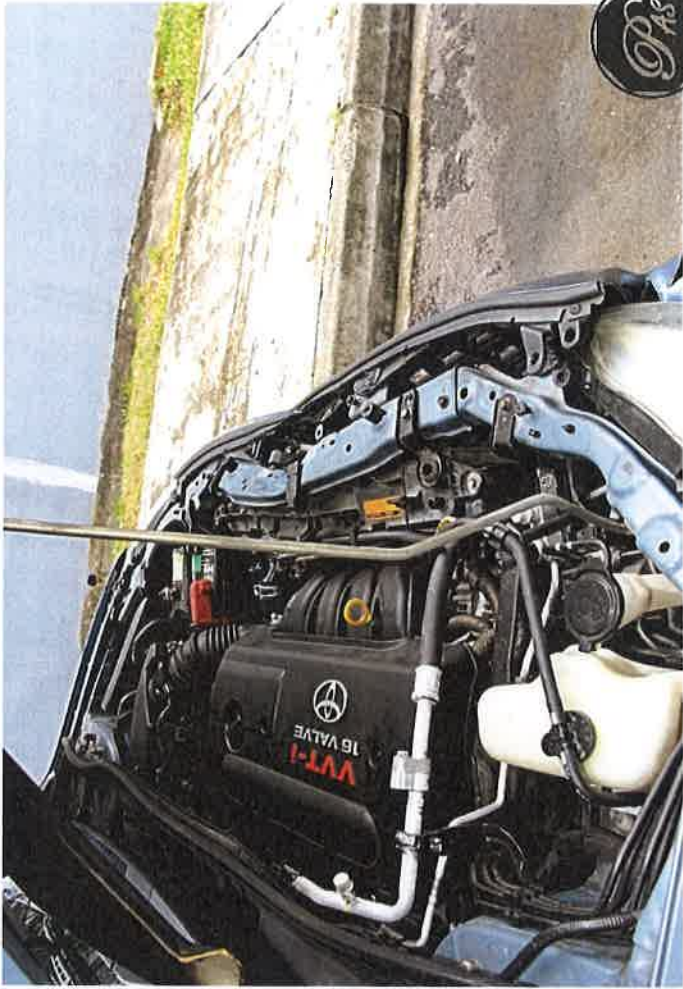
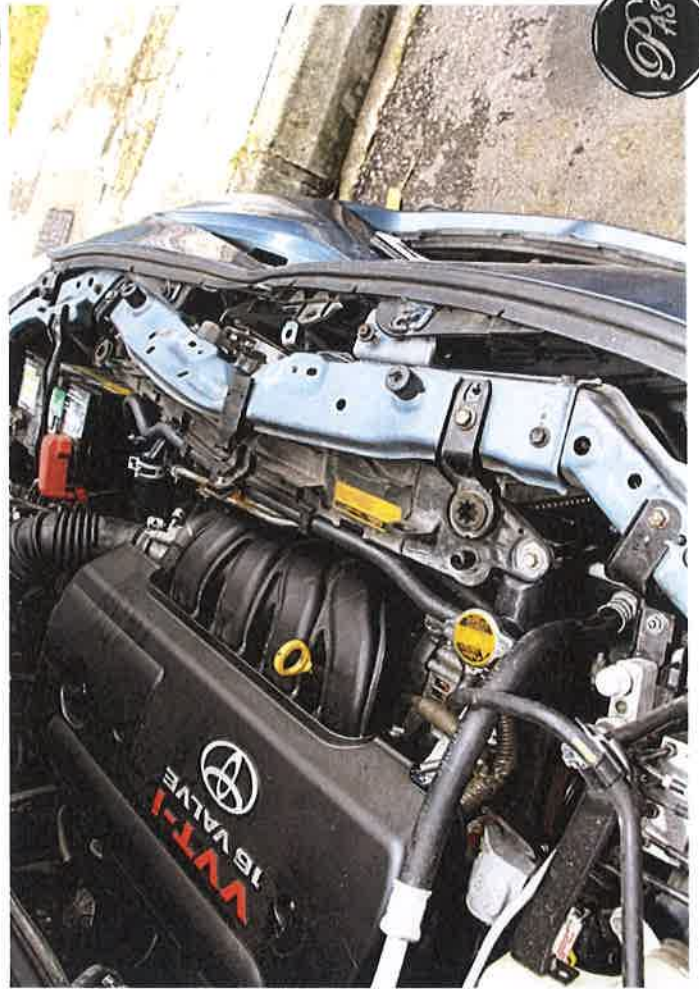
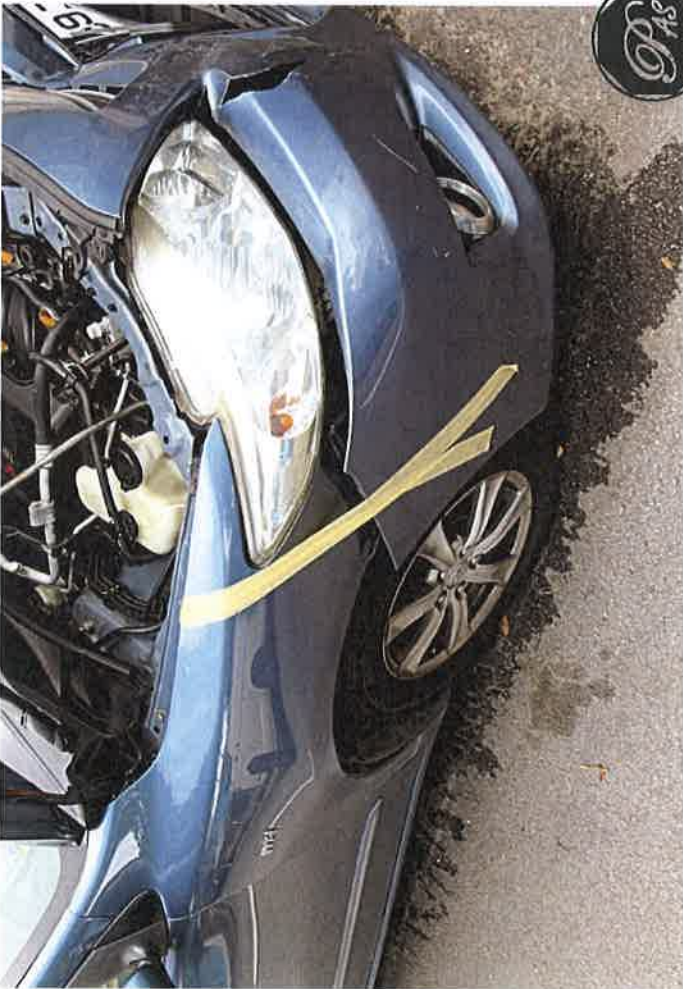
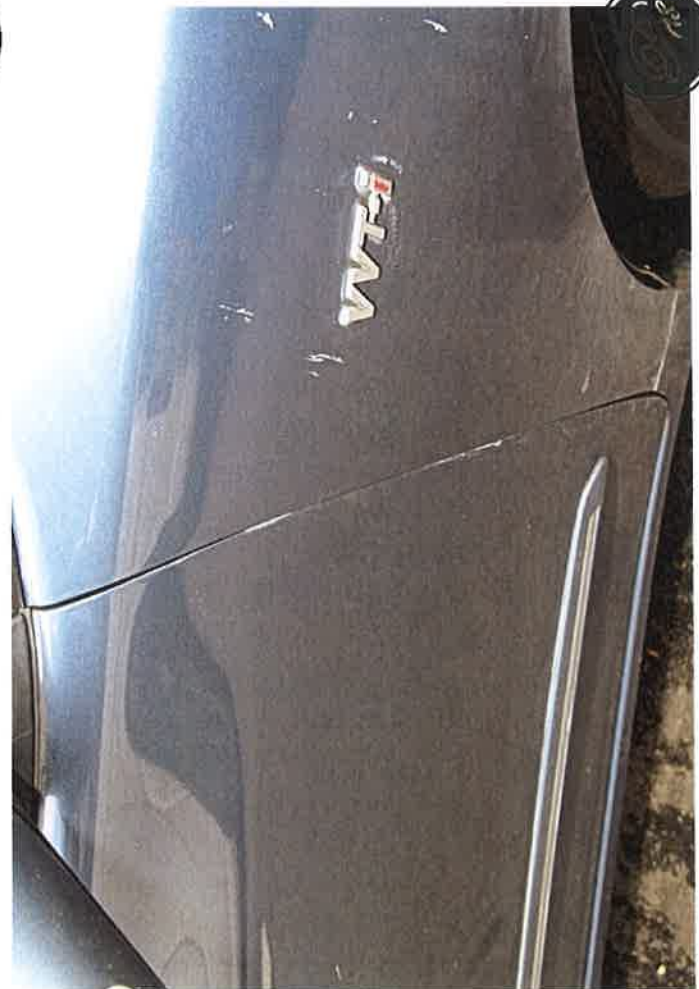
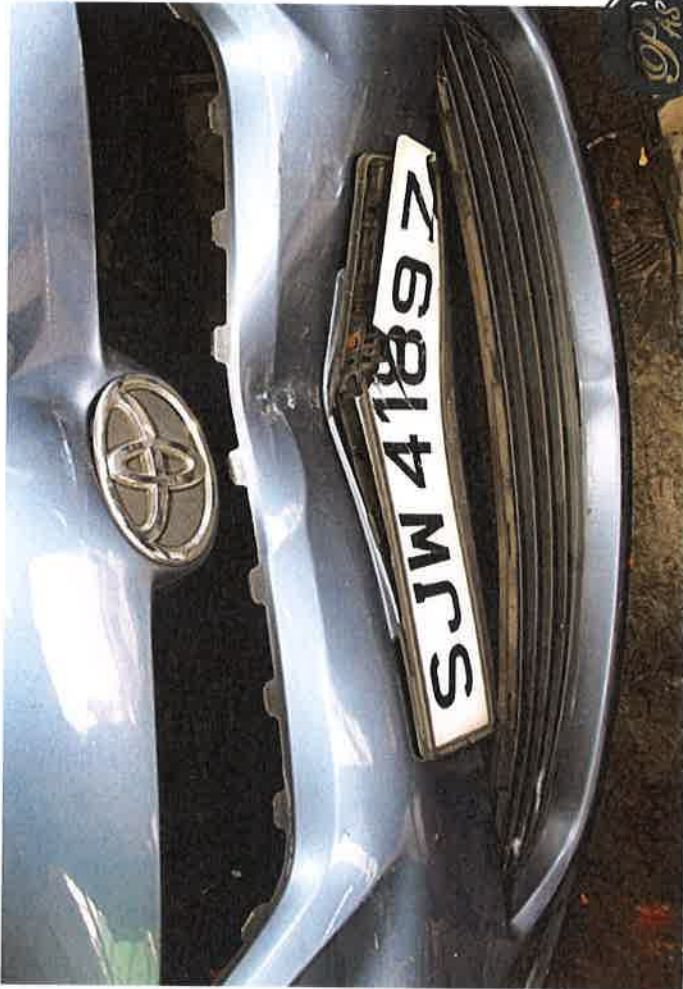
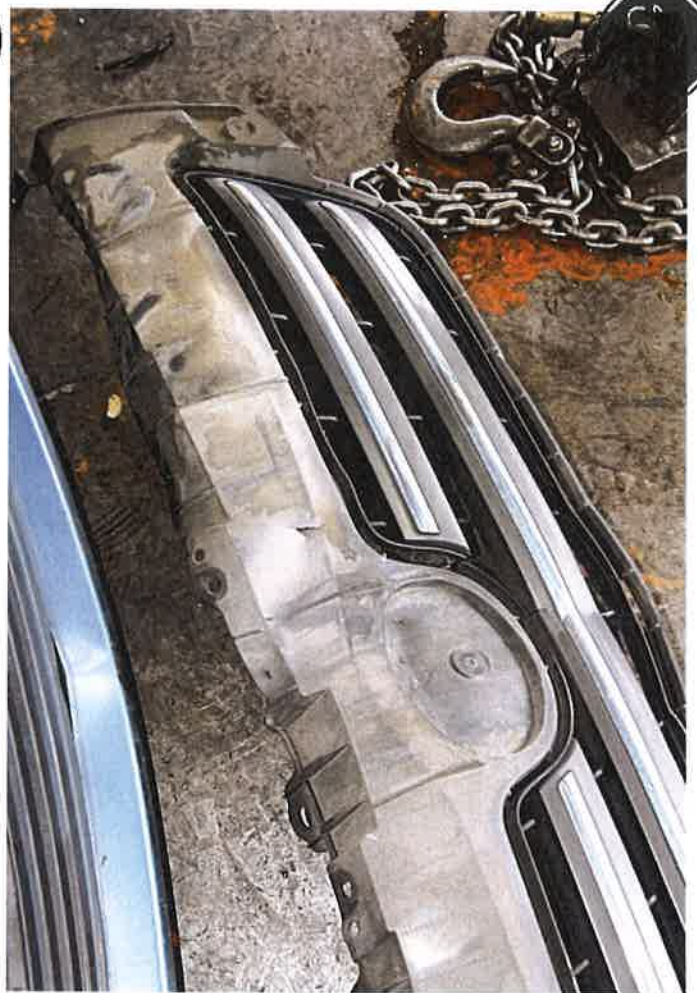
64 Photographs were taken at the time of inspection.

Other parts were also found damaged. (See schedule for details)

We have inspected thoroughly each and every item on the repairer's estimate against the actual damaged found on the vehicle. We list the breakdown of our findings and our recommendation as per schedule attached.

The repairer has agreed to undertake the repairs at a lump sum of SGD \$9,880.00.
